Pavement Condition Rating Summary 2024

Non-State Federal Aid Eligible Roadways
(as of August and September 2024)

BMTS

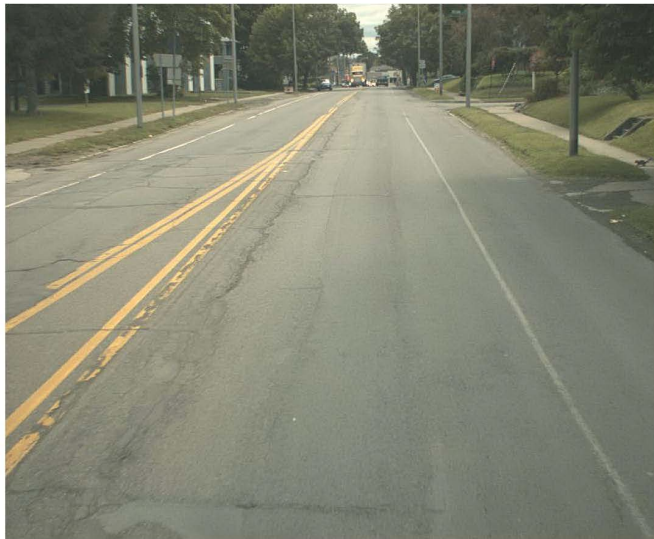
5
Poor

Frequent

Moderate
to
Severe

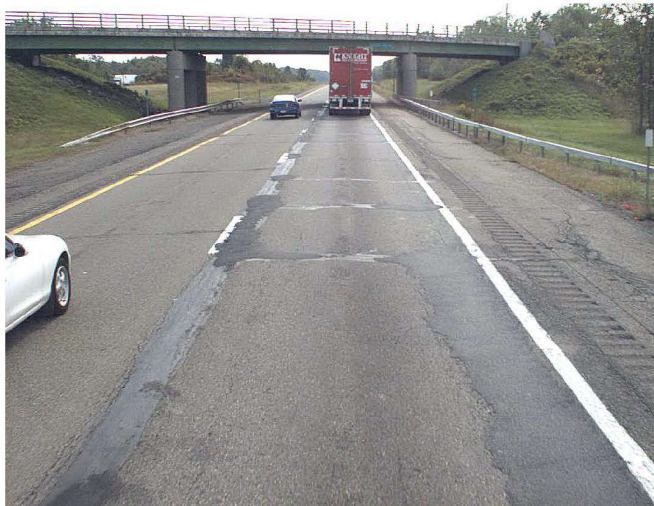
F-14

5
Poor

Frequent

Moderate
to
Severe

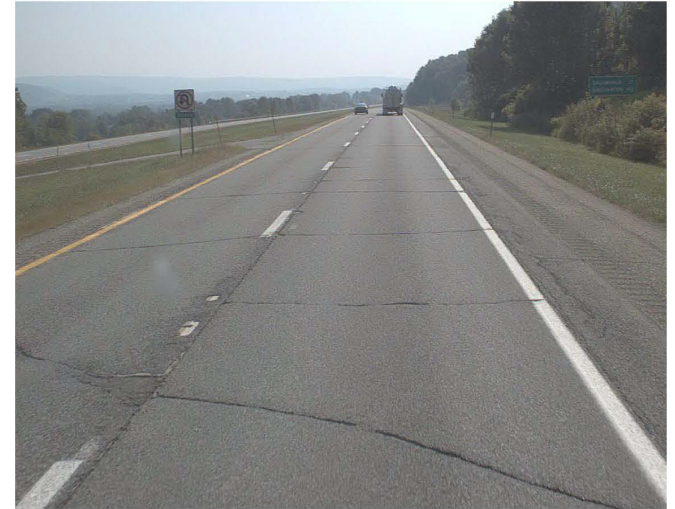
6
Fair

Frequent

Moderate

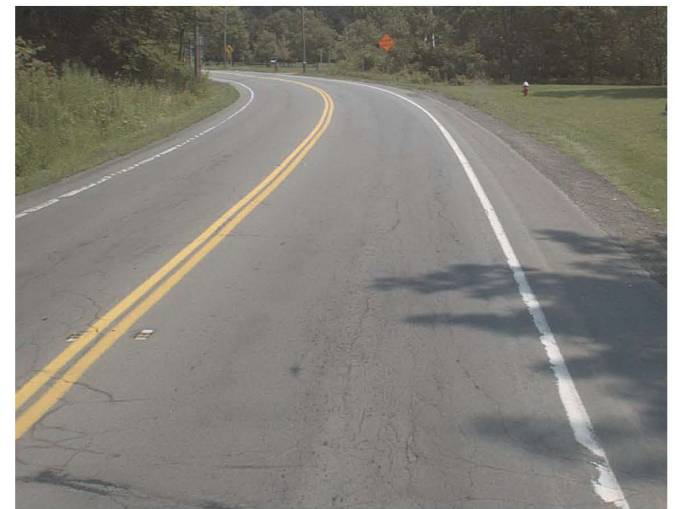
F-13

6
Fair

Frequent

Moderate
