# Two Rivers Greenway Trail Maintenance Report

PREPARED BY BMTS CENTRAL STAFF

# About the 2026 Trail Maintenance Report

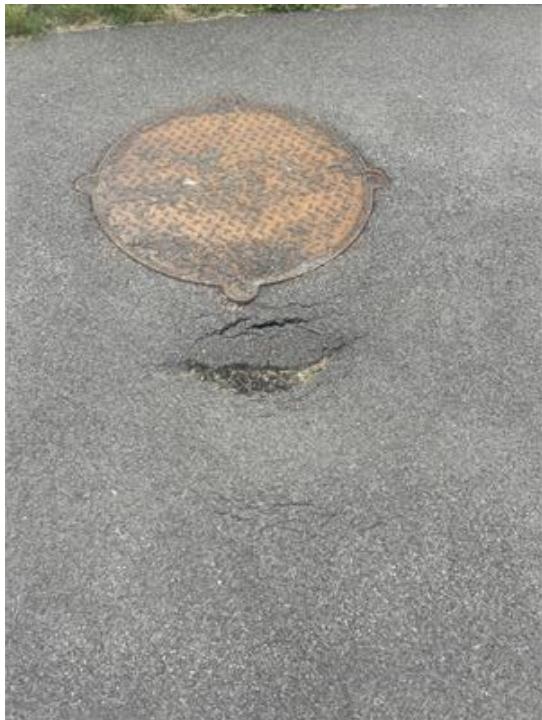
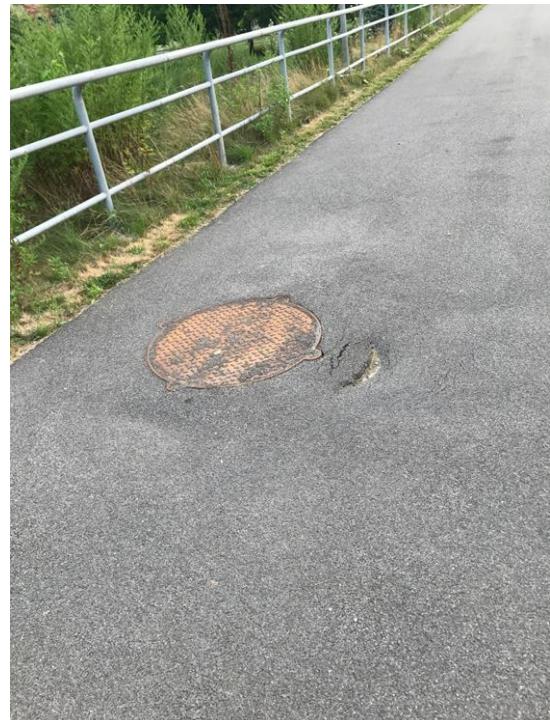
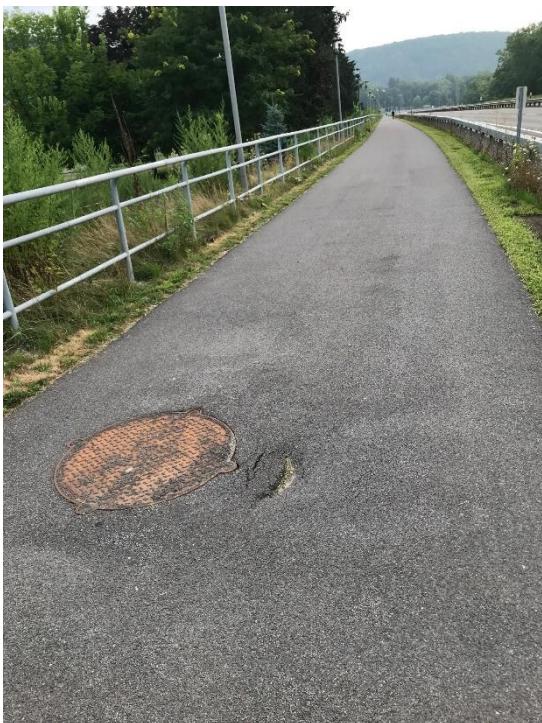
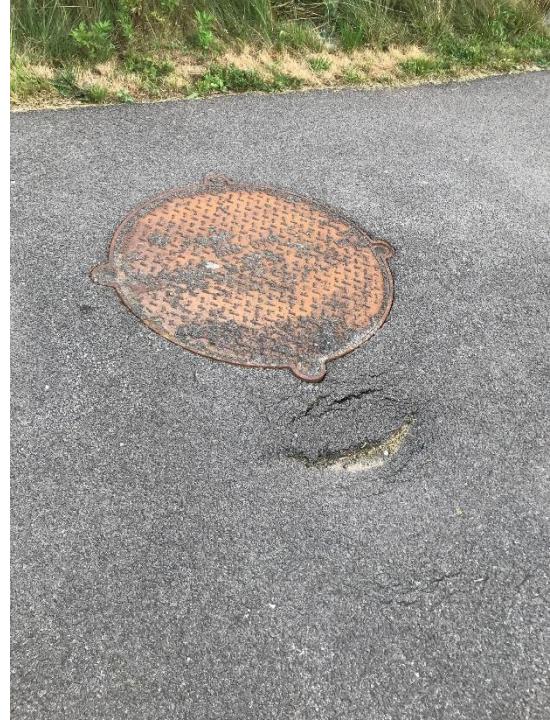
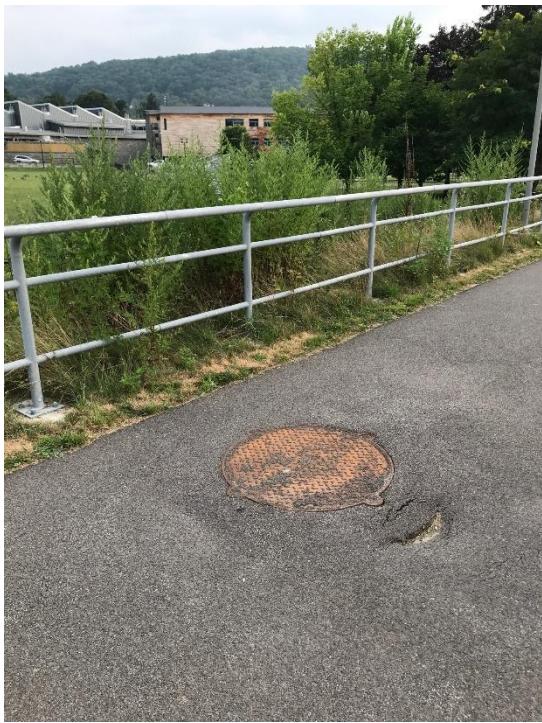
There was only one major issue on the 434 Greenway. On the Hallam Street to MacArthur Park sub-section, a manhole is sinking into the pavement, posing a hazard to pedestrians and bikers (see Appendix B, Photos 1-5).

*Photo 1: Cracking/Depression at Hallam Street to MacArthur Park (View 1)*

*Photo 2. Cracking/Depression at Hallam Street to MacArthur Park (View 2)*

*Photo 3. Cracking/Depression at Hallam Street to MacArthur Park (View 3)*

*Photo 4. Cracking/Depression at Hallam Street to MacArthur Park (View 4)*

*Photo 5. Cracking/Depression at Hallam Street to MacArthur Park (View 5)*

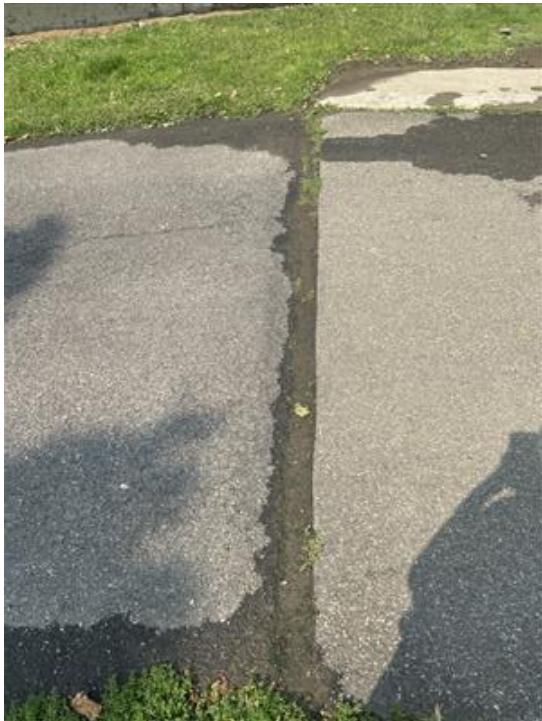
Four major issues were observed along the Binghamton Riverwalk. Three issues concerned large cracks that posed tripping/biking risks for users. These large cracks were located at the Water Street at Susquehanna St. to Holiday Inn (Appendix B, Photo 8), Riverwalk Court Street South (Appendix B, Photo 9), and the E Clinton Street to Eldredge St. segments of the trail (Appendix B, Photo 10) respectively. Sediment buildup and sinking pavement was a problem at the south entrance of the Confluence Tunnel (Appendix B, Photos 6 and 7).

*Photo 6: Cracking at Confluence Park*

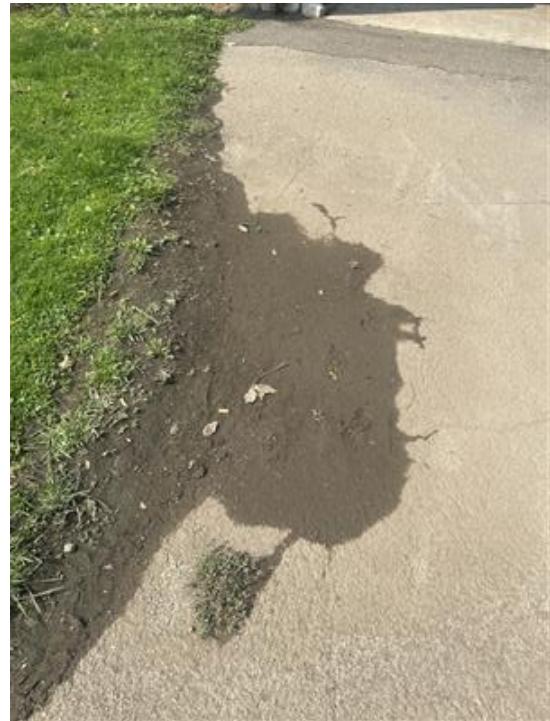
*Photo 7: Depression at Confluence Park*

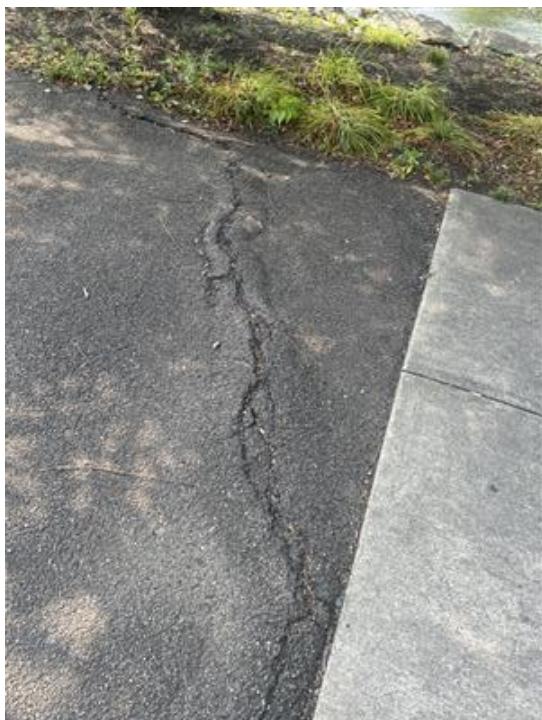
*Photo 8: Cracking at Water Street at Susquehanna St. to Holiday Inn*

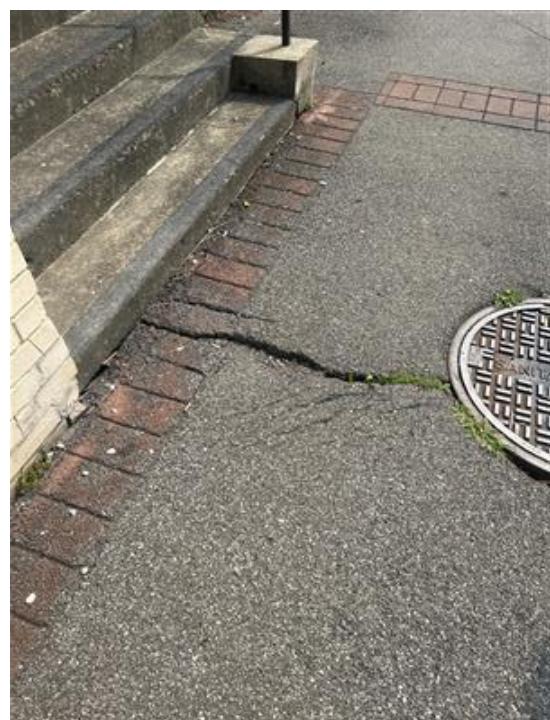
*Photo 9: Cracking at Riverwalk Court Street South*

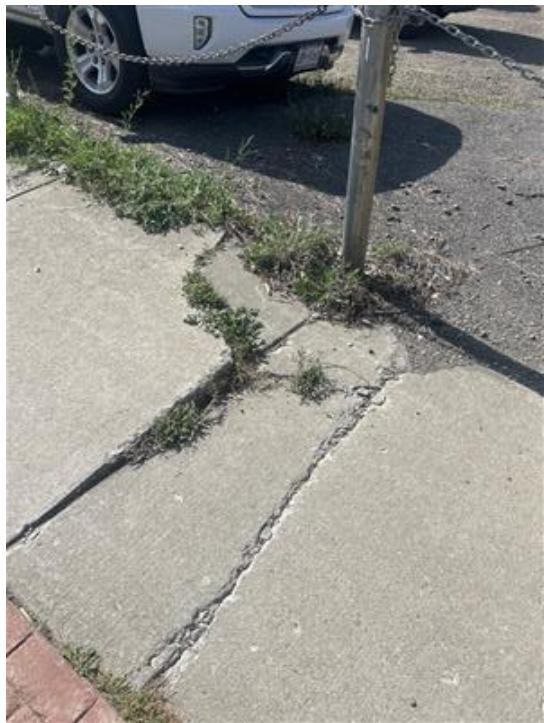
The percentage of good/excellent pavement was decreased by the poor condition of the pavement on the E Clinton Street to Eldredge subsection of the trail. Problems included large cracks and uncontrolled vegetation growth on the pavement (See Appendix A, Photos 8 and 11). The MLK Jr. Monument to E Clinton Street subsections have similar problems, with moderate pavement cracking.

*Photo 10: Cracking and Sinking at E Clinton Street to Eldredge*

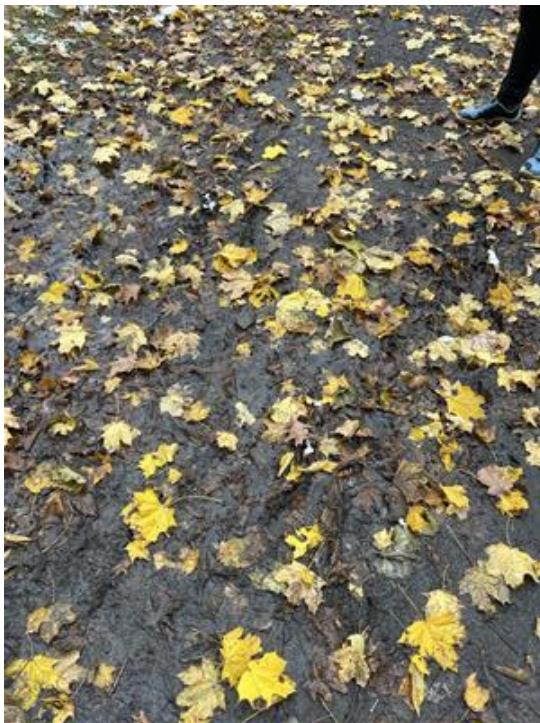
Four major issues were noted along the Chugnut Trail. Three issues involved depressions in the pavement, causing pooling water which obstructed the trailway and muddy conditions (Appendix B, Photos 11-13). The uneven pavement also poses a tripping hazard. One issue involved severe pavement cracking surrounding a manhole cover (Appendix B, Photo 14).

*Photo 11: Depression at Riverview Park to Southern Tier Community Center*

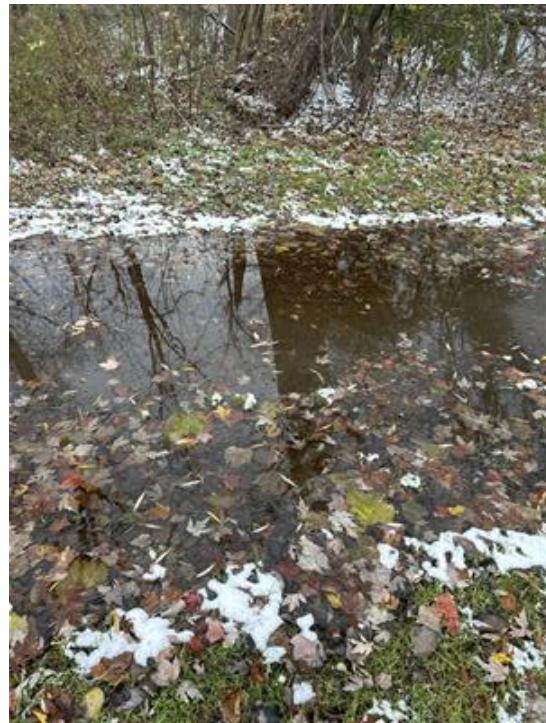
*Photo 12: Depression at Riverview Park to Southern Tier Community Center*

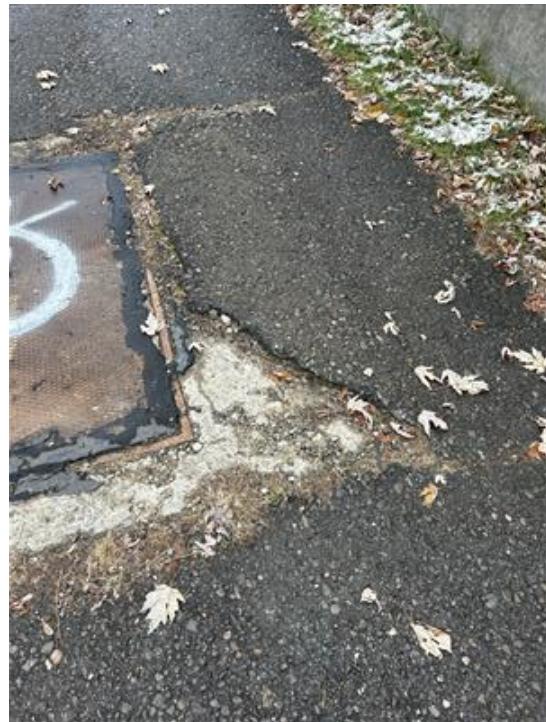
*Photo 14: Cracking at UE Tennis Courts to Endicott Village Water Department*

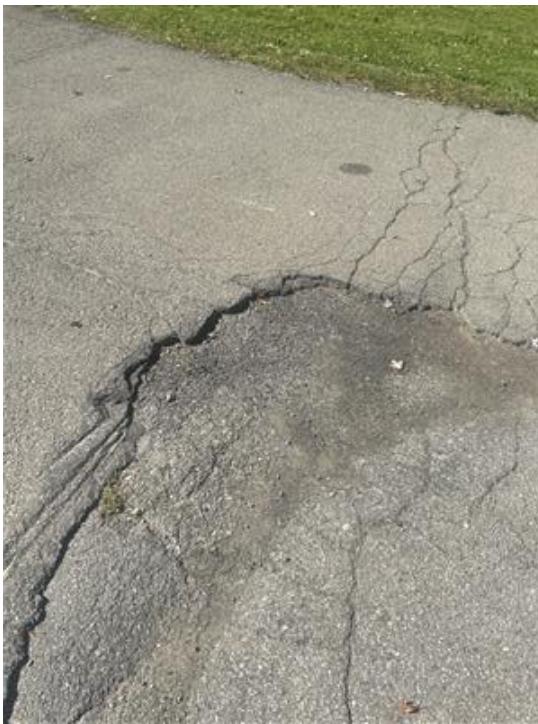
Seven major issues were observed on the Otsiningo Park Trail. Problems included pavement settling and cracking. Cracking was especially a problem on trail edges. The subsections with noted trail erosion were the northern Upper Front Street, the Otsiningo Riverwalk, Lake Loop West, and the Otsiningo Park/Route 11 Connection sub-sections (See Appendix B, Photos 15-21).

Photo 15: Cracking and Depression at Otsiningo Park/Route 11 Connection

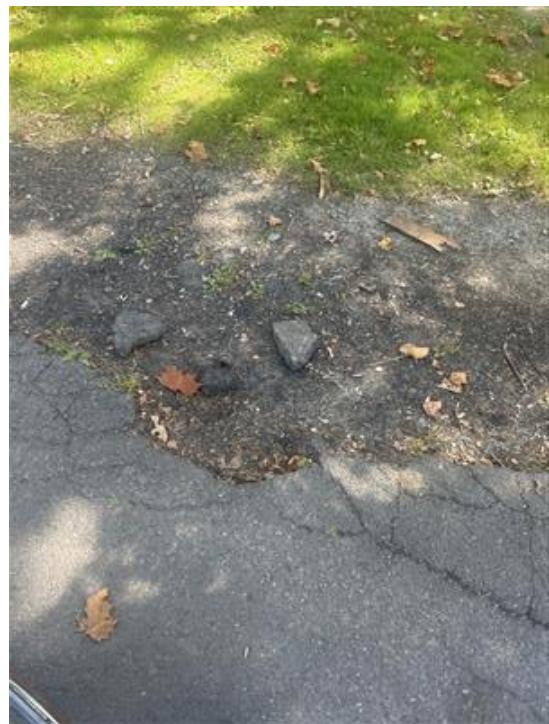
Photo 16: Cracking at Lake Loop West

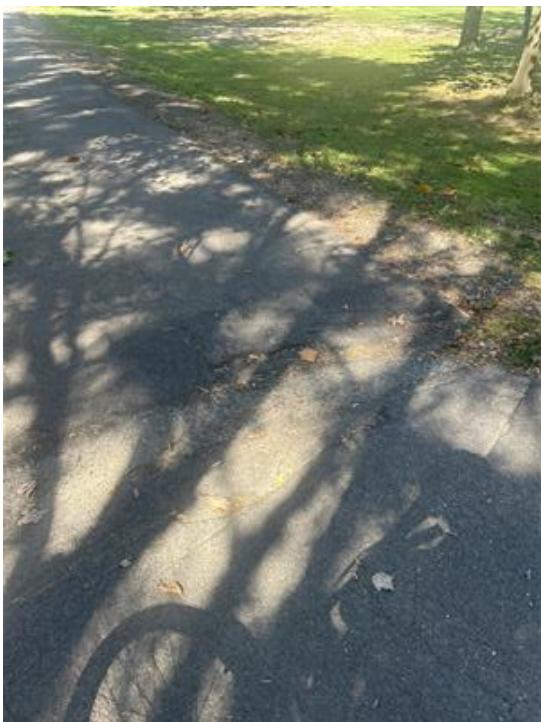
Photo 17: Unevenness at Otsiningo Park Loop Southwest

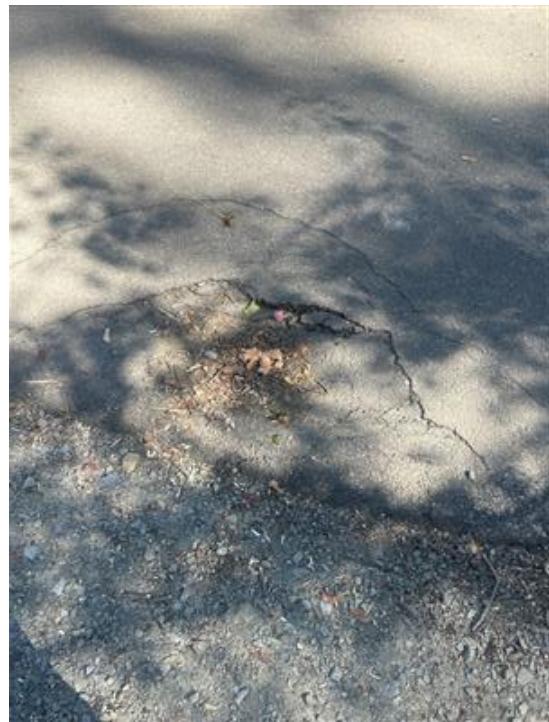
Photo 18: Cracking and Depression at Otsiningo Park Loop East

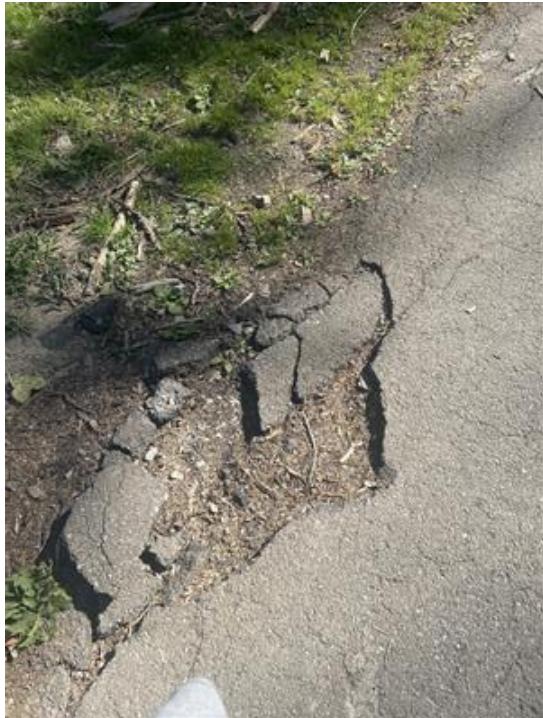
*Photo 19: Cracking at Otsiningo Riverwalk*

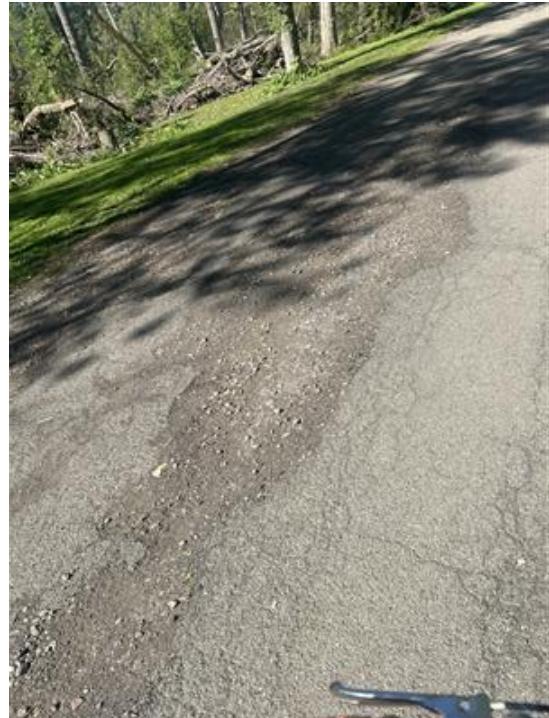
*Photo 20: Cracking and Raveling at Northern Upper Front Street*

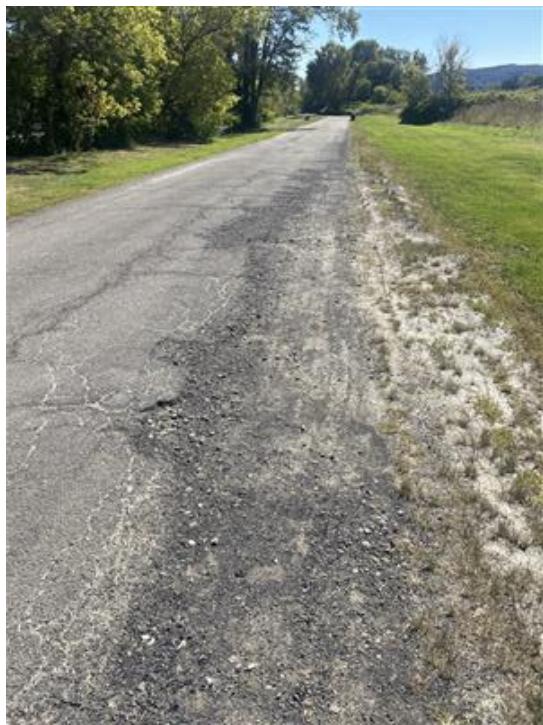
*Photo 21: Cracking and Raveling at Northern Upper Front Street*

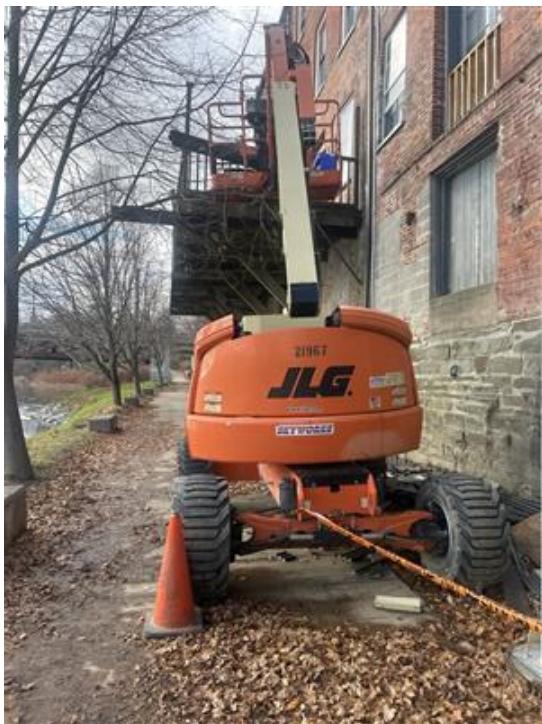
There was only one issue on the trail, an articulating boom lift was obstructing the trailway, caused by construction on adjacent properties (See Appendix B, Photo 22).

*Photo 22: Trail Obstruction on Main Trailway*

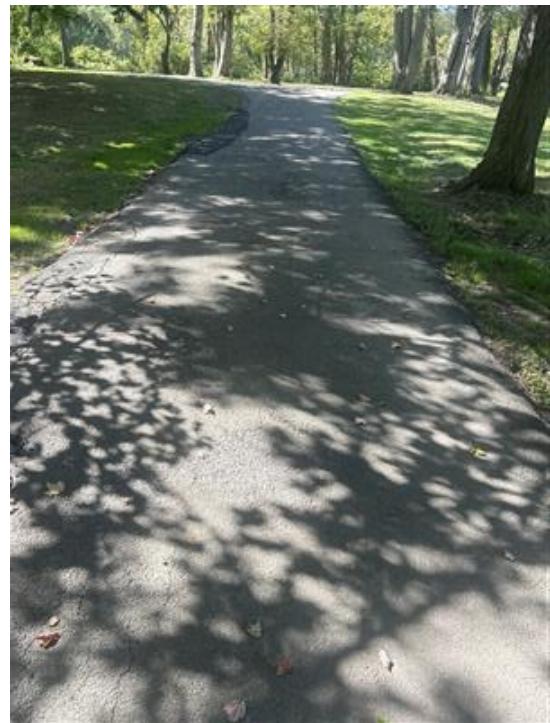
*Photo 24: Upheaval at Center Path/Western Loop Segment*

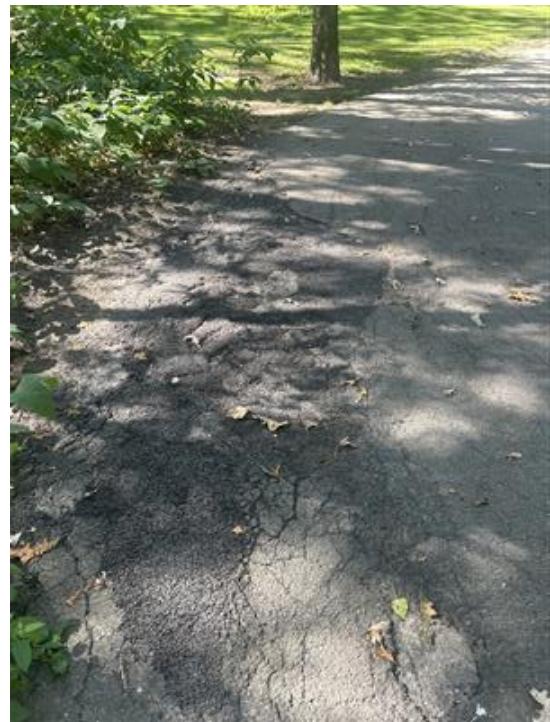
*Photo 26: Raveling at Southern Loop Segment*

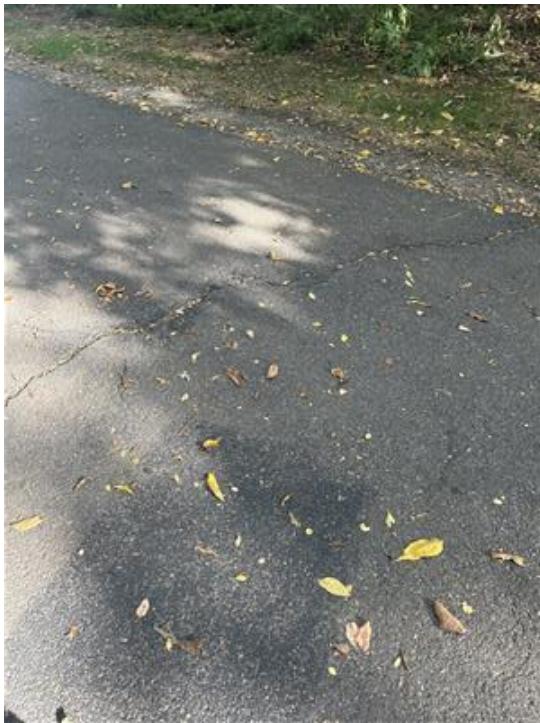
Two major issues were noted on the trail. Severe raveling and cracking have occurred on the Stroehmann Bakeries segment near the Castle Gardens Road access point (See Appendix B, Photo 32). Severe cracking and root growth was also noted as a problem on the Twin Orchards Park segment, creating uneven pavement (See Appendix B, Photos 30 and 31).

*Photo 30: Cracking at Twin Orchards Park Adjacent*

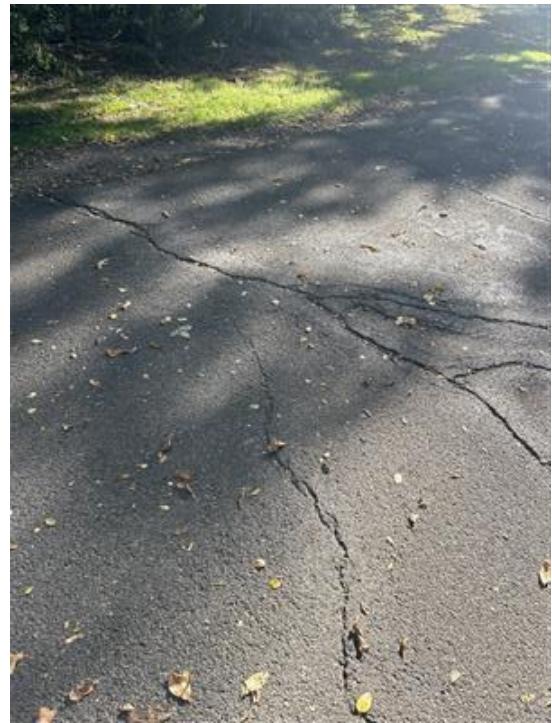
*Photo 31: Cracking at Twin Orchards Park Adjacent*

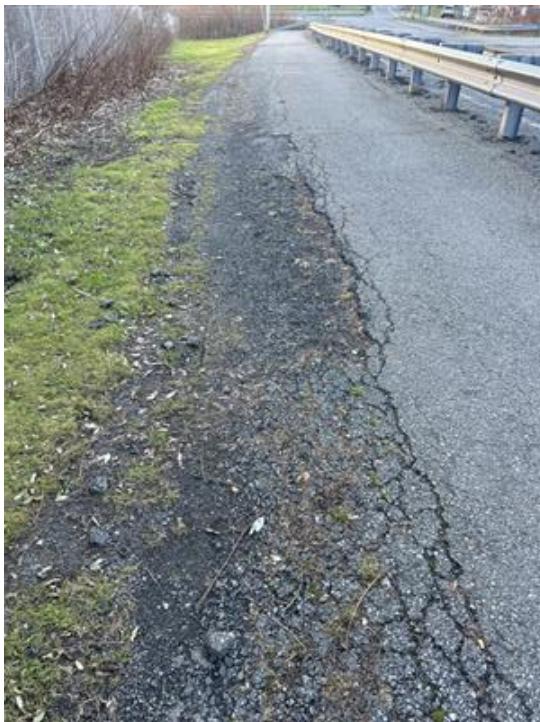
*Photo 32: Raveling at Stroehmann Bakeries*
