2026

Two Rivers Greenway Trail Maintenance Report

PREPARED BY BMTS CENTRAL STAFF

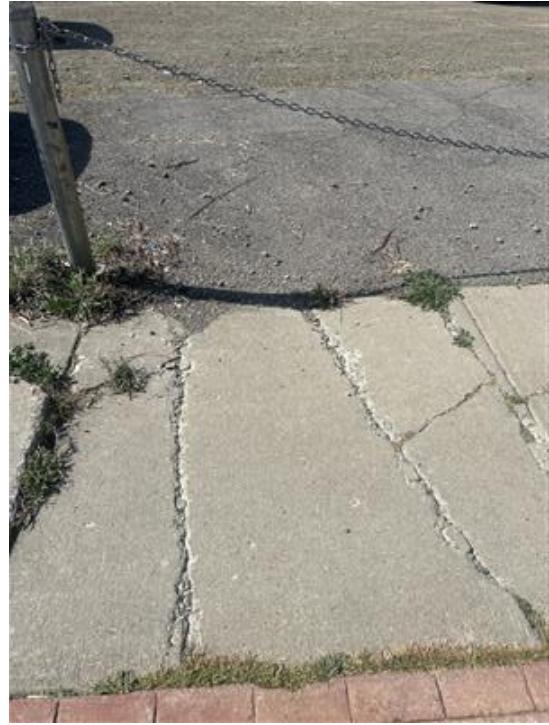
Photo 8. Sidewalk Cracking at E Clinton Street to Eldredge

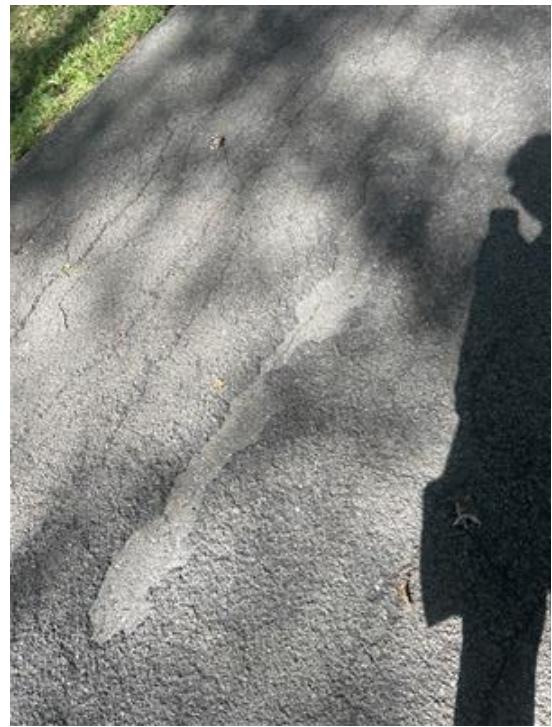
Photo 22. Asphalt Loss at Southern Loop Segment

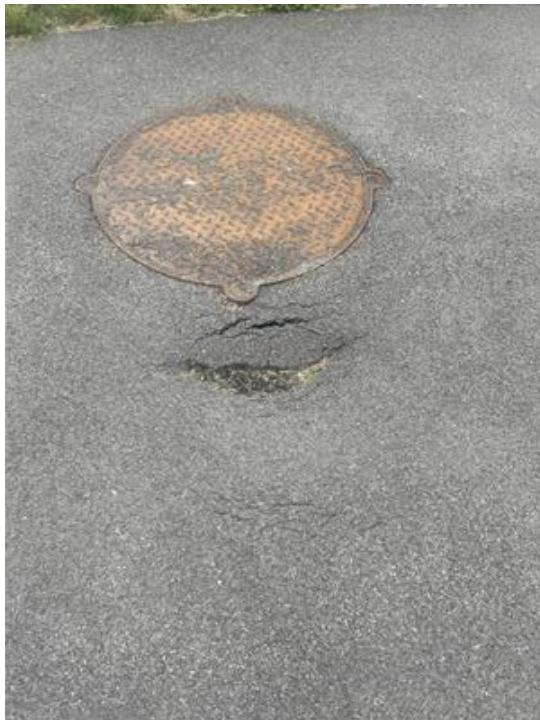
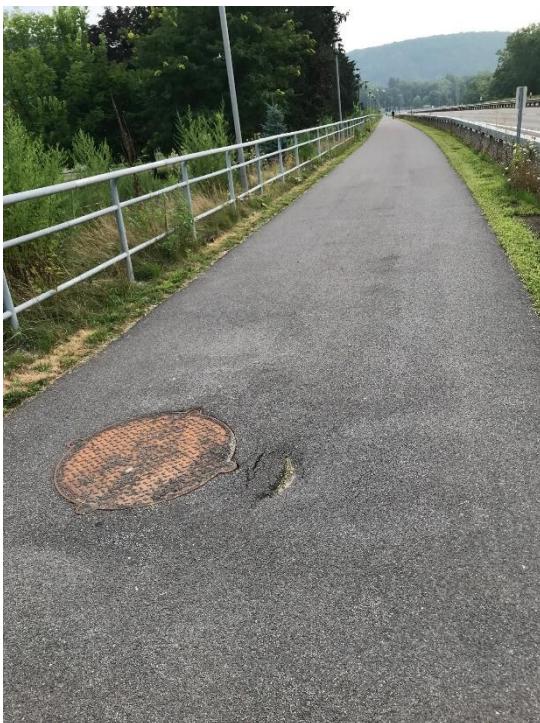
There was only one major issue on the 434 Greenway. On the Hallam Street to MacArthur Park sub-section, a manhole is sinking into the pavement, posing a hazard to pedestrians and bikers (see Appendix B, Photos 1-5).

Photo 1: Cracking/Depression at Hallam Street to MacArthur Park (View 1)

Photo 2. Cracking/Depression at Hallam Street to MacArthur Park (View 2)

Photo 3. Cracking/Depression at Hallam Street to MacArthur Park (View 3)

Photo 4. Cracking/Depression at Hallam Street to MacArthur Park (View 4)

Photo 5. Cracking/Depression at Hallam Street to MacArthur Park (View 5)

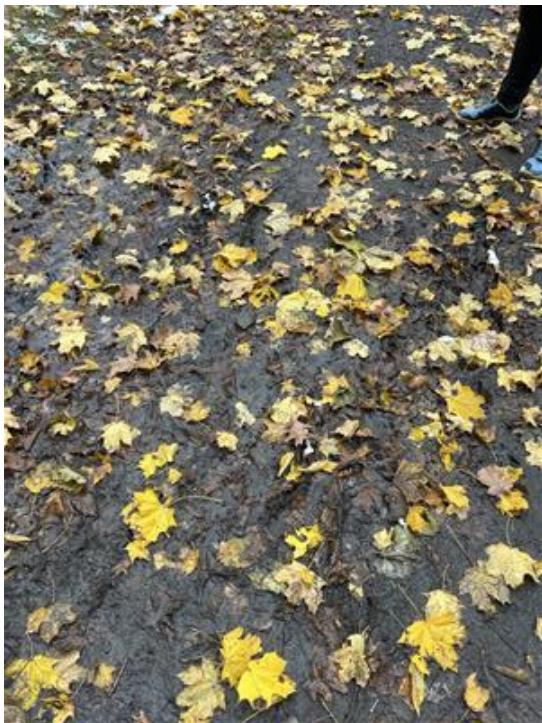
Four major issues were noted along the Chugnut Trail. Three issues involved depressions in the pavement, causing pooling water which obstructed the trailway and muddy conditions (Appendix B, Photos 11-13). The uneven pavement also poses a tripping hazard. One issue involved severe pavement cracking surrounding a manhole cover (Appendix B, Photo 14).

Photo 11: Depression at Riverview Park to Southern Tier Community Center

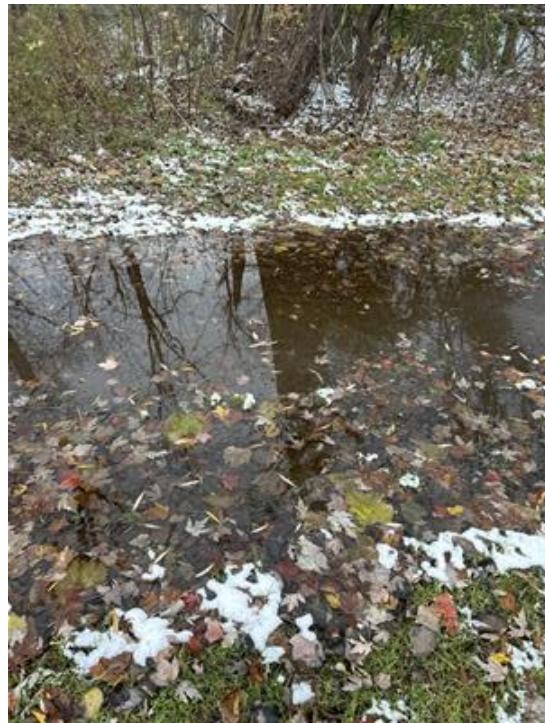
Photo 12: Depression at Riverview Park to Southern Tier Community Center

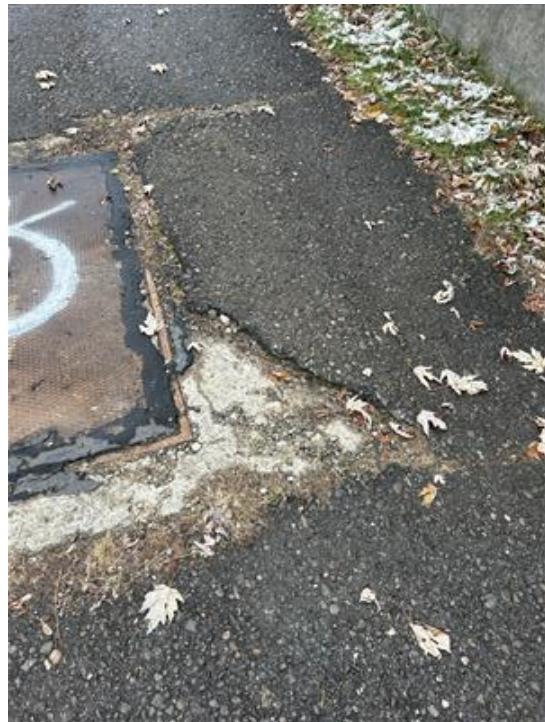
Photo 14: Cracking at UE Tennis Courts to Endicott Village Water Department

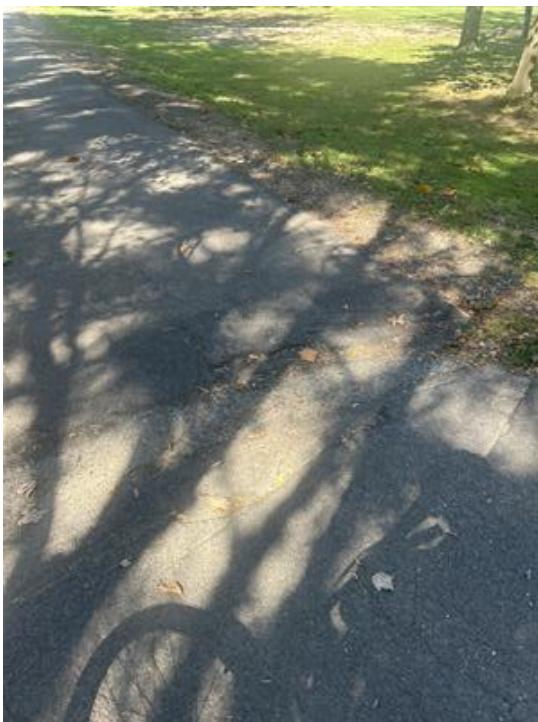
Photo 17: Unevenness at Otsiningo Park Loop Southwest
