# Pavement Condition Rating Summary 2026

Non-State Federal Aid Eligible Roadways  
(as of August 5-14, 2026)

**BMTS**

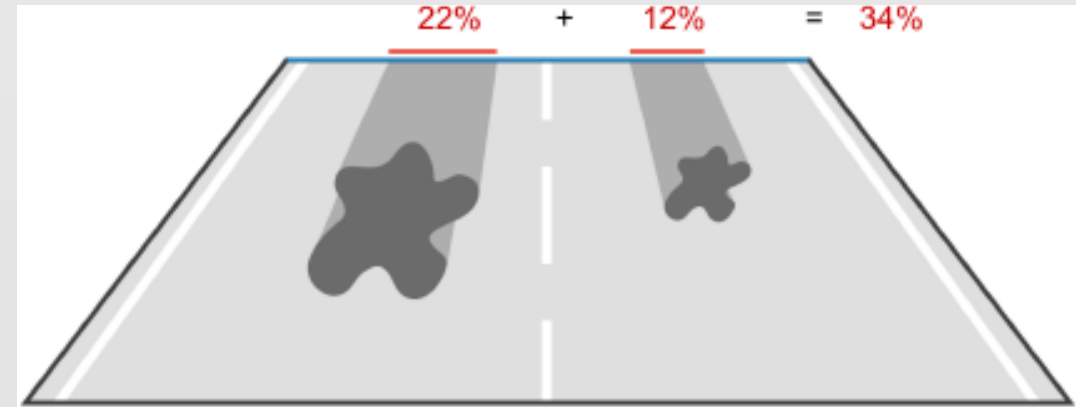
Figure 1. The two gray blobs present surface defects of the same type. In this window, the severity of the defect is defined as the ratio of defect's combined lateral extent to the surface width.

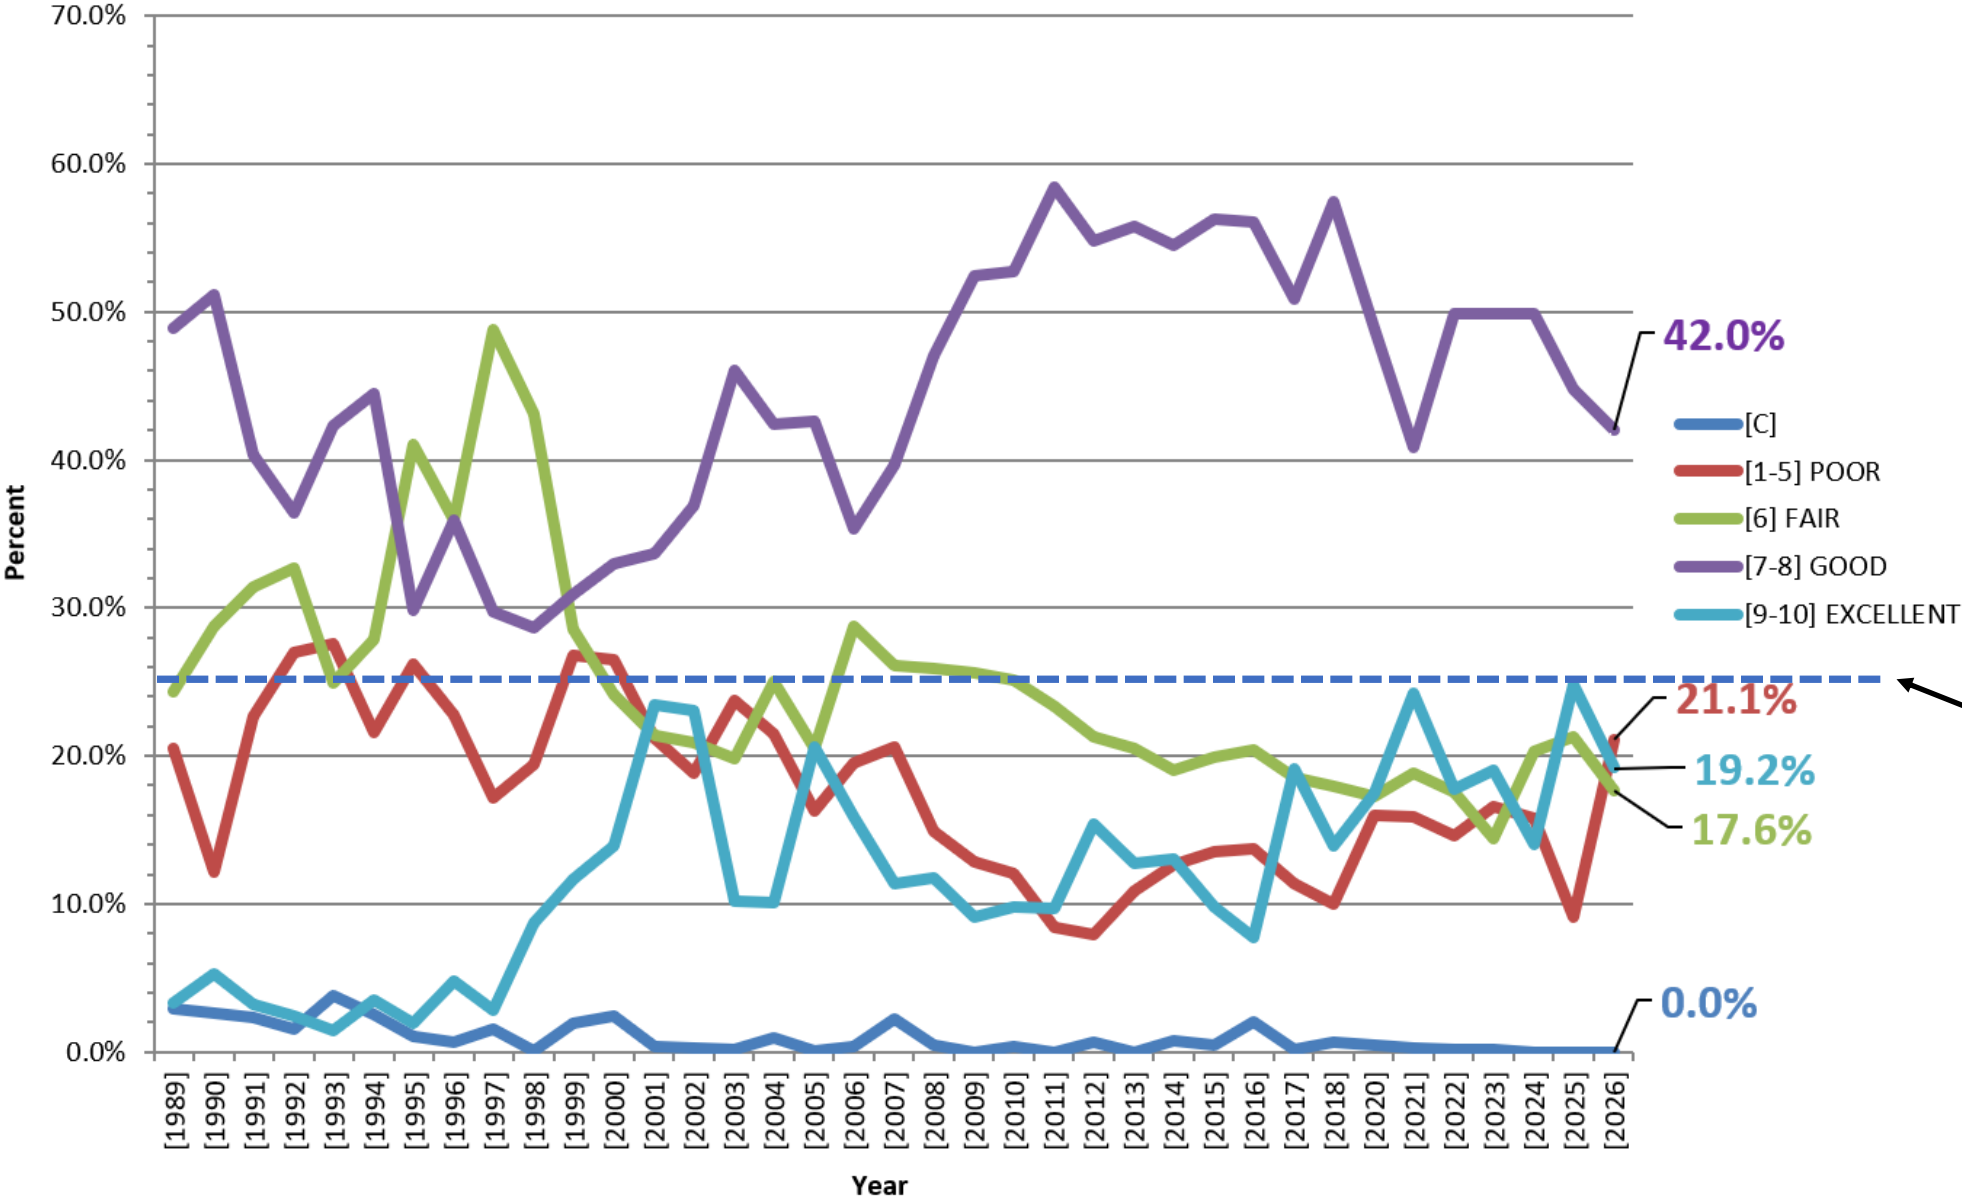
# Percent Mileage for COLLECTOR Road Segments

COLLECTORS  
No more than  
25% mileage  
rated **POOR**.

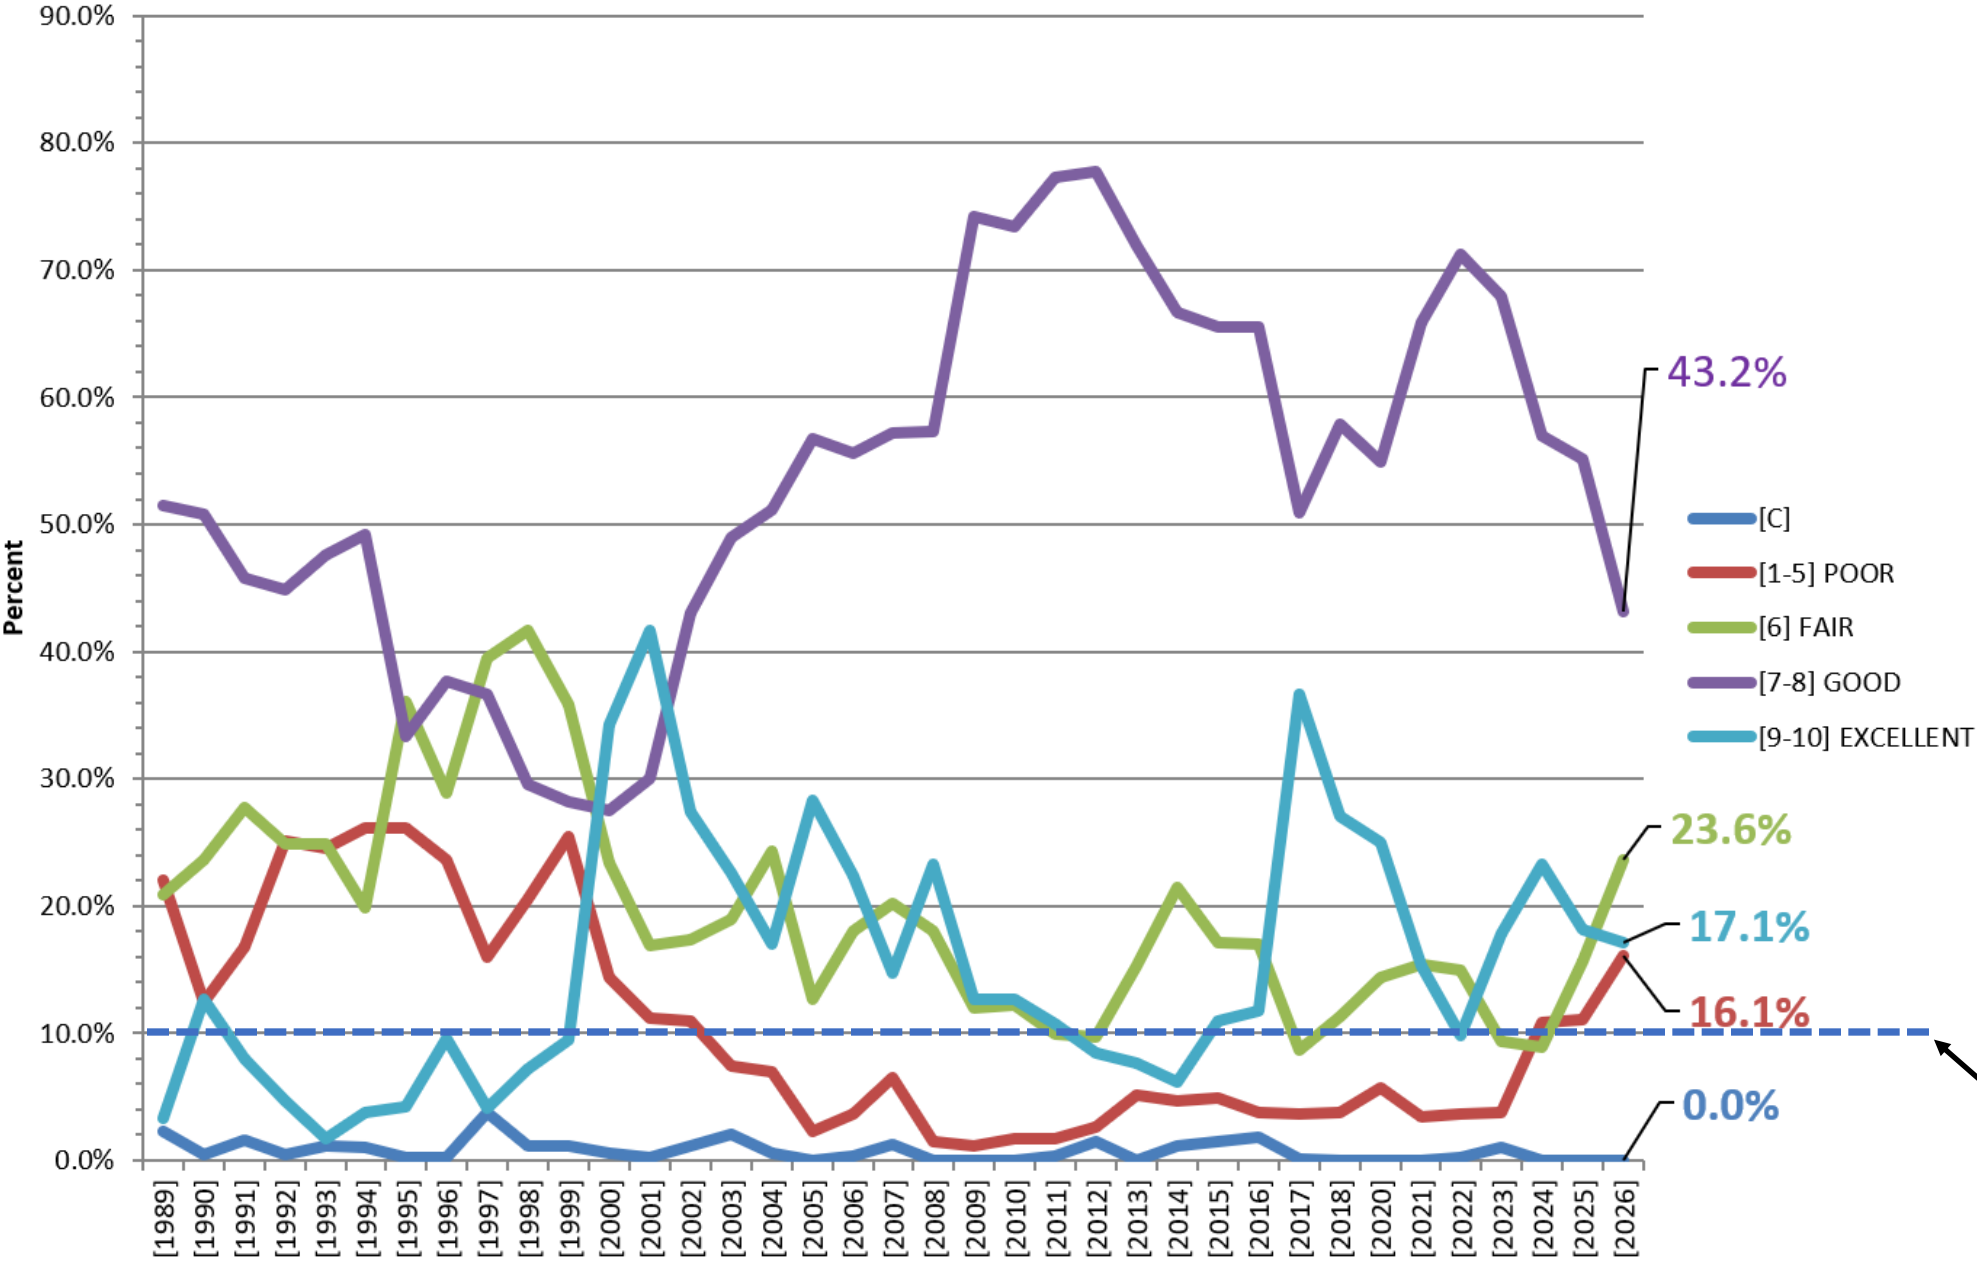
# Percent Mileage for MINOR ARTERIAL Road Segments

**MINOR ARTERIALS**  
No more than 10% mileage rated **POOR**.
