BMTS
SAFETY *ACTION* PLAN

Appendices

Project Profiles

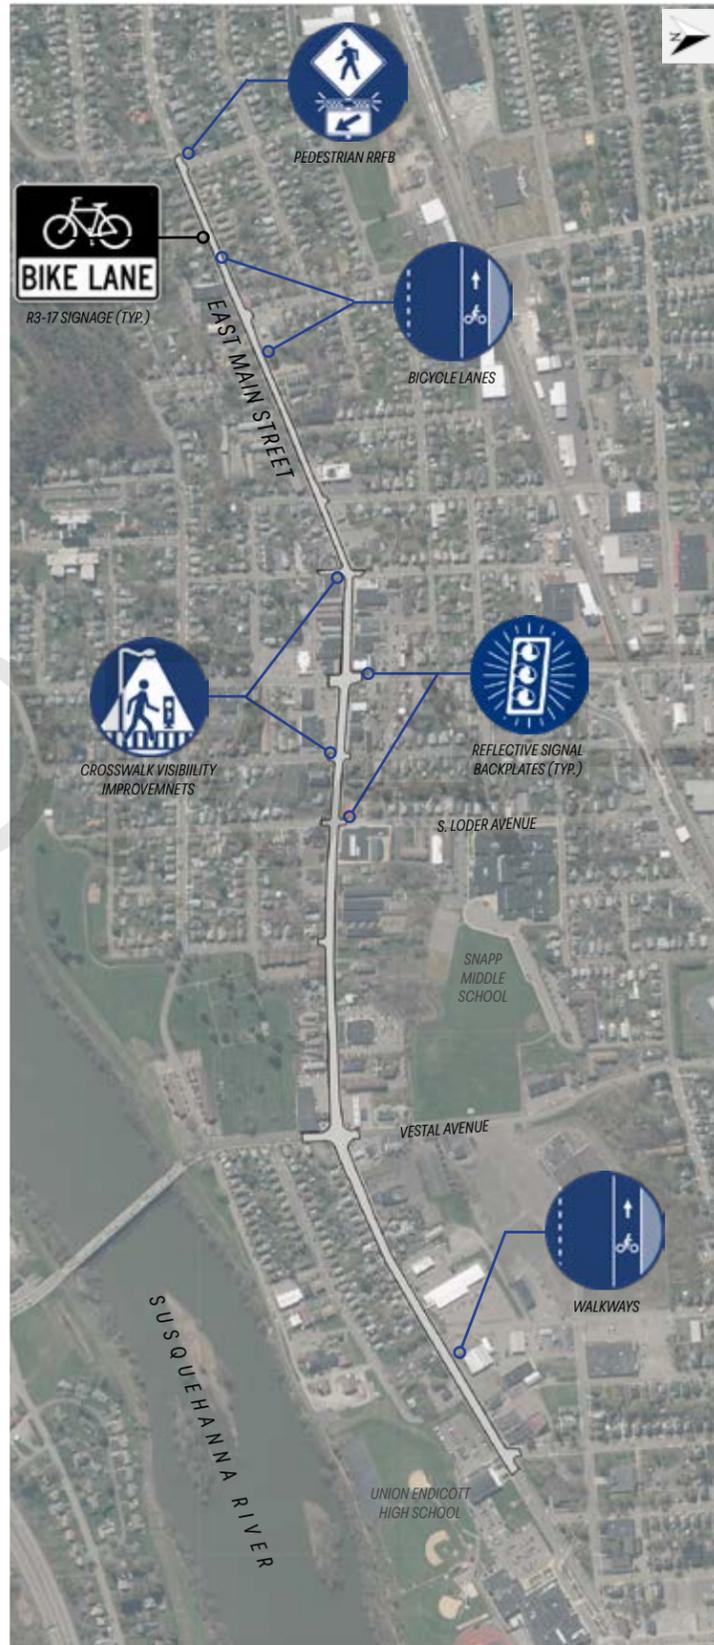
Proposed Improvements

Contributing factors at East Main Street from Bassett Avenue to Lincoln Avenue included deteriorated pedestrian infrastructure, outdated traffic control systems, and inconsistent bicyclist accommodations. Potentially relevant safety countermeasures at this location include, traffic signal upgrades with retroreflective backplates, rectangular rapid flashing beacons, and enhanced type LS crosswalks. Also proposed is the addition of bike lane signs and sharrow pavement markings to allow bicyclists traveling in the bike lanes from the east and west to share the travel lanes with other traffic in a safe manner. The existing symbols for the bike lanes to the west have faded and will be repainted as part of the implementation project. Rectangular reflective flashing beacons will be added at the midblock crossings of Bassett Ave and Badger Ave. The beacons will enhance visibility for drivers and make them aware when pedestrians are attempting to cross an intersection that does not have pedestrian signals due to the absence of a traffic light. New curb ramps, type LS crosswalks, and sharrows will be installed at the intersections of East Main St and Page Ave, Badger Ave, Exchange Ave, Liberty Ave, and Vestal Ave. The crosswalks present at these locations have faded significantly, and most of the curb ramps have deteriorated to fall out of ADA compliance. Replacing these facilities will allow all road users to cross in a safe manner. Adding and improving the sharrows will allow bicyclists to safely navigate the corridor and effectively connect the bike lanes present to the east and west. Traffic signal improvements with reflective backplates will be constructed at Exchange Ave, S Loder Ave, Vestal Ave, Harrison Ave, and Lincoln Ave. Some of these signals are outdated and in need of replacements, all of them lack reflective backplates. Improvements to these traffic signals will enhance the safe and efficient flow of traffic, reducing the risk of high injury crashes.

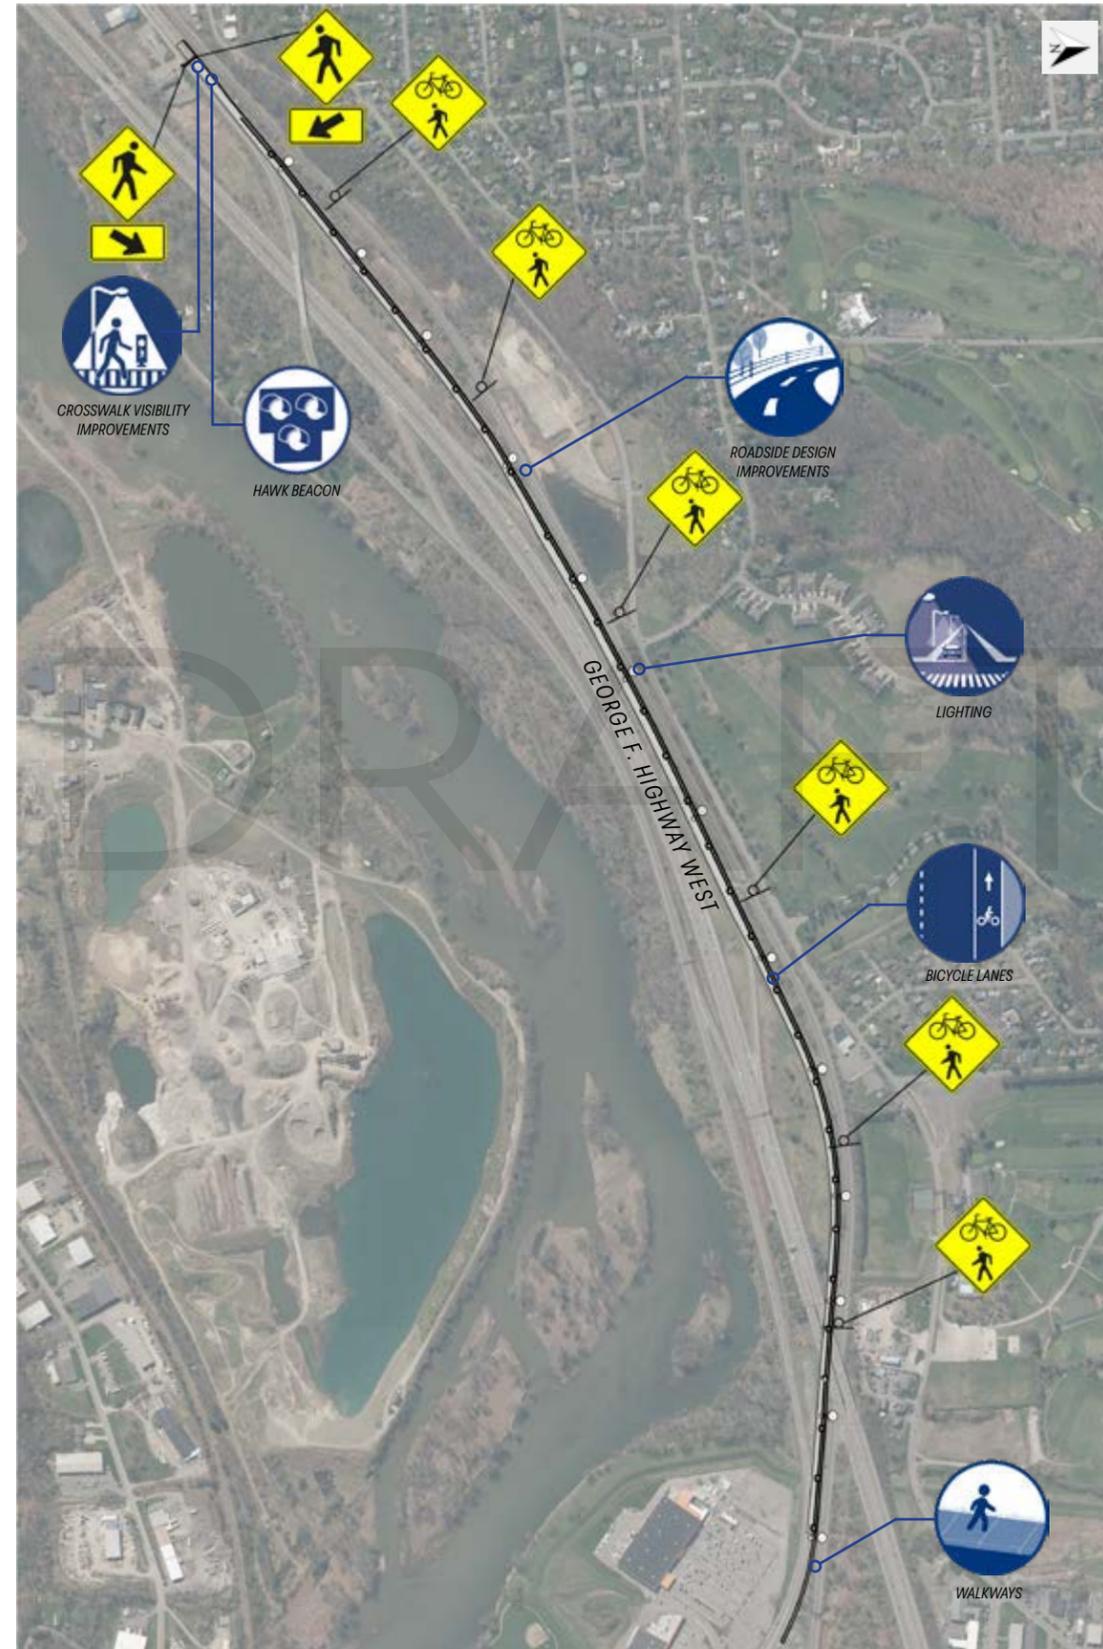
Proposed Improvements

Contributing factors at George F Highway West from the intersection with River Road to Main Street included a lack of pedestrian/bicycle accommodation, poor roadway lighting, deteriorated pavement and striping. Potentially relevant safety countermeasures at this location include, roadside design improvements, crosswalk visibility enhancements, bike lanes, walkways, lighting improvements, and a pedestrian hybrid beacon. These

countermeasures are all centered around the reconfiguration of the roadway to construct a shared use path on the north side of the highway. These improvements will require shoulder widening and guide rail relocation. This will include removing and replacing the old guide rail with improved box beam guide railing. The existing pavement edge will be extended approximately 4 feet, and the guide railing will be relocated approximately 6 feet towards the existing outside travel lane. This will create space for a 10-foot-wide shared use path accessible to both bicyclists and pedestrians. This pathway will begin to the east where the existing sidewalk will be extended approximately 600 feet to meet the asphalt path which consists of two 5-foot shared use lanes. The path will have pavement markings and signage to identify the direction of travel and occupancy of both pedestrians and bicycles. The path will be separated from the roadway by the new box beam guide railing. To the west the path will cross George F Hwy W with a type LS crosswalk. This crossing will have push buttons on either side that activate a pedestrian hybrid beacon, stopping traffic temporarily to permit safe crossing. This path will allow residents to safely travel between the cities of Endicott, Endwell and Johnson City. It will offer increased protection for vulnerable road users who are already using this corridor without any existing accommodations. Lighting improvements will also be added to the corridor to replace the existing outdated light poles with new LED streetlights. This will enhance the visibility of drivers traveling in the morning and evening to better see and avoid pedestrians, bicyclists and deer.

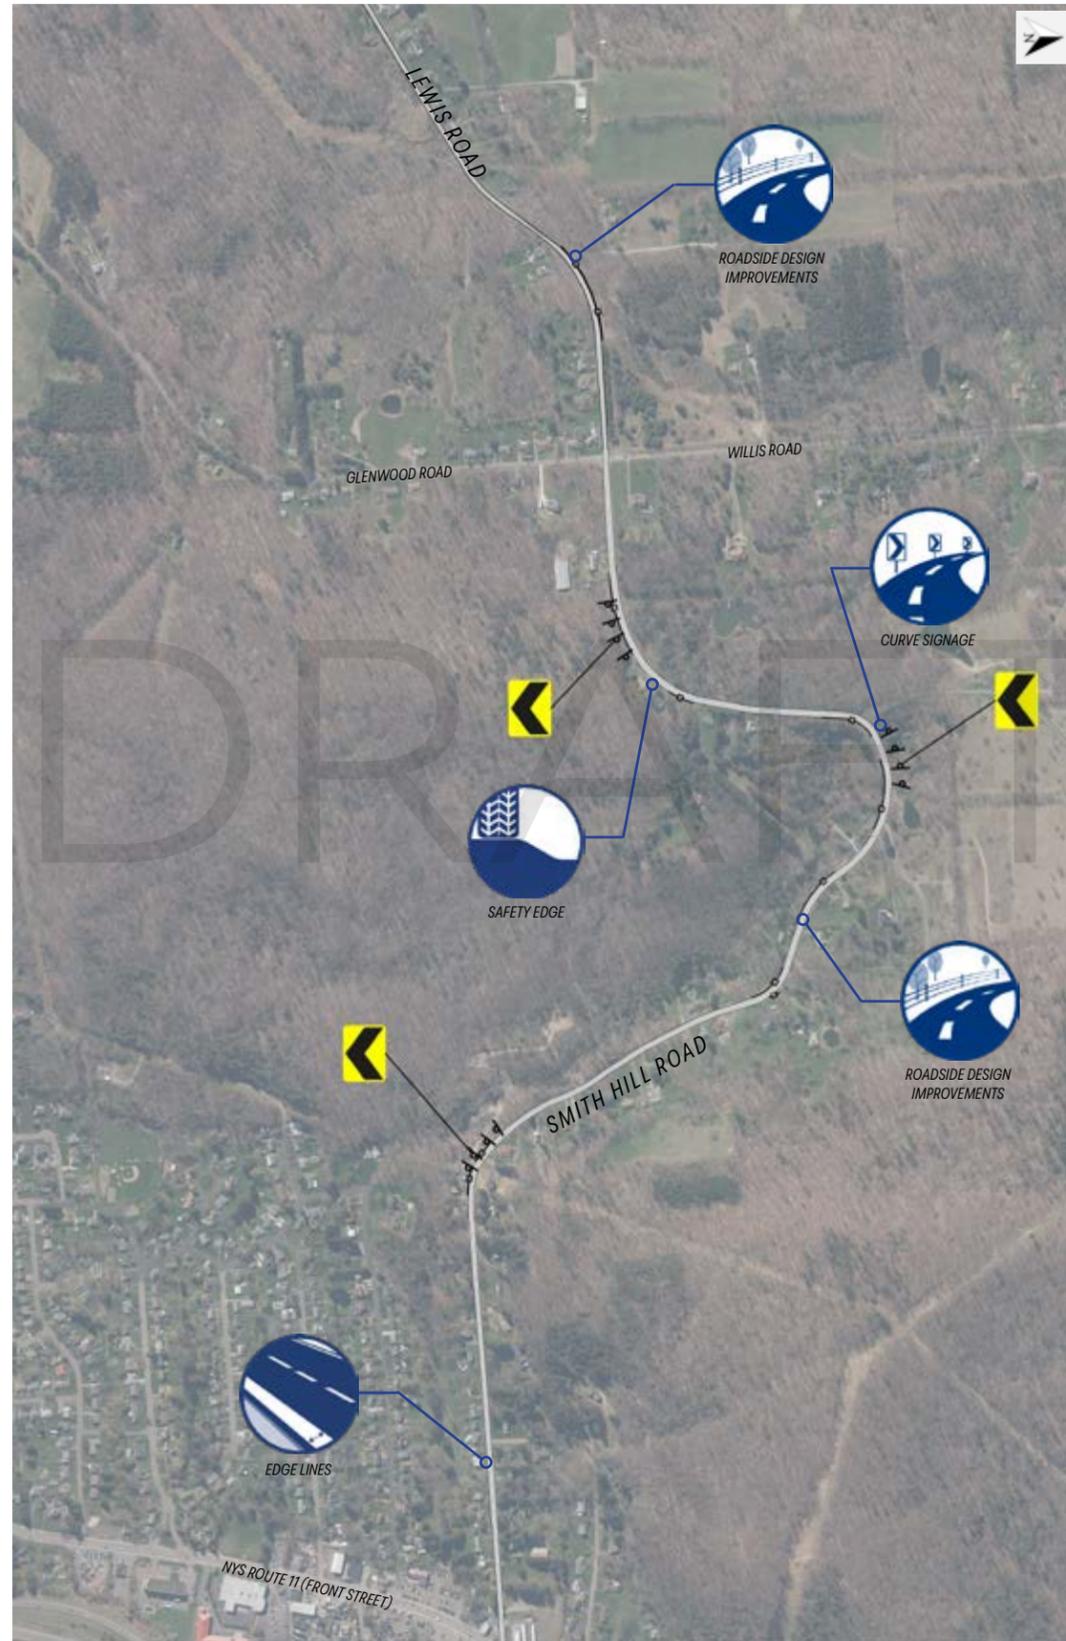
Proposed Improvements

Contributing factors at Lewis Road from Middle Stella Ireland Road to Upper Front Street included steep vertical and sharp horizontal curves, high run-off-road risk, and limited sight distance. Potentially relevant safety countermeasures at this high-injury corridor include wider edge lines, enhanced delineation at horizontal curves, safety edge installation, and roadside design improvements at curves. New 6" white epoxy edge lines will be striped onto Lewis Rd where they are currently missing. This will give drivers a better sense of where they are on the road and prevent them from straying too close to the edge of the travel lane. This will reduce the risk of run-off-road and head on crashes by keeping drivers appropriately positioned within their lane. Curve warning chevrons will be added to areas of sharp horizontal curvature and existing curve warning signs will be replaced. This will improve driver awareness of upcoming curves and reduce the risk of them crashing with other vehicles or fixed objects as they go around curves. Along the corridor, shoulder backup subbase will be added to provide drivers with additional recovery zones. To improve roadside safety at curves, existing guide railing that is in disrepair will be replaced and additional guide railing will be added at areas of extreme curvature. Lastly, there are some existing signage including a speed limit and curve warning sign that are covered up by vegetation. This vegetation shall be cut back and cleared to allow drivers to easily view the signage and have appropriate sight distance around curves.

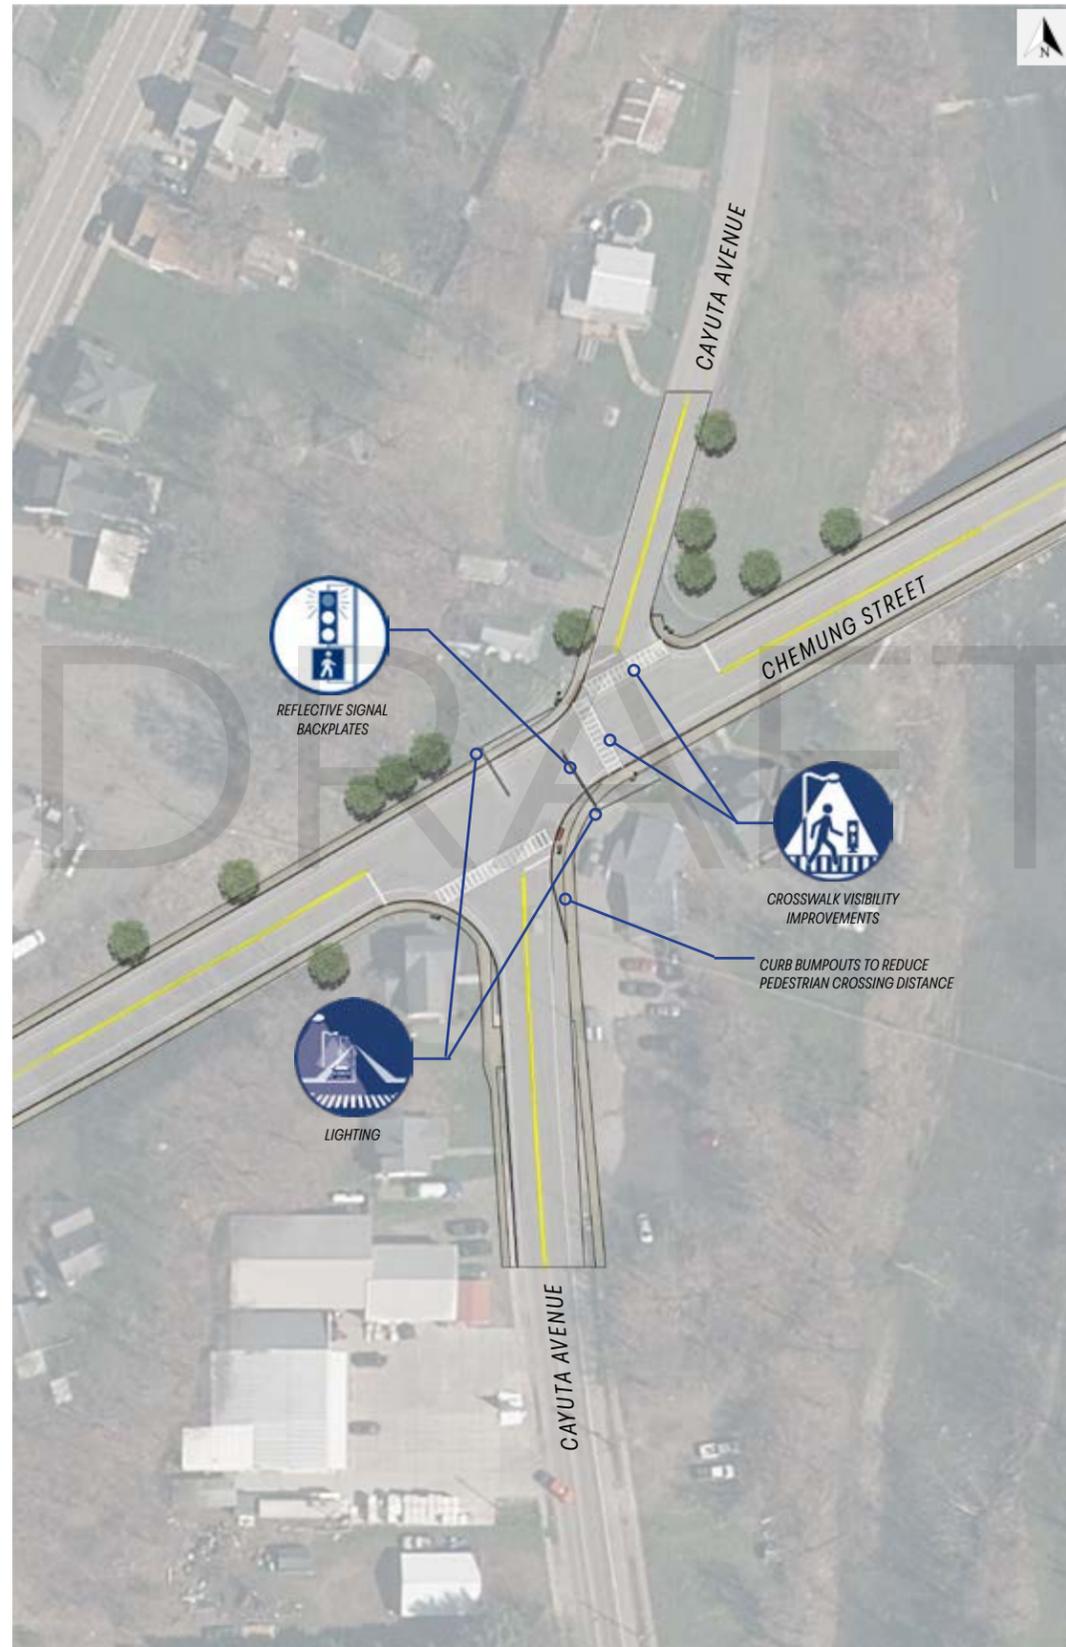
Proposed Improvements

Contributing factors at Chemung Street and Cayuta Avenue included skewed approaches to intersection, tight turning radii with on street parking, and obstructed sight distance. Potentially relevant safety countermeasures at this intersection include, the installation of high visibility crosswalks and stop bars, converting the intersection from stop control to traffic signal control, installing backplates with retroreflective borders, lighting improvements, and a curb bump out in the southeast corner of the intersection. The existing type LS crosswalks would be replaced with high visibility crosswalks to enhance drivers' ability to see the crosswalks and pedestrians crossing the intersection. 12" thick white epoxy stop bars would be installed at all approaches to the intersection along with the necessary supporting signage. The existing two-way stop would be converted to signal controlled, with the installation of 3-color traffic signals along each of the approaches. With these new traffic signals, pedestrian signal infrastructure will be installed at each of the crossings to give pedestrians guidance on when it is safe for them to cross. Implementing pedestrian signals enhances safety for both road users and pedestrians. Lighting improvements will be installed at the intersection to provide increased visibility of the intersection. The curb in the southeast corner of the intersection will be bumped out in order to shorten the crossing distance for crosswalk users. The new curb alignment will require some reconstruction of the side and installation of a new curb ramp with a cast iron detectable warning surface.

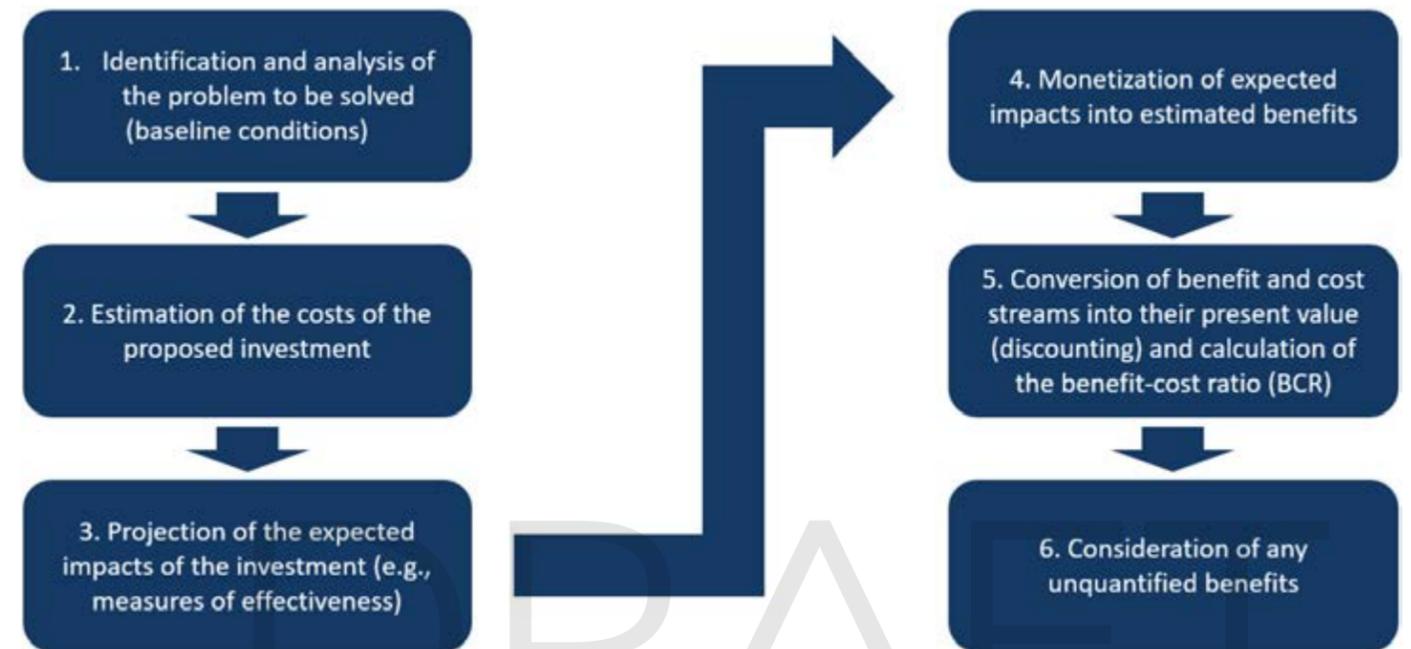
Figure 78. Benefit-Cost Analysis – Process Overview (Source: USDOT, May 2025, pg. 7)
