# BMTS safety ***ACTION*** plan

Draft Report

January 2026

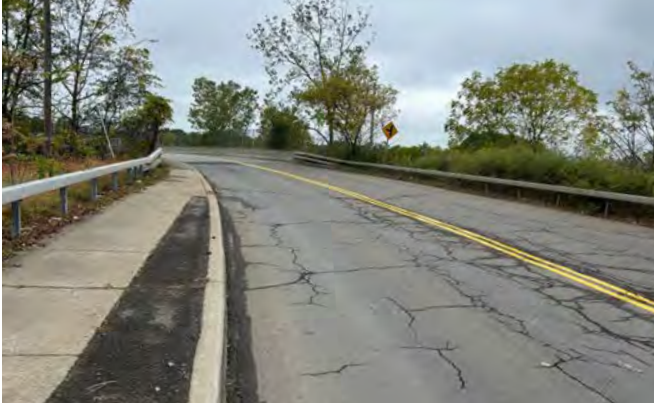
Photo 1: Conklin Ave over NYSW Railway looking west

- Lack of advanced warning signage
- Lack of bicycle and shared use lane markings
- Lack of audible pedestrian signals at signalized intersections

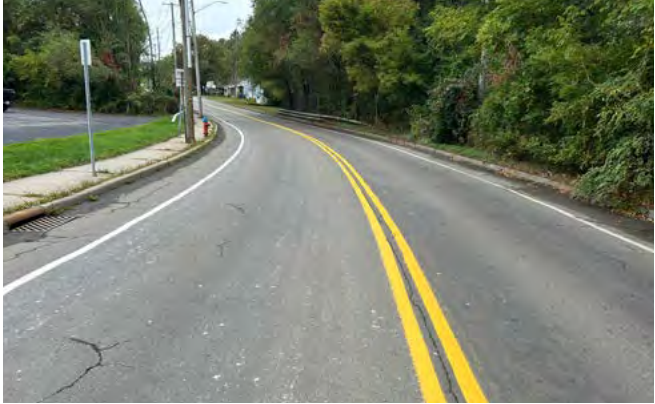
Photo 2: Conklin Ave east of Felters Rd looking east

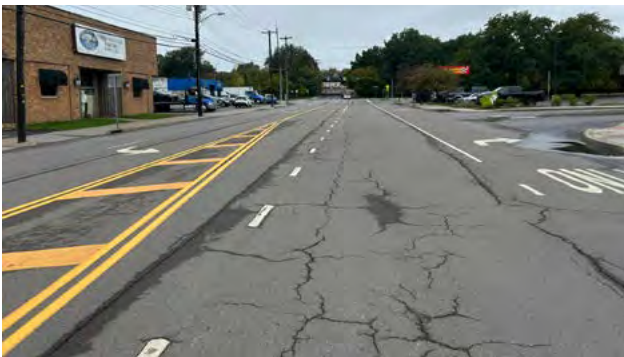
Photo 1: Robinson St Walgreens looking east

- Lack of advanced warning signage for uncontrolled pedestrian crossings
- Lack of bicyclist accommodations
- Pedestrian signal infrastructure is outdated

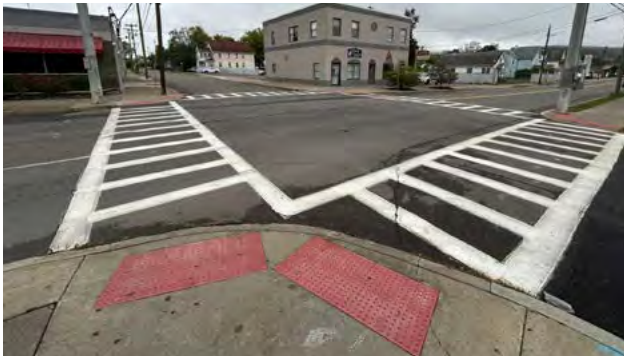
Photo 2: Robinson St and Griswold St looking northeast

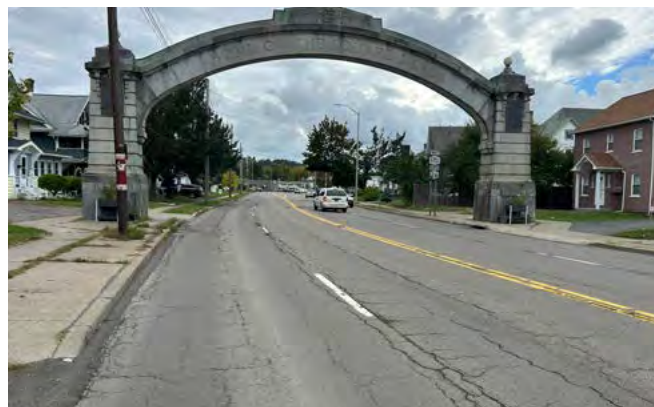
Photo 1: East Main St concrete arch looking west

- Deteriorated pedestrian infrastructure
- Outdated traffic control systems
- Inconsistent bicyclist accommodations

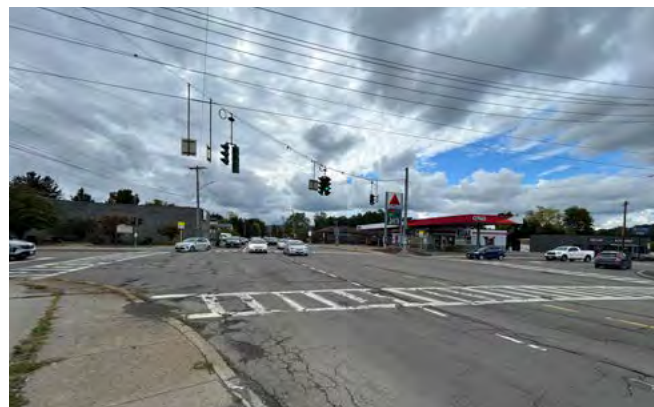
Photo 2: East Main St and Vestal Ave looking west

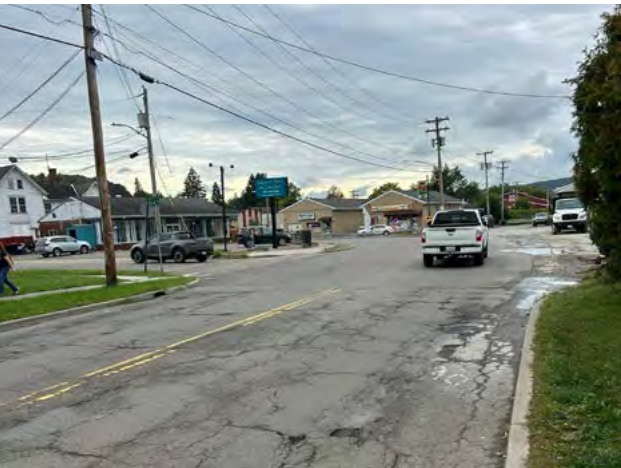
Photo 1: North street westbound looking northeast

- Lack of high visibility crosswalks at numerous intersections
- Uncontrolled crossings at Jefferson Avenue
- Faded striping throughout corridor

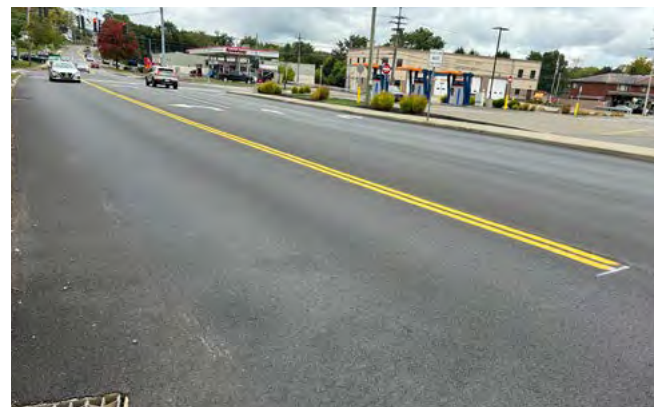
Photo 1: Hooper Rd looking southeast towards Country Club Rd

- Lack of high visibility crosswalks at intersections
- Lack of bicyclist accommodations
- Faded striping throughout corridor

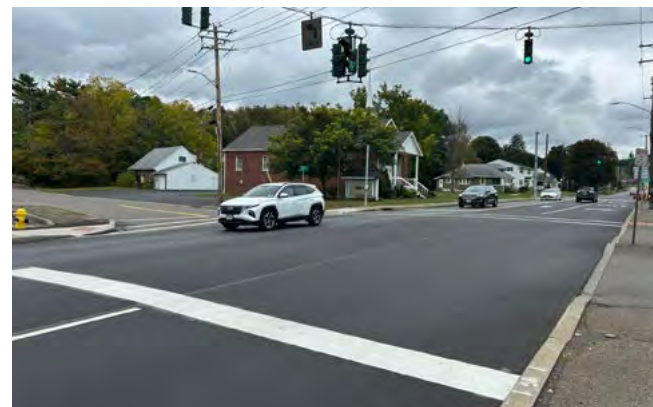
Photo 2: Hooper Rd and Smith Dr looking northwest

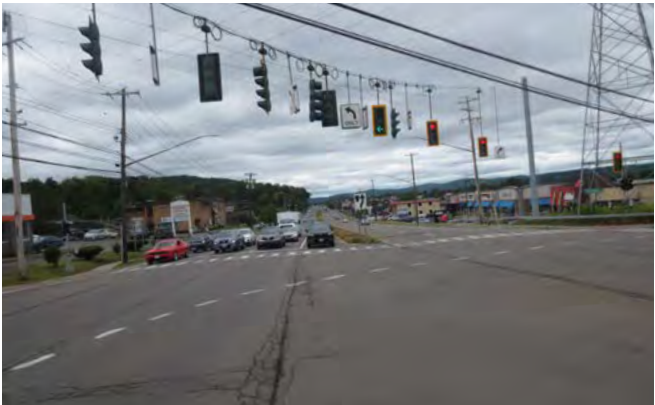
Photo 1: Vestal Pkwy E at Rano Blvd looking west

The east and westbound travel lanes are separated by a centerline median that varies between concrete barrier and curbed, vegetated area. These median barriers are in poor condition at many locations along this highway. Concrete sidewalks are present at limited locations, resulting in a lack of connectivity. There are a few slight horizontal curves and no significant vertical curves on this corridor leading to major no sight distance issues. Bike lanes are present in some locations along the corridor; however, they are inconsistent and present some difficulties for vulnerable road users

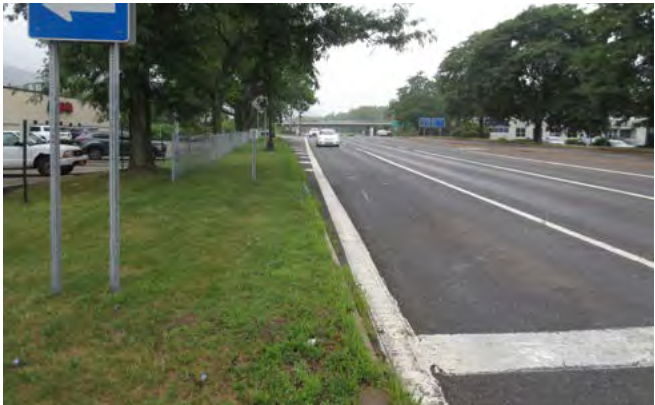
Photo 2: Vestal Pkwy E looking west

navigating the corridor. Pedestrian crossings exist at most of the intersections along the corridor. Three other projects were identified in the action plan at high-injury intersections along the Vestal Pkwy E corridor.

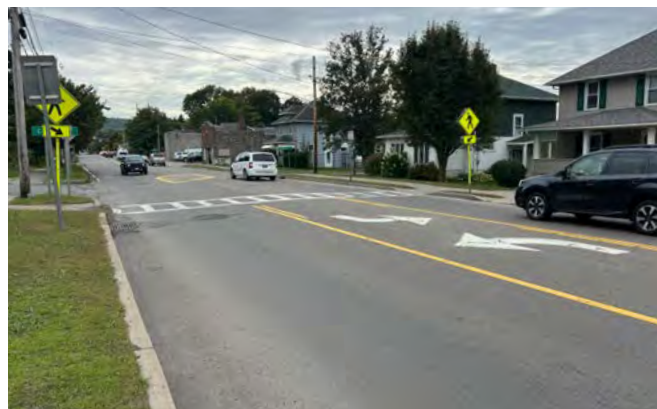
Photo 1: South end of high-injury corridor looking south

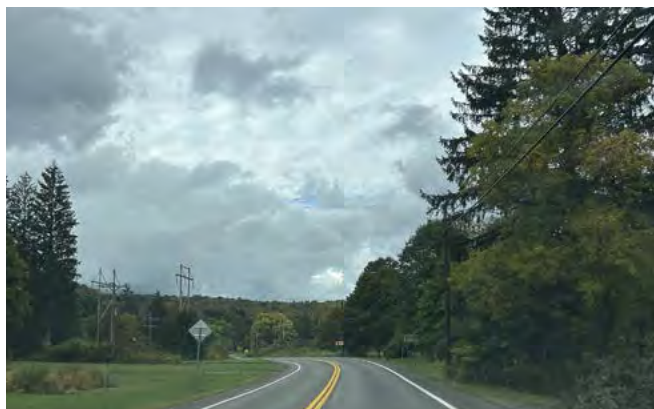
Photo 2: Union Center-Maine Highway looking north

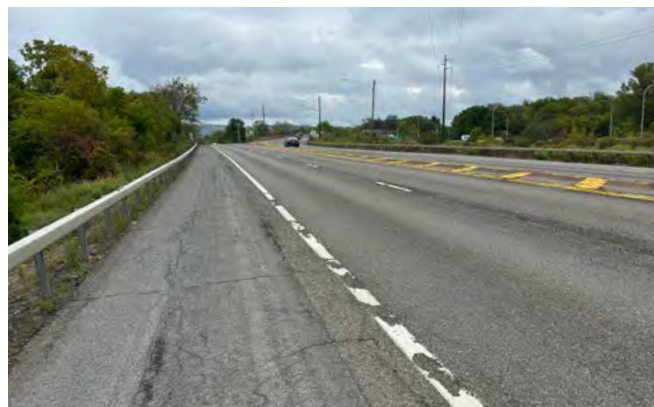
Photo 1: George F Highway westbound looking east

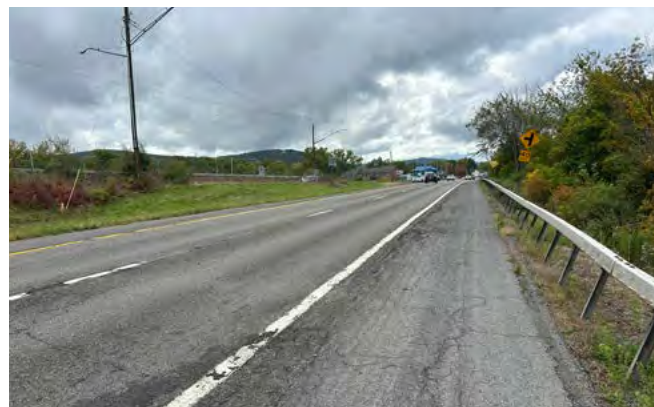
Photo 2: George F Highway westbound looking west

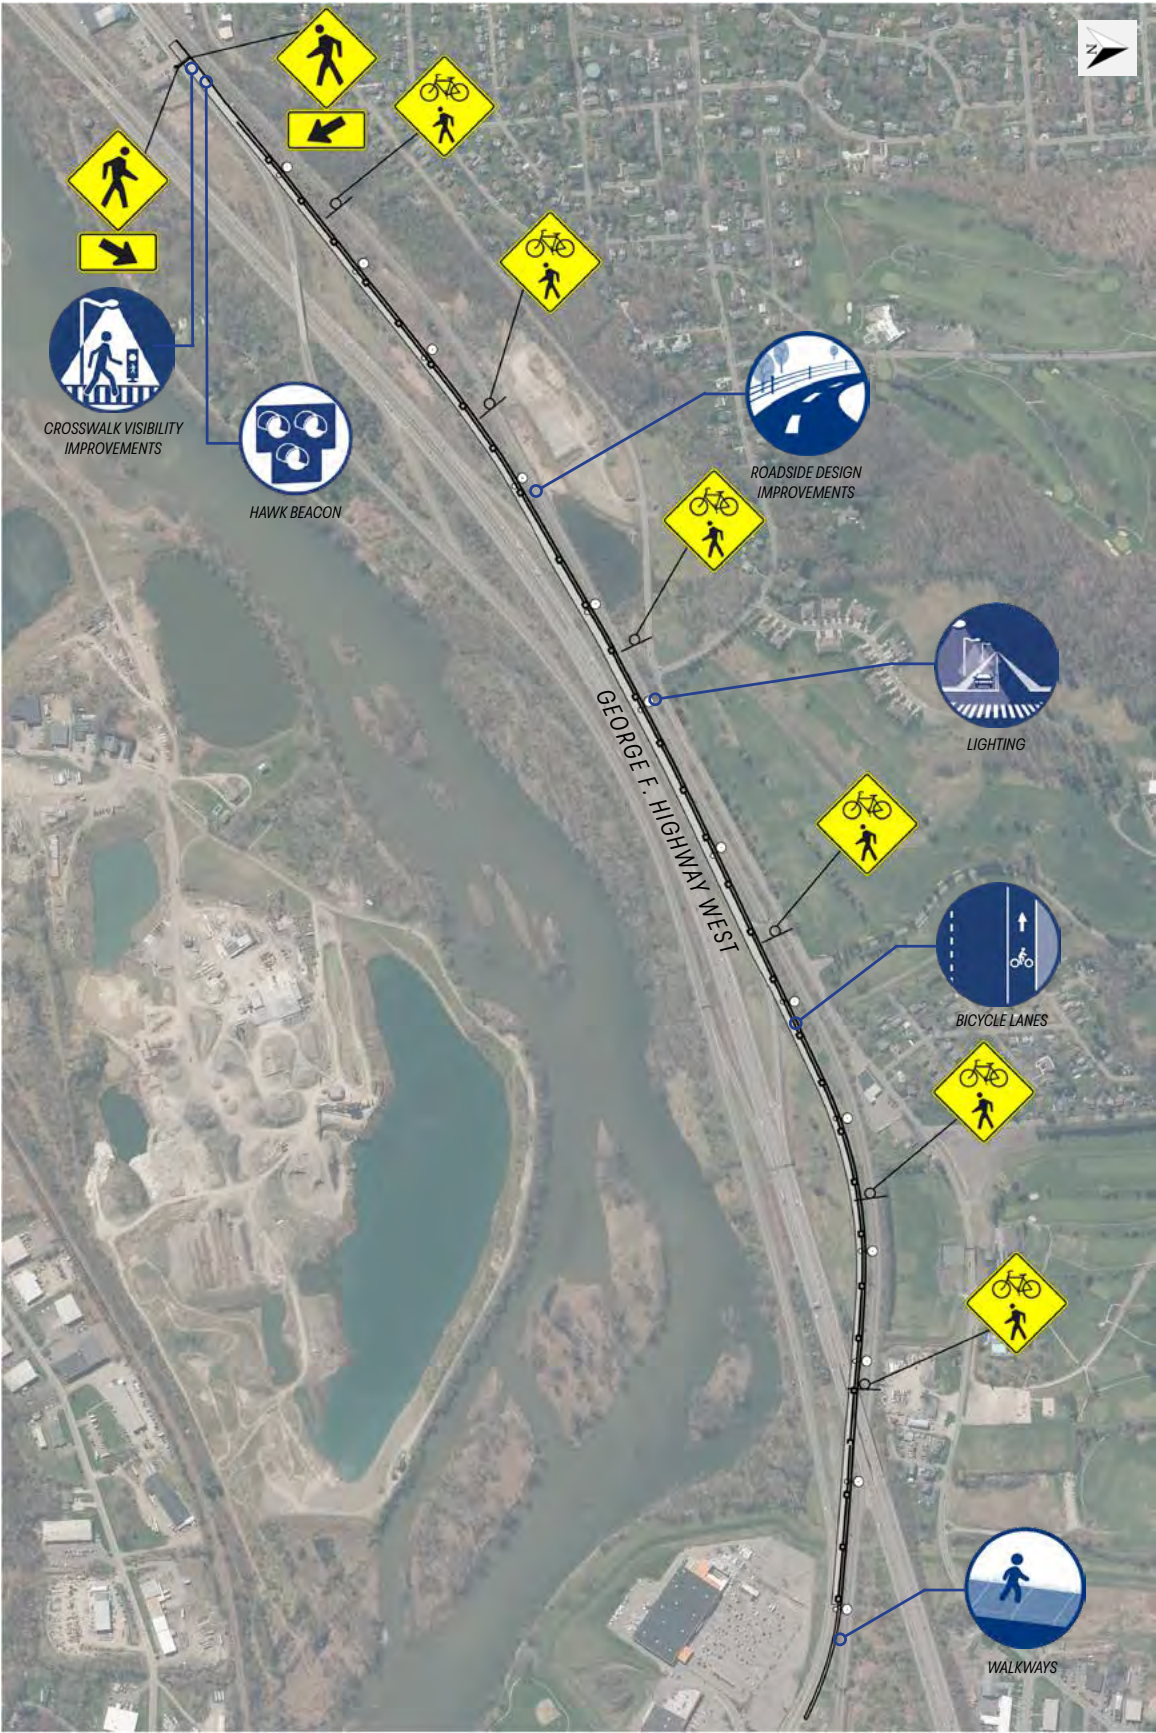
Proposed Improvements

Contributing factors at George F Highway West from the intersection with River Road to Main Street included a lack of pedestrian/bicycle accommodation, poor roadway lighting, deteriorated pavement and striping. Potentially relevant safety countermeasures at this location include, roadside design improvements, crosswalk visibility enhancements, bike lanes, walkways, lighting improvements, and a pedestrian hybrid beacon. These

countermeasures are all centered around the reconfiguration of the roadway to construct a shared use path on the north side of the highway. These improvements will require shoulder widening and guide rail relocation. This will include removing and replacing the old guide rail with improved box beam guide railing. The existing pavement edge will be extended approximately 4 feet, and the guide railing will be relocated approximately 6 feet towards the existing outside travel lane. This will create space for a 10-foot-wide shared use path accessible to both bicyclists and pedestrians. This pathway will begin to the east where the existing sidewalk will be extended approximately 600 feet to meet the asphalt path which consists of two 5-foot shared use lanes. The path will have pavement markings and signage to identify the direction of travel and occupancy of both pedestrians and bicycles. The path will be separated from the roadway by the new box beam guide railing. To the west the path will cross George F Hwy W with a type LS crosswalk. This crossing will have push buttons on either side that activate a pedestrian hybrid beacon, stopping traffic temporarily to permit safe crossing. This path will allow residents to safely travel between the cities of Endicott, Endwell and Johnson City. It will offer increased protection for vulnerable road users who are already using this corridor without any existing accommodations. Lighting improvements will also be added to the corridor to replace the existing outdated light poles with new LED streetlights. This will enhance the visibility of drivers traveling in the morning and evening to better see and avoid pedestrians, bicyclists and deer.

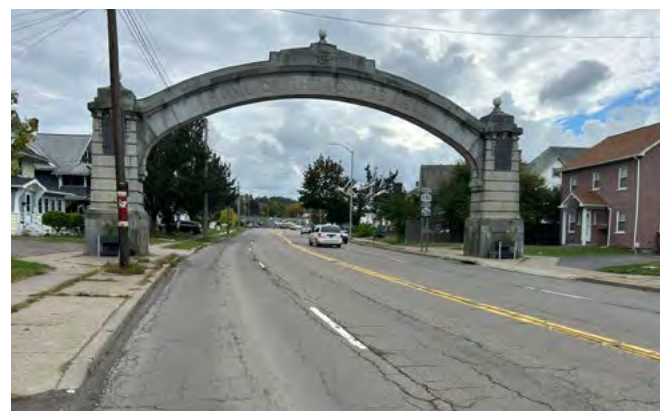
Photo 1: Kirkwood Ave at First Christian Church looking north

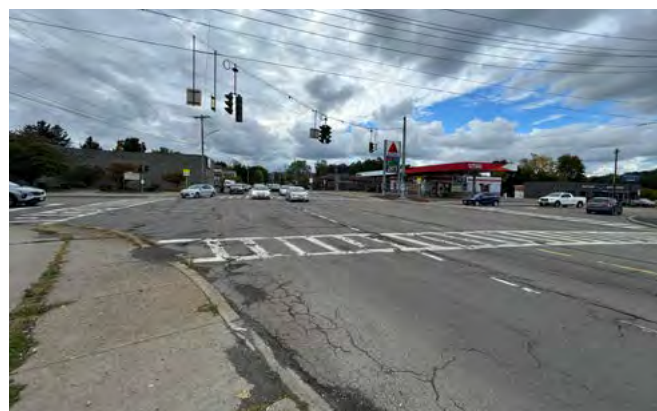
Photo 2: Kirkwood Ave south of Johnson Rd looking south

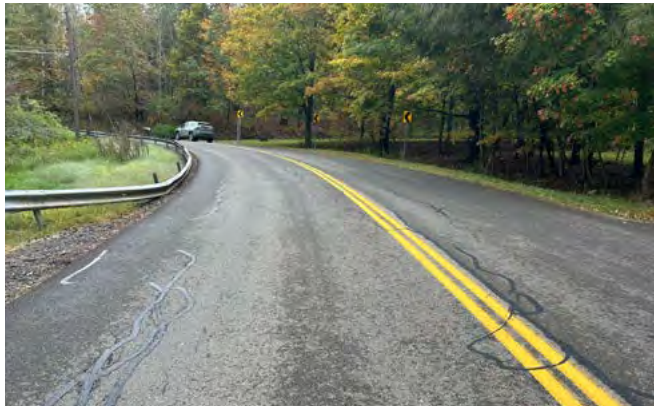
Photo 1: Lewis Rd looking north

Passing is restricted within the entire stretch with the use of a full barrier double yellow centerline. White edge lines are missing from the majority of the corridor. The striping is overall in good condition, but there are several stretches where it has faded and needs updating.

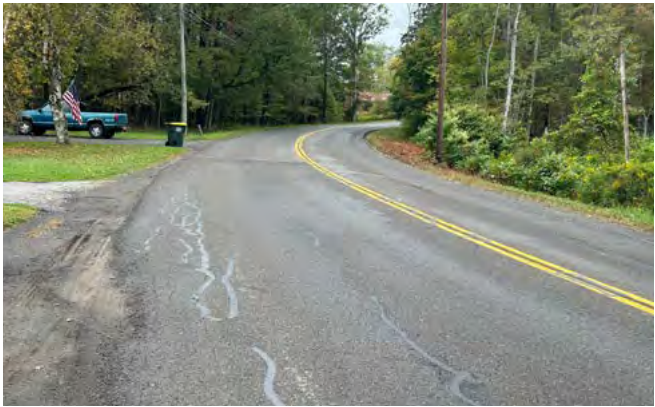
Photo 2: Lewis Rd looking west

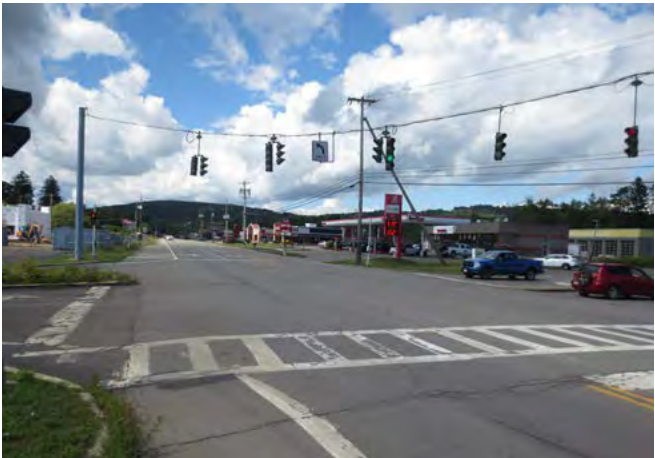
Photo 1: Intersection of State Route 17C and Grand Union Plaza

Signage indicates that there is a bike lane which begins at the entrance to Wendy's and continues along both approaches into the village of Owego. There are, however, no existing pavement markings to indicate the presence of bike lanes. There are several "no driving on shoulder" signs along the road. Light posts are scattered throughout the corridor,

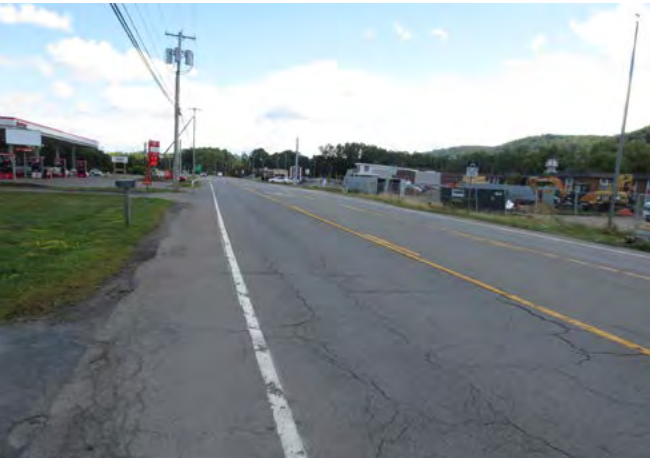
Photo 2: State Route 17C westbound looking east

This segment of State Route 17C (NY-17C) is 0.97 miles long and is located just to the east of the Village of Owego. There was a total of 65 crashes during the study period from 2019 to 2023, with 6 of those crashes resulting in injury. There were 2 crashes involving pedestrians and 1 crash with a bicyclist. 1 of the pedestrians suffered serious injuries from the crash. The speed limit of this road is 40 mph throughout the entire length included in the high-injury network. The width of the road ranges between 40-ft and 50-ft and maintains one travel lane each way with a centerline two-way left turn lane. Each travel lane is approximately 11 feet wide, the left turn median has a width of 12 feet. There are shoulders on either side ranging from 2-ft to 11-ft throughout the corridor.

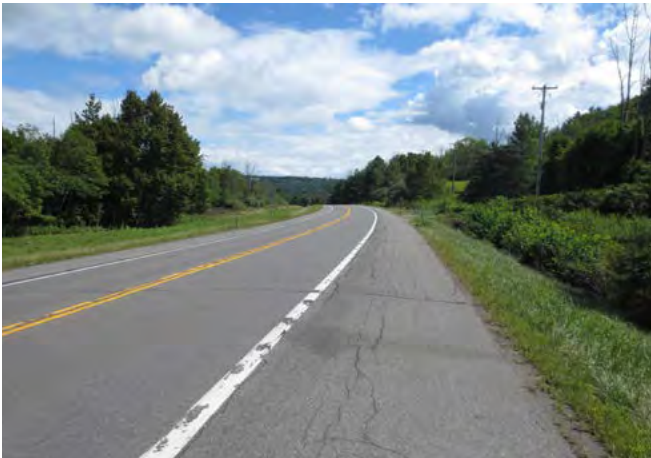
Photo 1: Outside of Owego Town Hall looking east on NY-434

The three-leg intersection with NY-17 Access Road is controlled by span wire traffic signal which also includes pedestrian signal infrastructure for crossing NY-434 with a type LS crosswalk. The intersection with the I-86 on/off ramps features yield control for the I-86 off ramp and is uncontrolled along NY-434. The three-leg intersection with Degroat Road features stop control on Degroat Road and is uncontrolled along NY-434. The corridor lacks pedestrian infrastructure such as sidewalks and curb ramps. The entirety of the corridor is void of street lighting.

Contributing factors at NY-434 from the intersection with Degroat Road to northwest of the NY 17C Access Road included sharp horizontal curves, insufficient warning signage, and no lighting present in corridor. Potentially relevant safety countermeasures at this location include, enhanced delineation for horizontal curves through the installation of curve warning signage including chevrons, installation of deer warning signage, the addition of traffic signal backplates with retroreflective borders, and lighting improvements. Curve warning signage and chevrons will be installed at each of the horizontal curves throughout the corridor. This enhanced signage will increase driver awareness of the upcoming curves and prevent vehicles from straying outside of their travel lane or off the around these curves, preventing crashes of all types. The curve warning signage will include supplemental signage to recommend a lower speed around the curves with a high concentration of crashes. This lower speed will increase drivers’ reaction time and ability to maintain their travel path around curves. Due to the high number of crashes involving animals, deer warning signage will also be installed to increase roadway users’ awareness of the potential presence of deer throughout the corridor. To provide increased visibility of the signal heads at the intersection, traffic signal backplates with retroreflective borders will be installed at the intersection with NY 17 Access Road. Lighting improvements would be installed at the intersections with NY 17 Access Road and the I-86 ramps to provide increased visibility and enhance safety at the intersections. These lighting improvements will also improve drivers’ capability to see during dawn and dusk hours when deer are the most active, decreasing the potential for fatal or serious injury crashes involving deer.

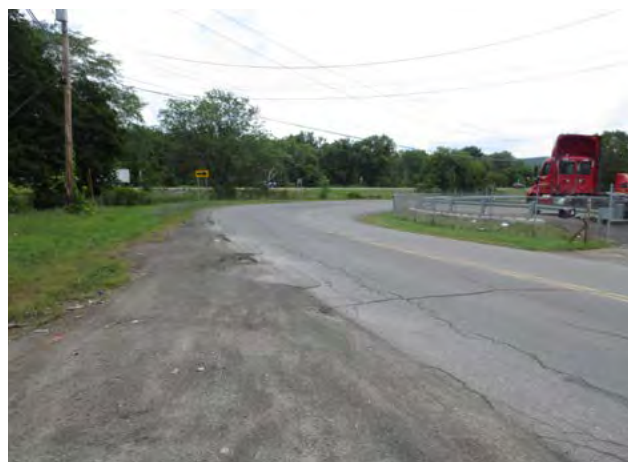
Photo 1: Looking north past upper bend in Sulphur Springs Rd. to I-86

The high incidence of roadway departure crashes along the corridor is influenced by curves and limited or outdated guide railing. Sight distance obstructions are caused by the several significant horizontal and vertical curves throughout the corridor. Despite these curves and the presence of ditches and fixed objects along the side of the road, there is very little guide railing to protect vehicles that stray from their travel lane off the road. The existing guide railing on the south end of the high-injury corridor is outdated corrugated guide railing that is in need of replacement. The speed limit on this section of Sulphur Springs Rd is posted at 45 mph. Sulphur Springs Road maintains one travel lane in each direction for the entire corridor.

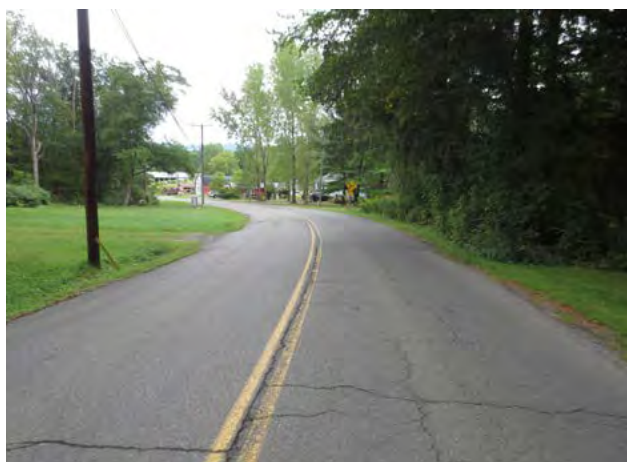
Photo 2: Sulphur Springs Rd. looking north near middle of segment

The corridor is lacking pedestrian infrastructure such as sidewalks, curb ramps, and crosswalks. The east end of the corridor in the eastbound direction is the end of the greenway bicycle path. The entirety of the corridor is void of street lighting. There are steep ditches on either side of the road throughout the corridor which present a dangerous condition in the event of a run-off-road crash, also known as a roadway departure crash.

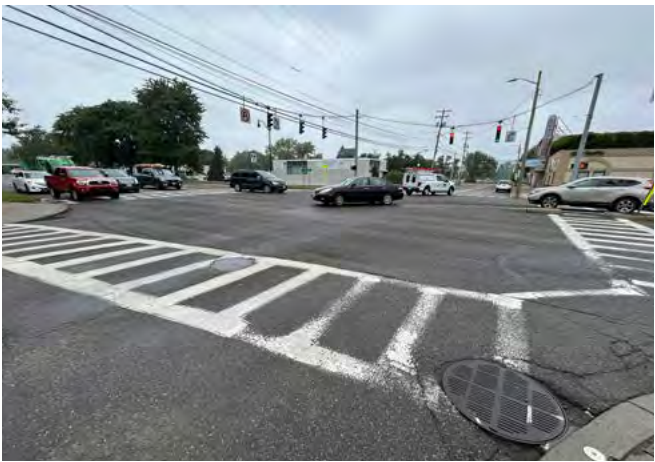
Photo 1: Northeast corner looking west

- Long crossing length (pedestrian exposure)
- Very high volume of traffic
- Faded crosswalk striping

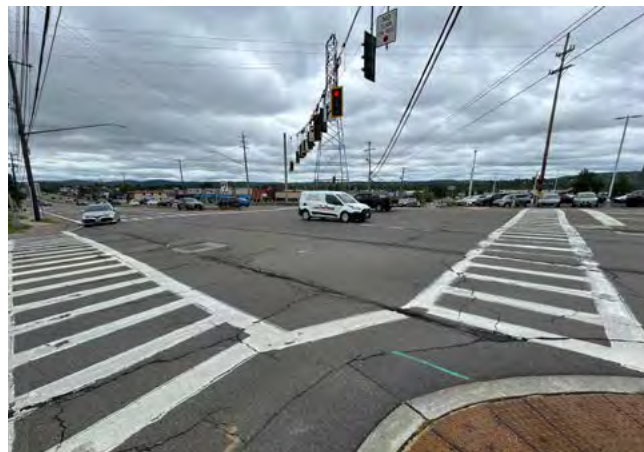
Photo 1: Southeast corner of intersection looking northwest

There are type LS crosswalks along each of the approaches which are accompanied by ADA compliant pedestrian signals. The crossing distances along Vestal Pkwy E measure approximately 100 feet in length. There is currently a leading pedestrian interval present for these crossings. There is existing concrete sidewalk present along each of the approaches. The curb ramps are in good condition and some of the detectable warning units are ADA compliant cast-iron while others are plastic warning units. Field

observations showed the pavement at this intersection is in fair condition with some minor cracking. The striping is also in fair condition, with the crosswalks having faded in some locations.

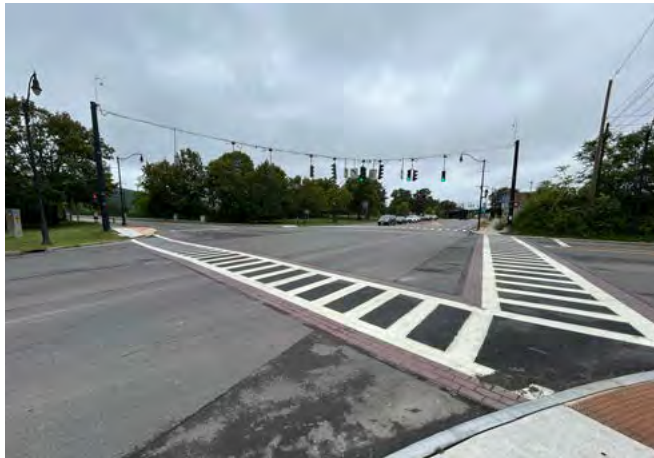
Photo 1: Northeast corner looking west

The intersection has type LS crosswalks present on the eastbound, southbound, and westbound approaches. These crosswalks are accompanied by ADA compliant curb ramps and pedestrian signals. There is currently no crosswalk on Tompkins St. There are concrete sidewalks on both sides

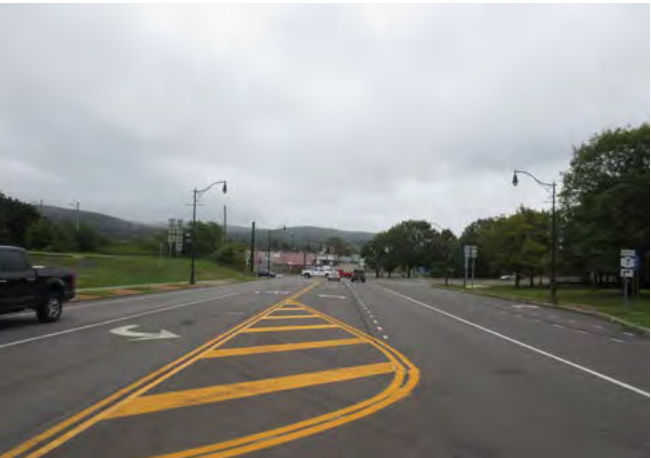
Photo 2: Northwest corner looking south

of all four approaches except for the south side of the westbound approach. The intersection follows the city speed limit of 30 mph for all approaches and traffic is controlled at the intersection with Brandywine Ave by a signal supported via span wire. Field observations showed that the pavement and striping are in fair condition.

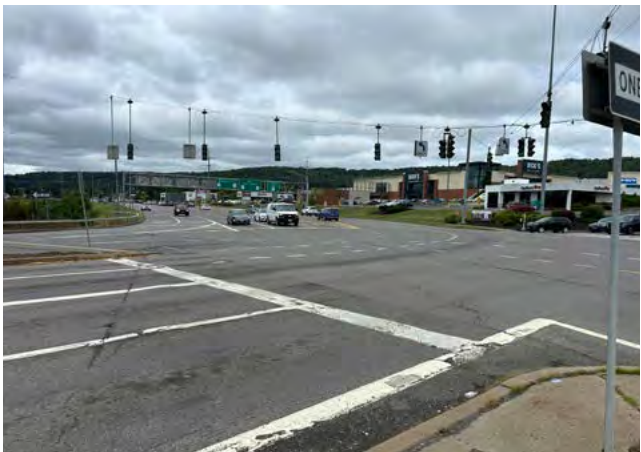
Photo 1: Concrete island in southeast corner looking northwest

The NYSDOT has planned a project which will add a dedicated left turn lane along the southbound approach. There is centerline guide rail on the southbound approach. There is concrete sidewalk along both the eastbound and westbound approaches. The sidewalk is in fair condition, and the curb ramps are in poor condition, not in ADA compliance. There is a crosswalk across Reynolds Rd at the north end of the intersection connecting the sidewalks, and across Harry L Dr on the east end of the intersection connected to the pedestrian refuge island. There are push buttons at the crossings of Harry L Dr and Reynolds Rd. There are audible pedestrian signals at east of the crossing locations with the exception of the slip ramp in the southeast corner.

configurations. Potentially relevant safety countermeasures at this intersection include, sidewalk improvements, crosswalk enhancements, rectangular rapid flashing beacons (RRFB), concrete refuge islands, a median barrier, and signage improvements. The sidewalks at this intersection are in fair condition, but the curb ramps and associated warning units have deteriorated significantly and are in need of replacement to meet ADA standards. These new curb ramps and warning units will ensure safe crossing for visually impaired users. New crosswalks will be painted at the existing locations over the existing faded LS crosswalks. This will allow crosswalks to be properly visible to all the vehicles moving through this busy intersection. New edge lines, lane lines, and dotted turn lines will be striped on where the existing striping has faded with the deteriorated pavement. The concrete refuge island in the southeast corner is nearing the end of its service life, has cracking, deformation and vegetation growth. This island needs repairs to function as a safe refuge for pedestrians crossing Harry L Dr. A solar powered RRFB will be installed on the existing pedestrian sign present at the slip ramp crossing in the southeast corner.

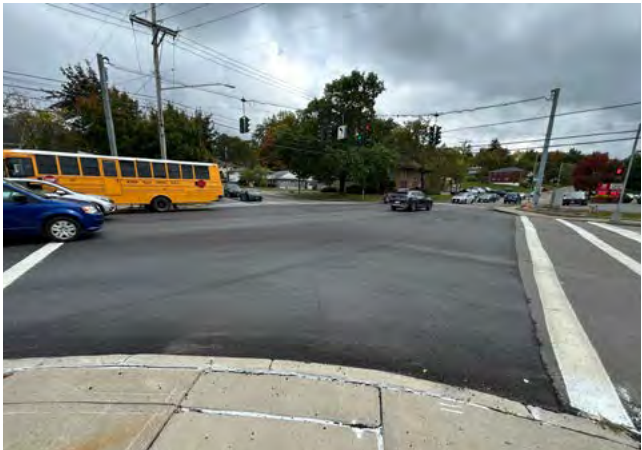
Photo 1: Southwest corner of Hooper Rd and Country Club Rd

The intersection features traffic control by span wire traffic signal including compliant pedestrian signals at all approaches. Curb ramps and type S crosswalks are present at all approaches to the intersection. All of the curb ramps have plastic detectable warning units in lieu of NYSDOT standard cast iron detectable warning units. All approaches to the intersection feature sidewalks with the exception

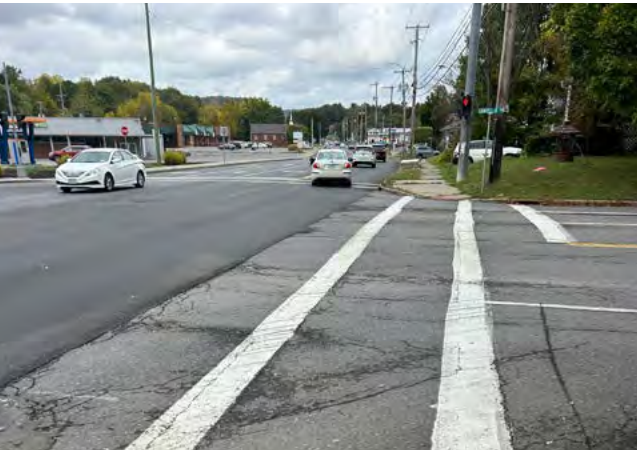
Photo 2: Northeast corner looking west on Hooper Rd

- Faded striping and poor intersection sight distance
- Lack of high visibility crosswalks
- Lack of bicyclist accommodations
- Long crossing length (pedestrian exposure)

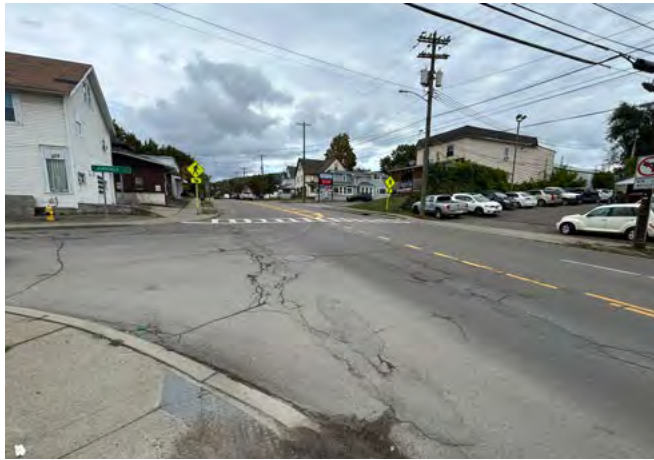
Photo 1: Southwest corner of intersection looking north

Field observations showed the remnants of curb ramps at sidewalk endpoints, but they have fallen out of ADA compliance. The striping at this intersection is in good condition, however the pavement has severe cracking.

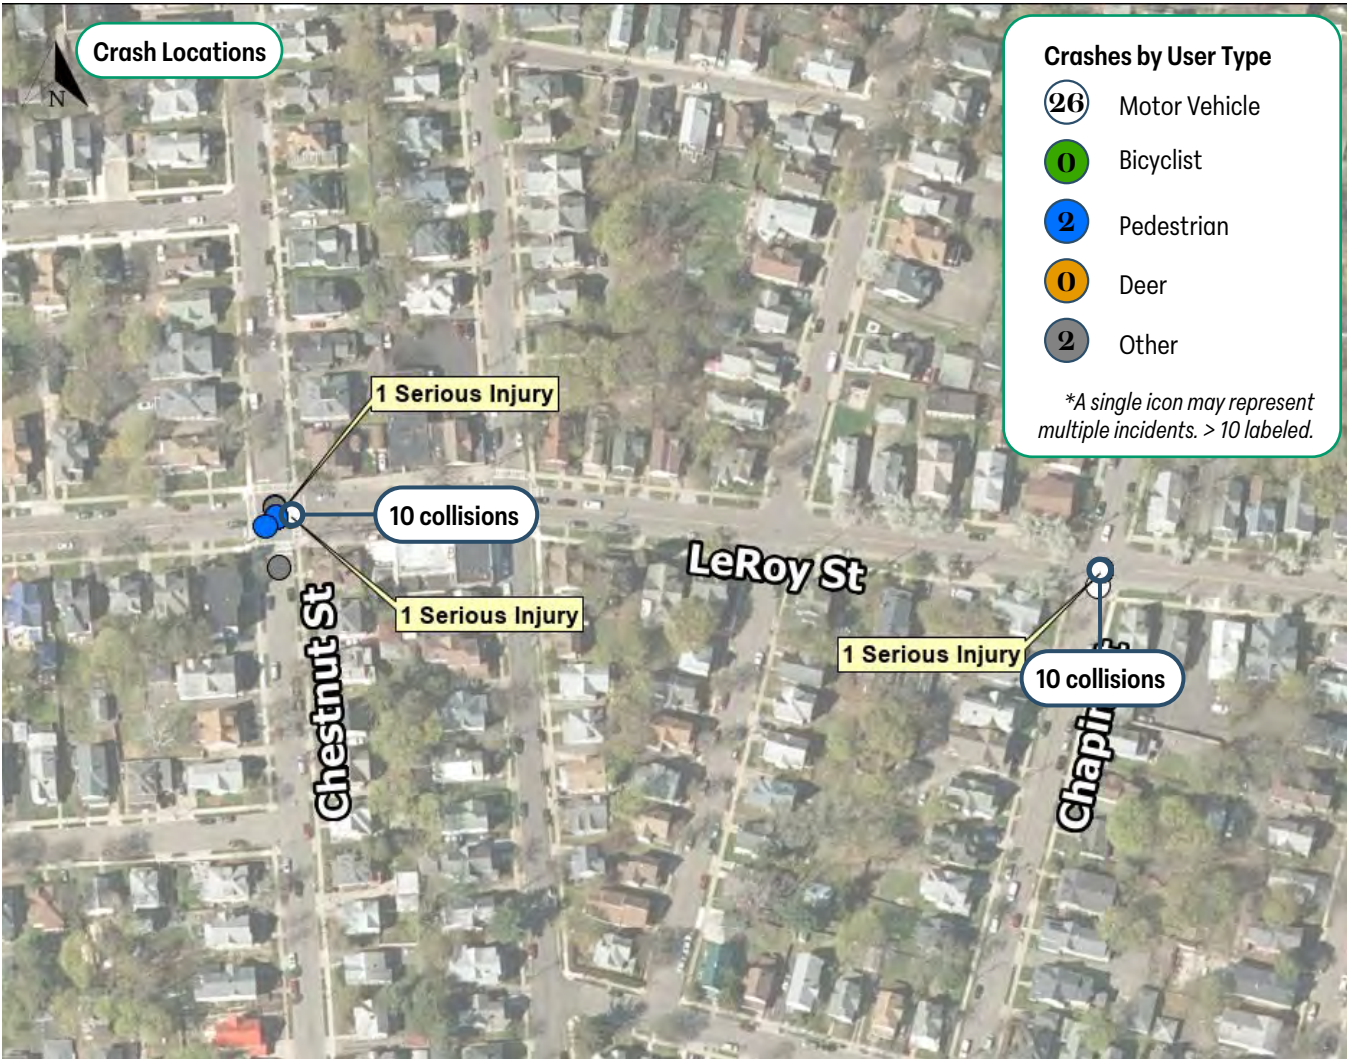
Crash Data

- Lack of pedestrian signals – Leroy/ Chestnut
- Lack of crosswalks – Leroy/Chapin
- Poor sight distance from stopping locations at two uncontrolled approaches – Leroy/Chapin
- Tight turning radii with on street parking

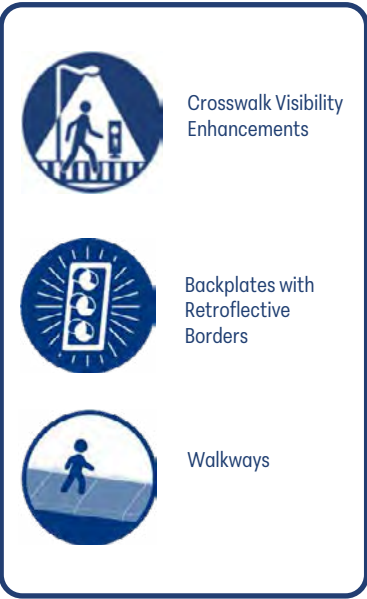
Proposed Countermeasures

Contributing factors at Leroy, Chestnut, & Chapin Streets included lack of crosswalks, pedestrian signals, poor sight distance from stopping locations at the Leroy and Chapin approaches, and tight turning radii. Potentially relevant safety countermeasures at these intersections include, traffic signal enhancements, pedestrian infrastructure improvements, installation of high visibility crosswalks, curb bump outs at all corners of the intersection, and enhanced warning signage. The existing traffic signals at Chestnut St are outdated and are in need of traffic signal backplates with retroreflective borders. These backplates will provide increased visibility of the signal heads at the intersection of Leroy Street and Chestnut Street. At Leroy and Chestnut St there are currently no pedestrian signals at any of the crossing locations. It is necessary to install pedestrian signals to provide increased protection for pedestrians crossing at this intersection where there were two crashes involving pedestrians during the study period. Currently at Chapin St, there are no crosswalks present and the type LS crosswalks at Chestnut St have faded. To address this, high visibility crosswalks will be installed at all approaches to both intersections. These will increase driver awareness of pedestrian crossings and reduce the risk of crashes involving vulnerable road users. To further accommodate pedestrians, curb bump outs will be installed in all corners of both intersections to shorten the crossing distance for crosswalk users. Pedestrian crossing warning signage will be installed at the intersection of Leroy Street and Chapin Street to provide increased visibility at the uncontrolled crossings.

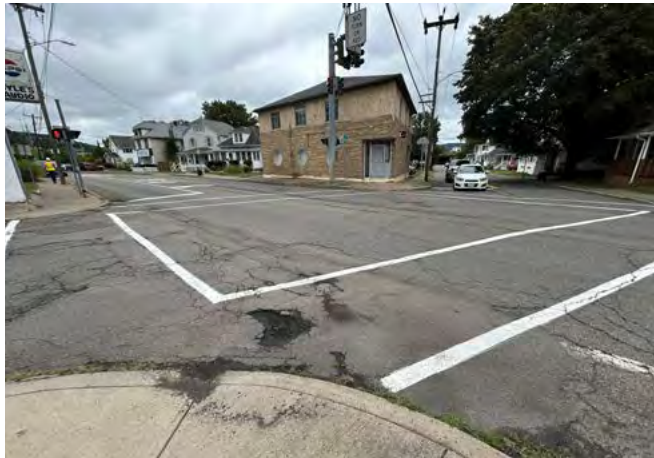
Photo 1: Northwest corner looking southeast

- Deteriorated or cracked sidewalks and curb ramps
- Poor intersection sight distance
- Cracked pavement and faded striping

Contributing factors at Harry L Drive, Lester Avenue, and Zoa Avenue included deteriorated or cracked sidewalks and curb ramps, poor intersection sight distance, cracked pavement and faded striping. Potentially relevant safety countermeasures at this intersection include, reconstructing walkways with curb bump outs and ADA compliant curb ramps, new type LS crosswalks, lighting improvements, rectangular rapid flashing beacons, signage improvements and traffic signal upgrades. Curb bump outs will allow for safer pedestrian crossing by shortening crossing distances and slowing down traffic. ADA-compliant curb ramps will be installed at all approaches so the visually impaired can safely navigate the intersection. By restriping the crosswalks to combine the standard layout with ladder lines, the crosswalks will be more visible to drivers and further improve the safety of pedestrian crossings. Additional overhead lighting will be installed on the signal pole in the southeast corner to increase visibility of the entire intersection. Neon green advanced pedestrian warning signs are recommended to be installed east of the intersection which will flash when a user activates the pedestrian signal. Vegetation removal is required to unveil the speed limit sign east of the intersection. Lastly, the traffic signals at the intersection are in need of replacement with upgraded signal heads including yellow retroreflective backplates. Also recommended is the replacement of the existing pedestrian signals with updated signals that include countdown timers and audible push buttons.

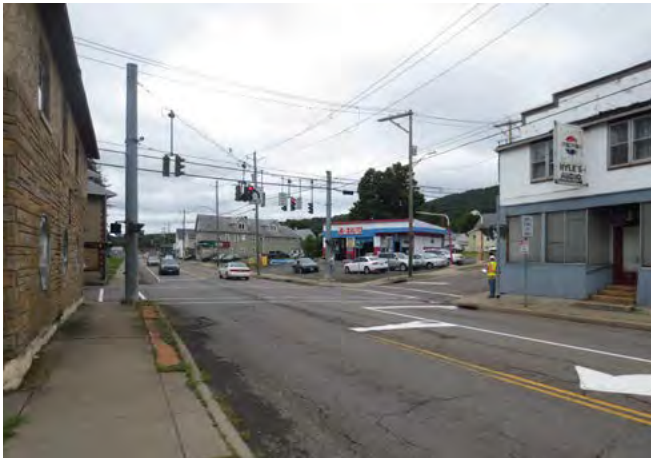
Photo 2: Harry L Dr eastbound looking West

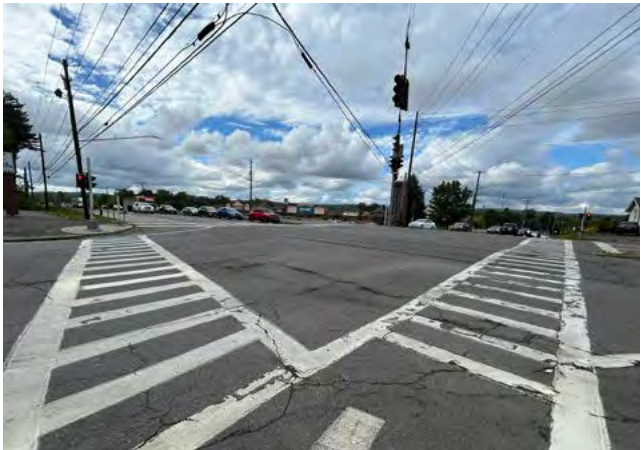
Photo 2: Southeast corner of intersection looking northwest

Field observations showed the pavement is in poor condition with significant cracking. There are existing type LS crosswalks that have faded with the deteriorated pavement. The longest crossing along Vestal Pkwy E is over 110-ft in length. Audible pedestrian signals with push buttons are present at each of the crossings. There are curb ramps in good condition with ADA compliant cast iron detectable warning units at three of the four corners except to the southwest where there is a concrete island with no curb ramp.

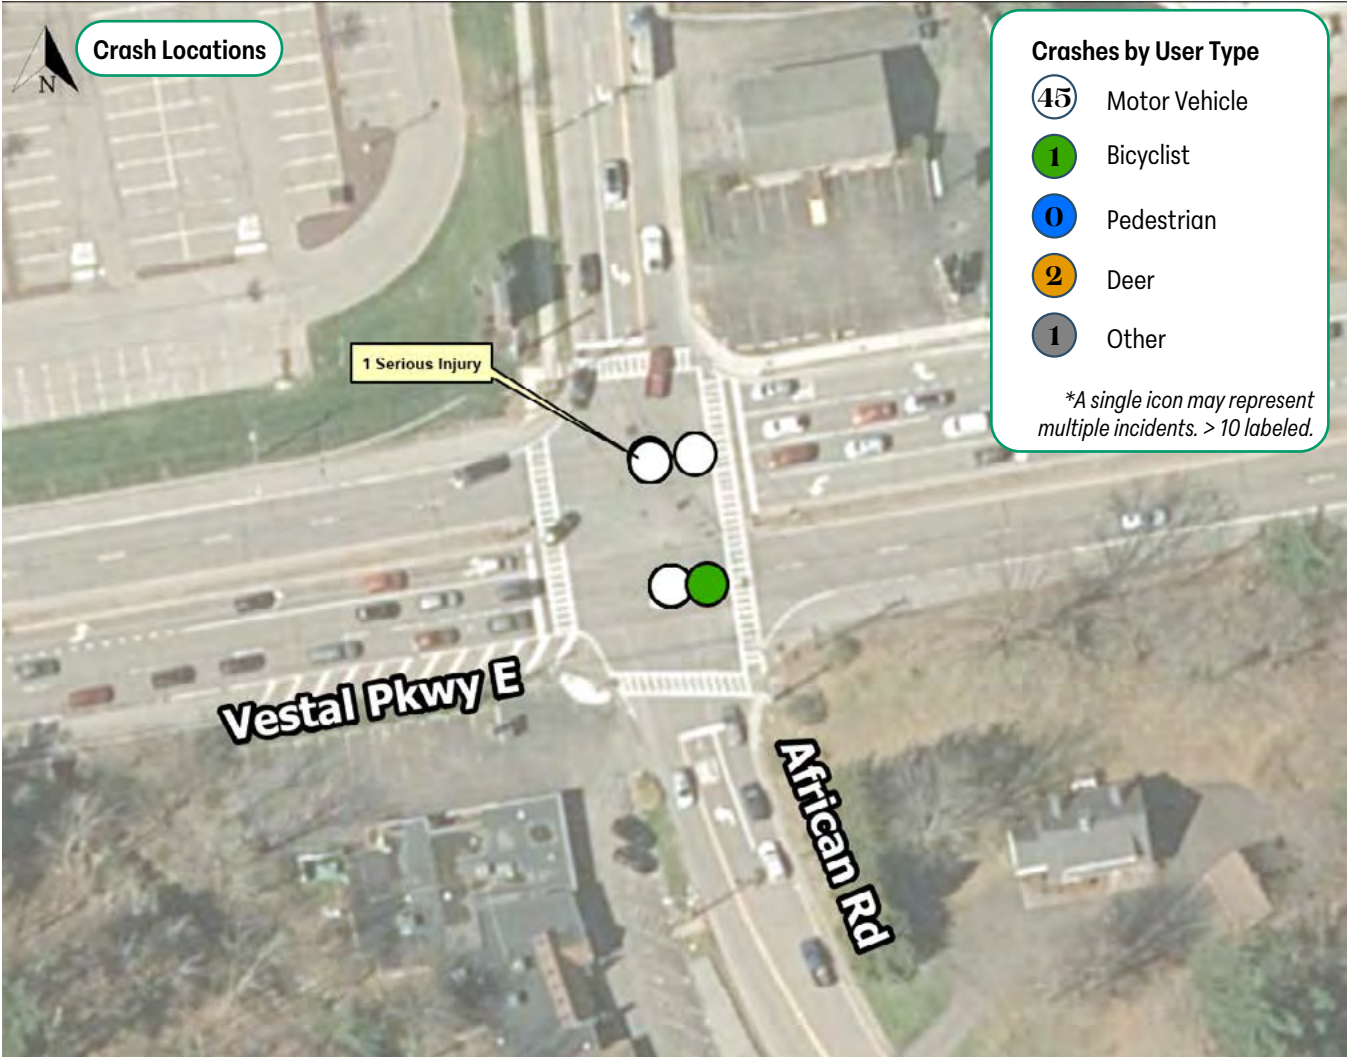
## Crash Data

- Long pedestrian crossing length
- High traffic volume
- Faded crosswalk striping

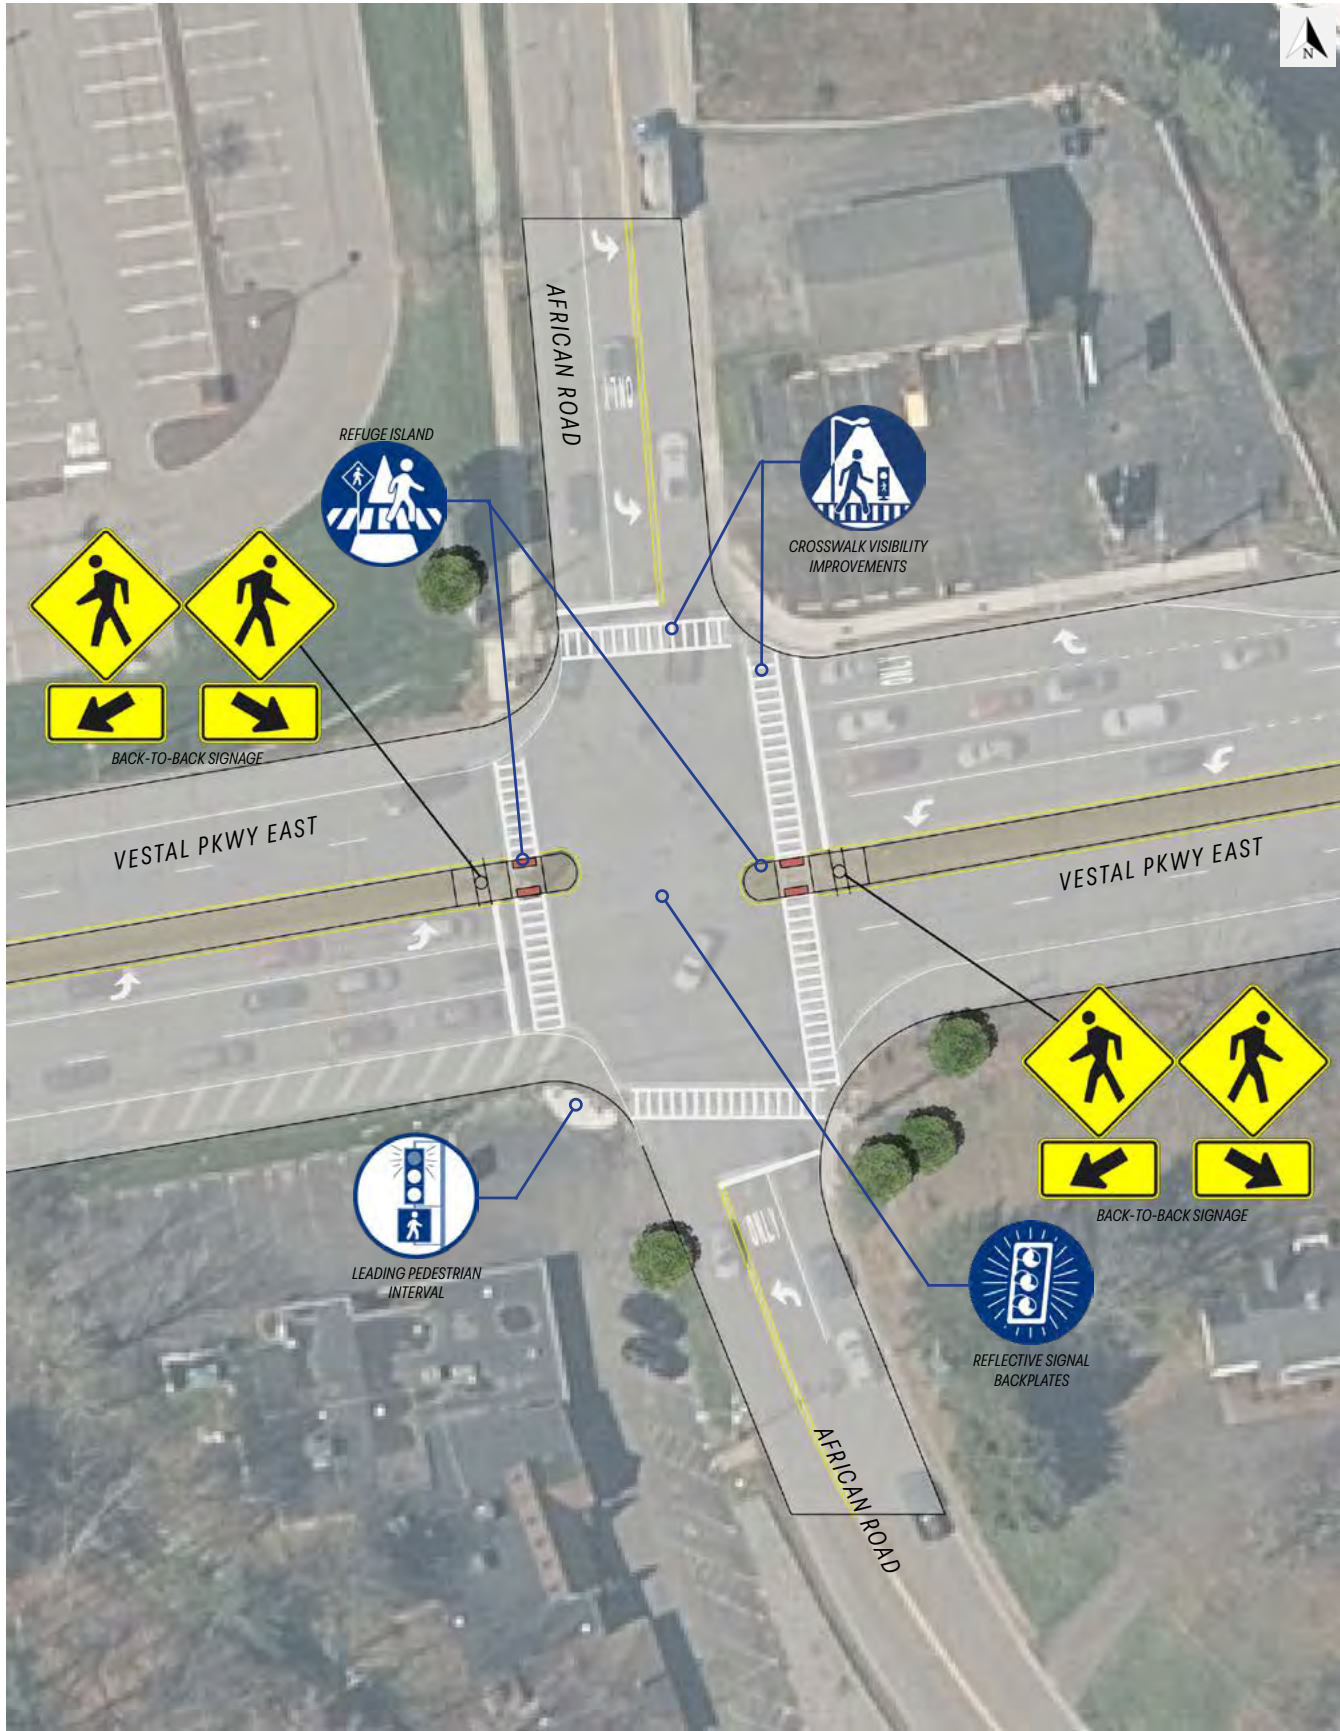
Proposed Improvements

Crosswalk Visibility Enhancements
