# BMTS safety ***ACTION*** plan

Draft Report

January 2026

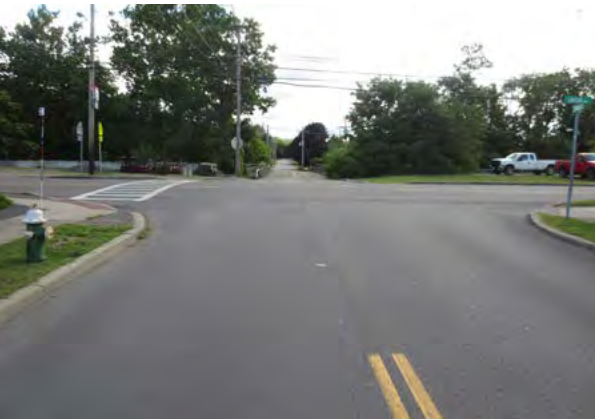
Photo 1: Eastbound approach looking east

A total of 4 crashes occurred during the study period between 2019 and 2023, with 3 of these crashes resulting in injury. The crash types observed within the study period at this intersection were left turn, rear end, and right angle crashes. The intersection features stop control at the eastbound and westbound approaches while the northbound and southbound approaches are uncontrolled. The northbound and southbound approaches to the intersection maintain one travel lane in each direction, with parking on the east side of the road. The eastbound approach maintains one travel lane in each direction with parking on the south side of the street. The westbound approach is a narrow bridge which maintains one travel lane in each direction and has no shoulder. The bridge surface is asphalt pavement which has deteriorated and has missing sections along the edges.

There is also a wooden pedestrian path along the north side of the bridge connecting to the existing sidewalks. Curb ramps and sidewalks are present at all approaches to the intersection with the exception of sidewalks at the westbound approach. All of the curb ramps presently have plastic detectable warning units in lieu of NYSDOT standard cast iron detectable warning units. A Type LS crosswalk is present crossing the southbound approach on Cayuta Avenue while faded Type L crosswalks are present at the two

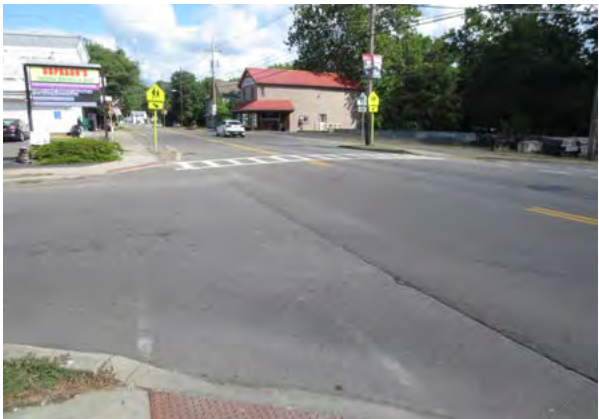
Photo 2: Southwest corner looking north

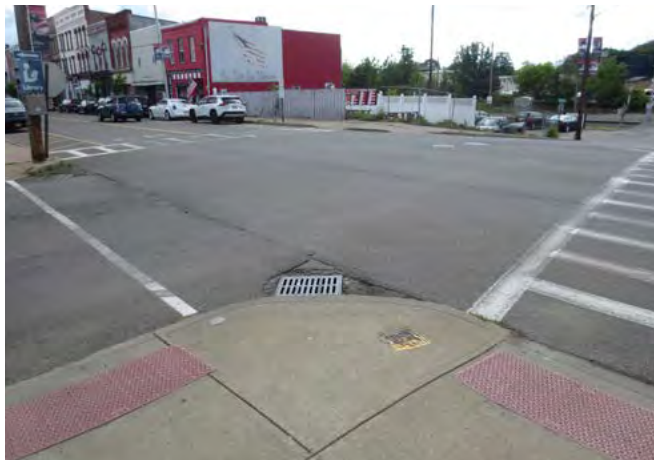
Photo 1: Northwest corner looking southeast

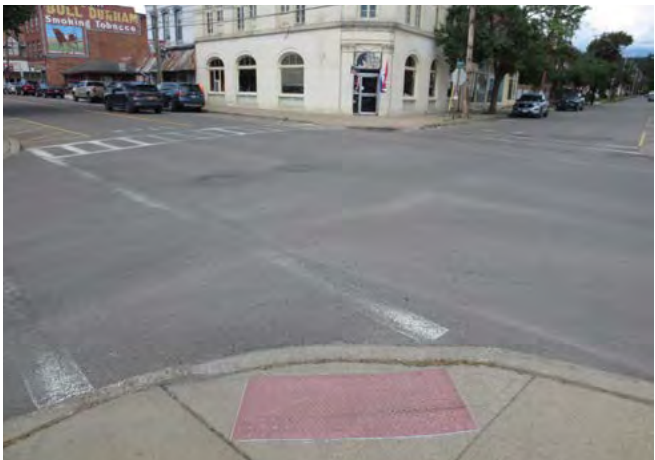
Photo 2: Southeast corner looking northwest

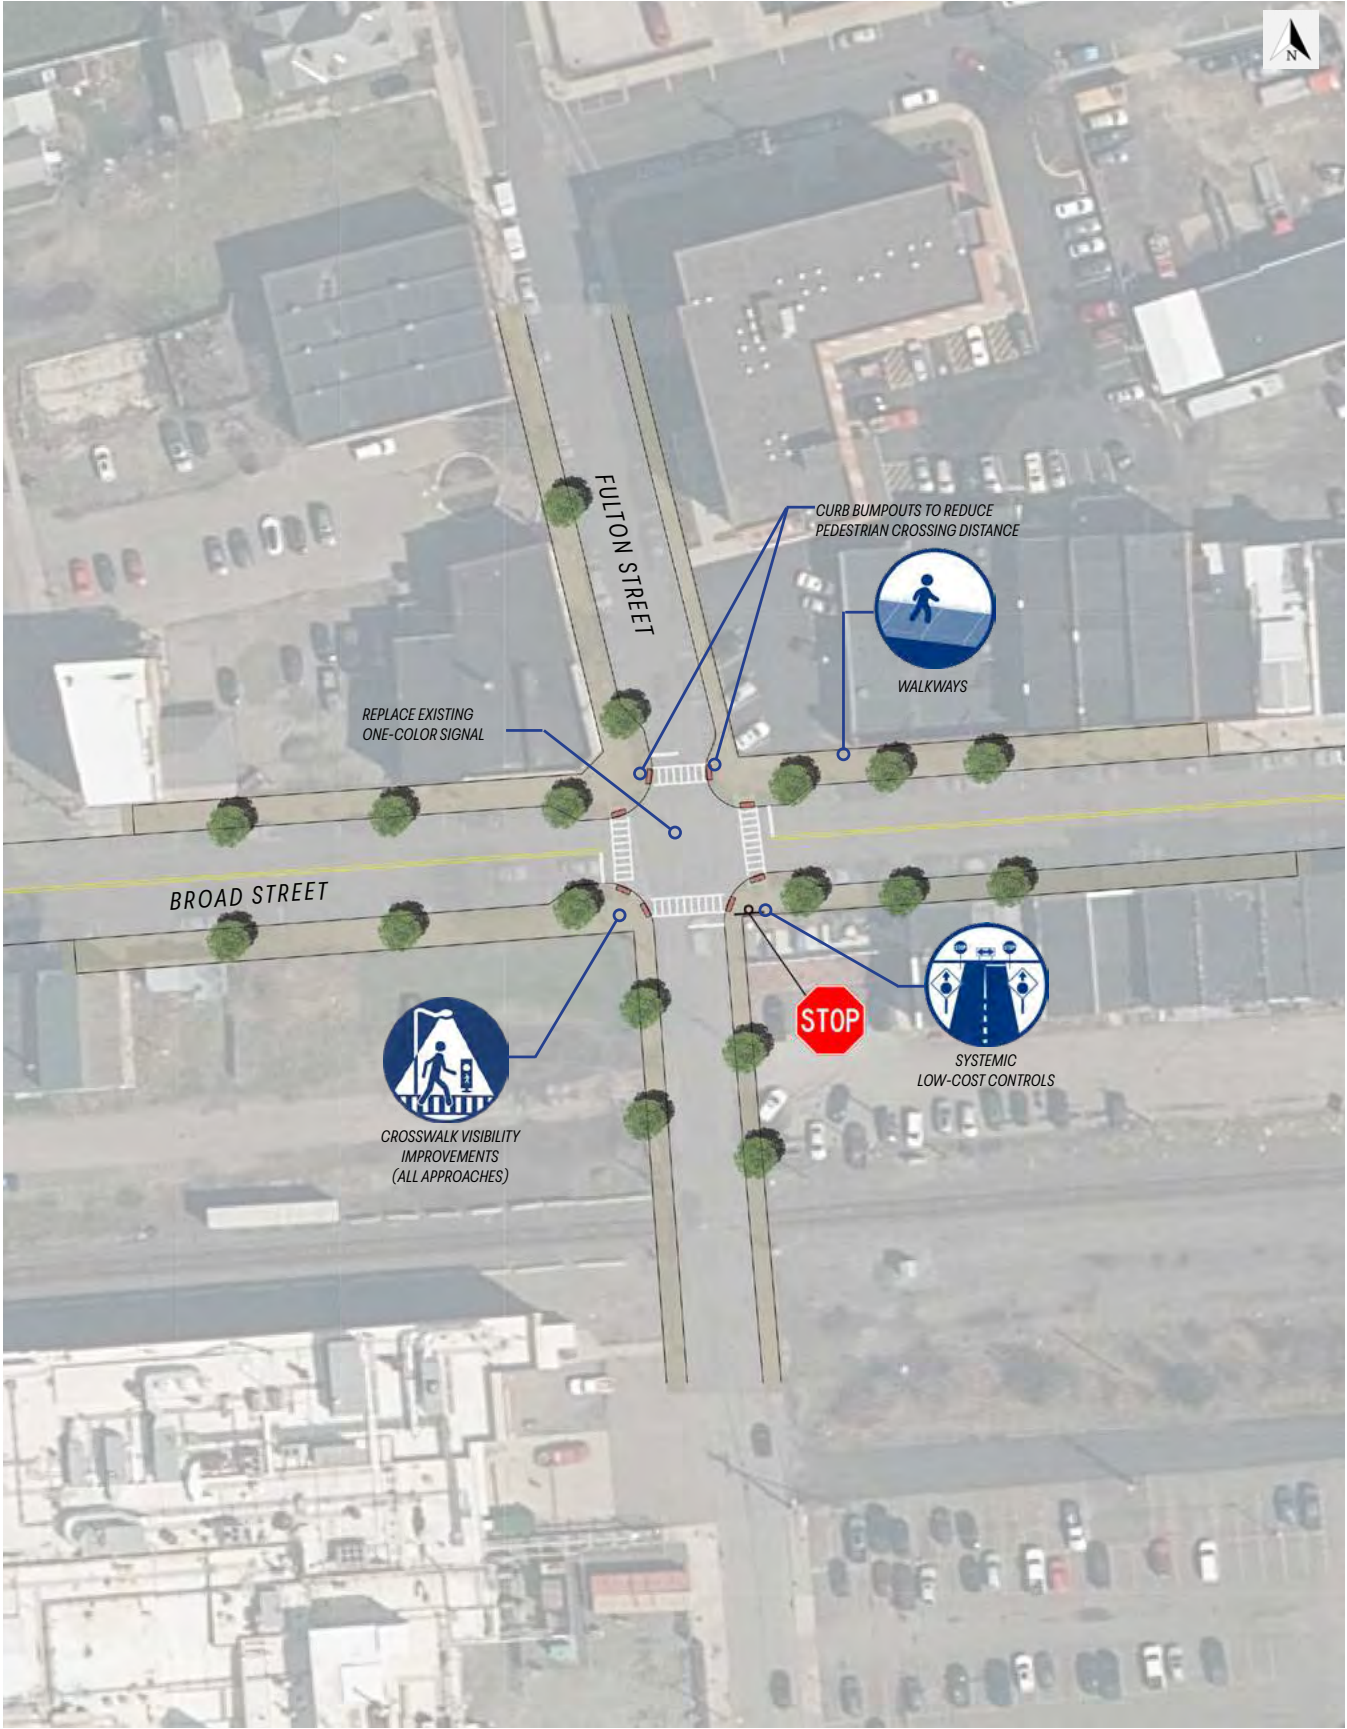
Proposed Improvements

Crosswalk Visibility Enhancements

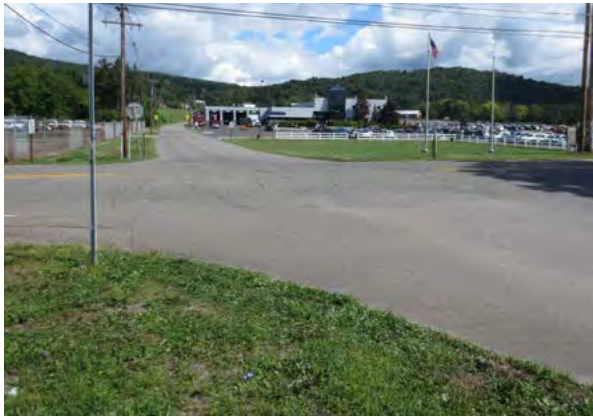
Photo 1: Southbound approach looking north

The travel lanes are separated by a full barrier, double yellow line which is extremely faded on the existing pavement. The eastbound and westbound approaches to the intersection on NY 17C maintain one travel lane in each direction with a striped shoulder. Neither intersecting corridor featuring

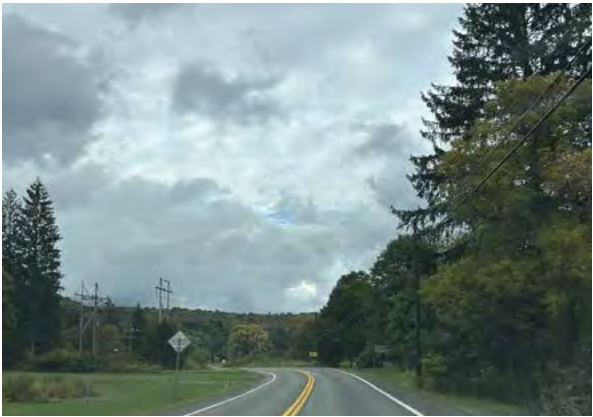
Photo 2: Middle of intersection looking east

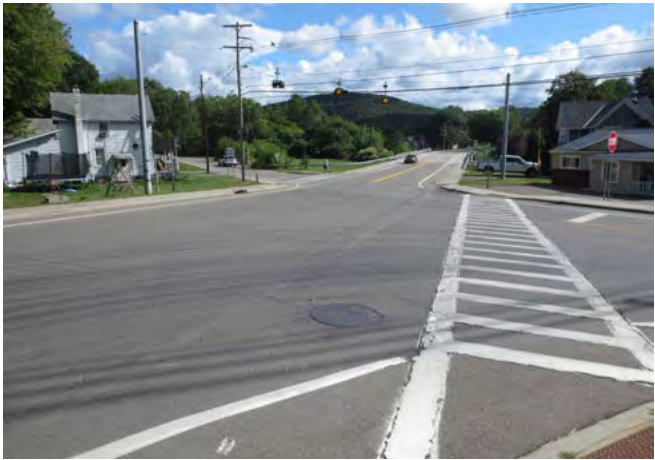
Photo 1: Chemung St and Cayuta Ave southwest corner looking east

Curb ramps and sidewalks are present at all approaches to the intersection with the exception of sidewalks going up the southbound approach. All curb ramps at the intersection have NYSDOT standard cast iron detectable warning units. Type LS crosswalks are present at the northbound and southbound approaches on Cayuta Avenue. The intersection features street lighting on the northwest corner and along the east side of Cayuta Avenue and the south side of Chemung Street. Signage on Chemung St indicates the State Route 17 bike path proceeds to the east and west.

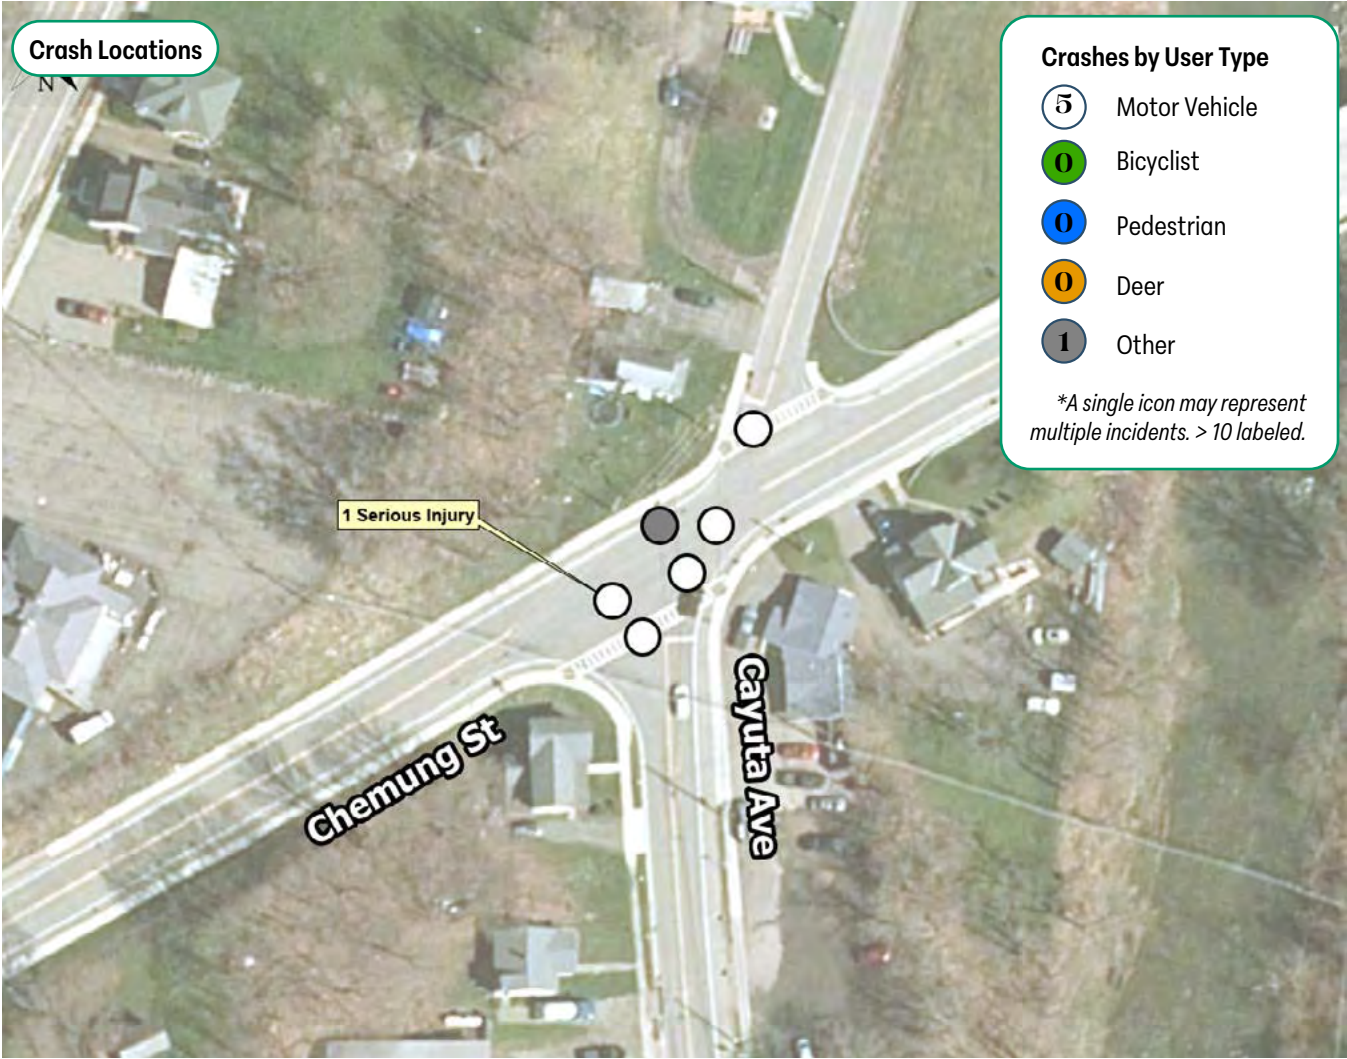
Crash Data

- Skewed approaches to intersection
- Tight turning radii with on street parking
- Obstructed sight distance

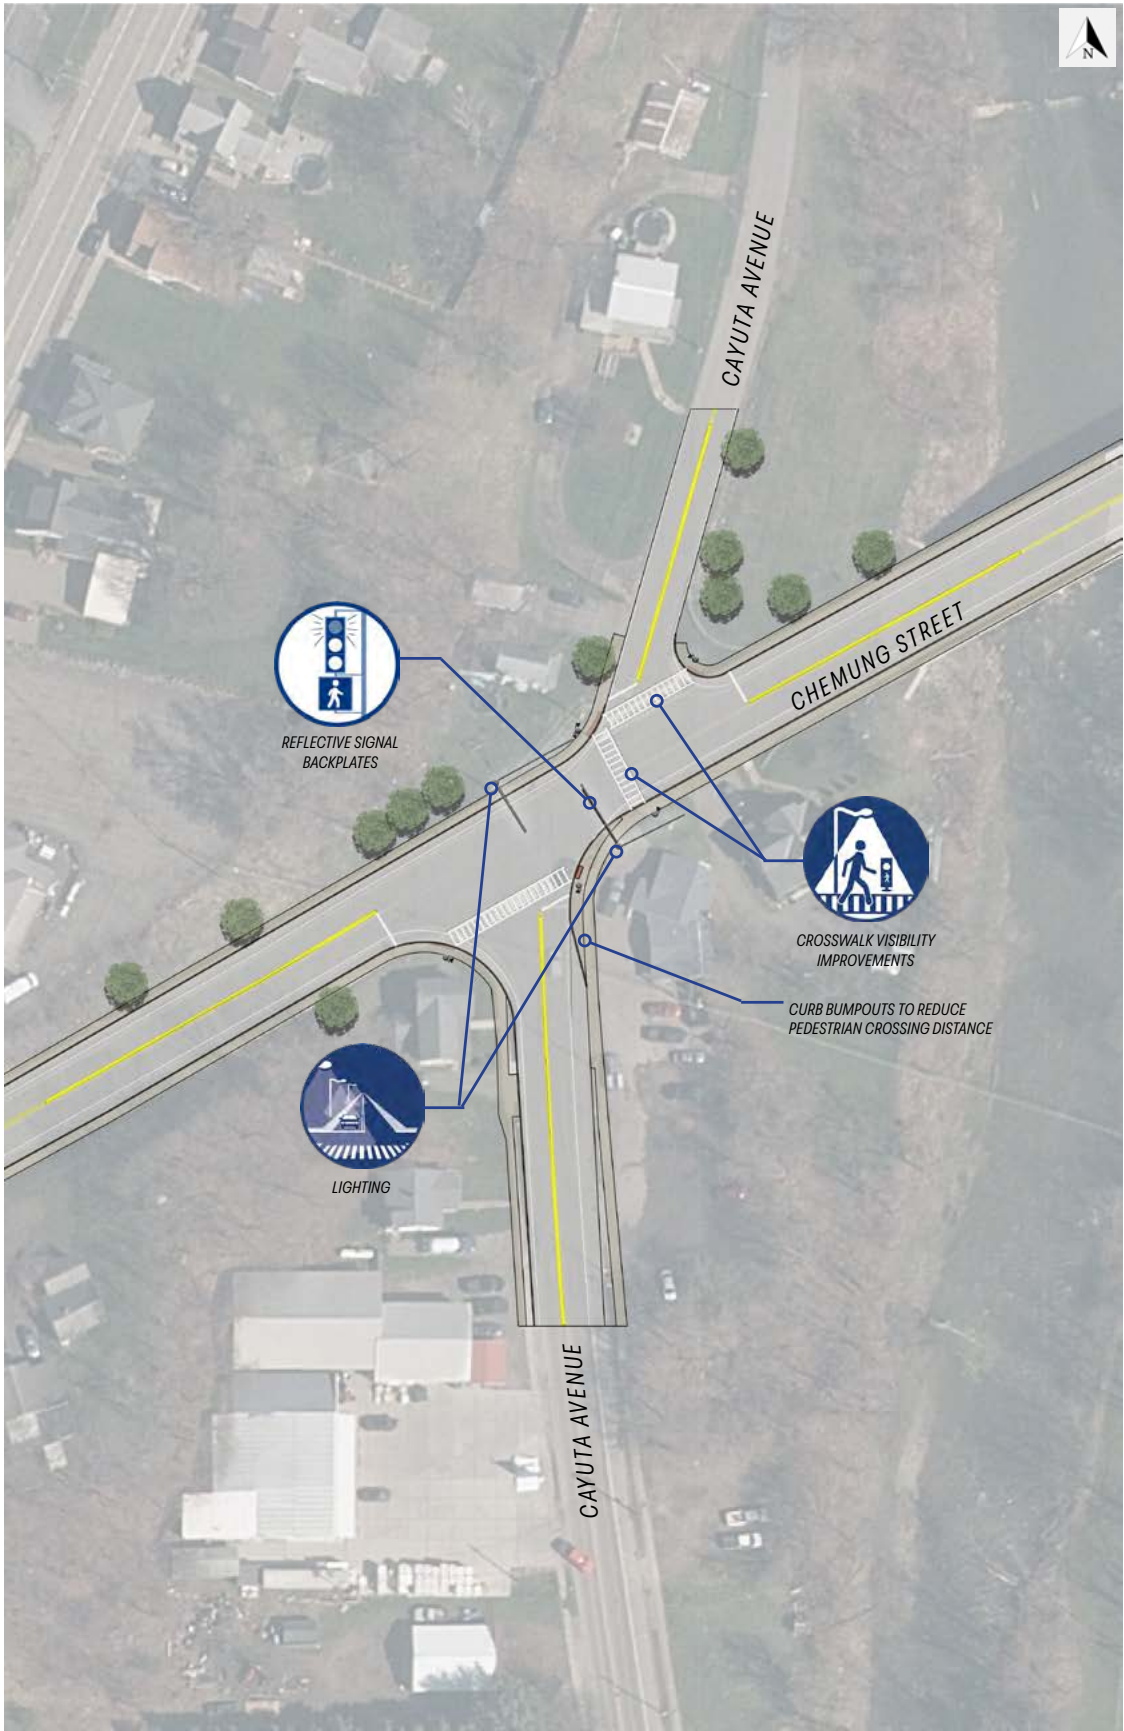
Proposed Improvements

Contributing factors at Chemung Street and Cayuta Avenue included skewed approaches to intersection, tight turning radii with on street parking, and obstructed sight distance. Potentially relevant safety countermeasures at this intersection include, the installation of high visibility crosswalks and stop bars, converting the intersection from stop control to traffic signal control, installing backplates with retroreflective borders, lighting improvements, and a curb bump out in the southeast corner of the intersection. The existing type LS crosswalks would be replaced with high visibility crosswalks to enhance drivers' ability to see the crosswalks and pedestrians crossing the intersection. 12" thick white epoxy stop bars would be installed at all approaches to the intersection along with the necessary supporting signage. The existing two-way stop would be converted to signal controlled, with the installation of 3-color traffic signals along each of the approaches. With these new traffic signals, pedestrian signal infrastructure will be installed at each of the crossings to give pedestrians guidance on when it is safe for them to cross. Implementing pedestrian signals enhances safety for both road users and pedestrians. Lighting improvements will be installed at the intersection to provide increased visibility of the intersection. The curb in the southeast corner of the intersection will be bumped out in order to shorten the crossing distance for crosswalk users. The new curb alignment will require some reconstruction of the side and installation of a new curb ramp with a cast iron detectable warning surface.

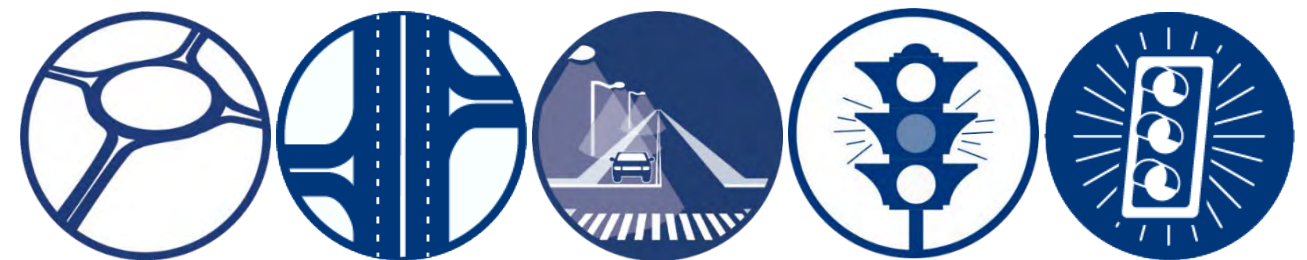
- Stop-Controlled T Intersections (Three Legs)
  - Same set of Basic and Supplemental Countermeasures as Four Leg
    - Double arrow warning sign on stop-controlled approach (as shown in **Figure 63**)

Figure 63. Basic Low-Cost Countermeasures for Stop-Controlled T Intersections (Source: FHWA-SA-09-020, Figure 1 (pg. 6))

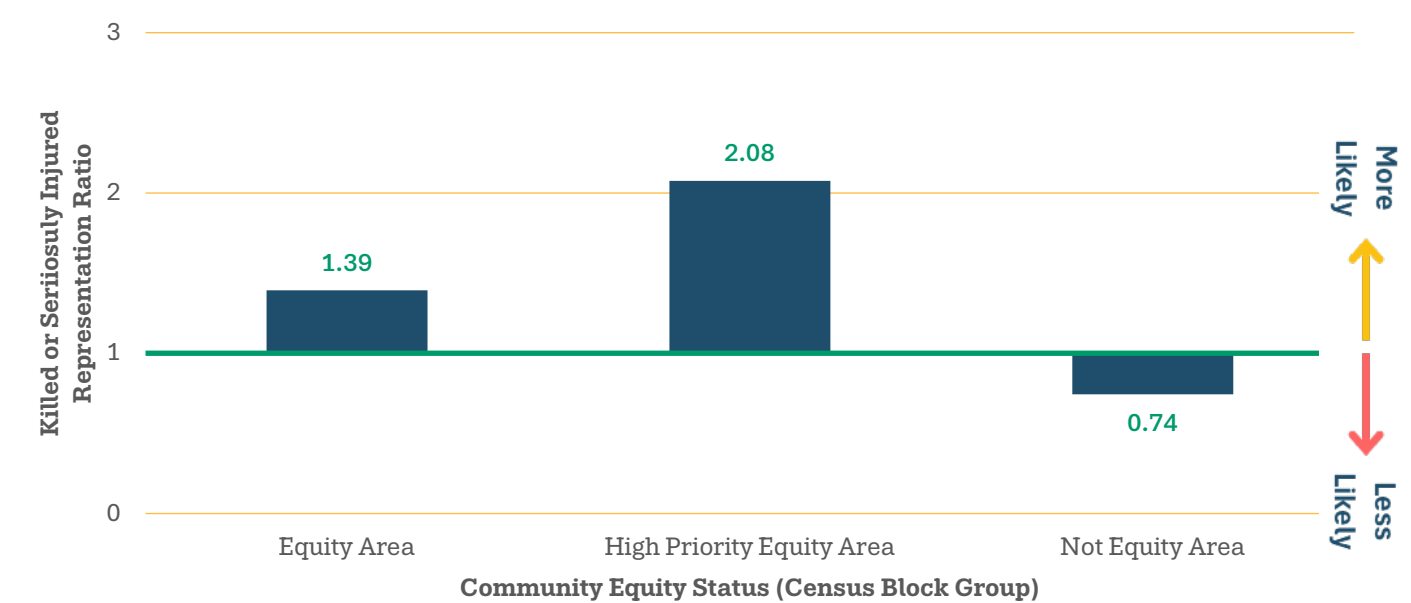
Community Equity Status	LENGTH	FATAL OR SERIOUS INJURY (KSI) CRASHES			ALL INJURY (KABC) CRASHES		
	Share of Roads	Crash Count	Share of Crashes	Represent. Ratio	Crash Count	Share of Crashes	Represent. Ratio
Equity Area (Top 21-40%)	18%	83	25%	1.39	482	27%	1.49
High Priority Equity Area (Top 20%)	10%	72	22%	2.08	510	28%	2.70
Not Equity Area	72%	176	53%	0.74	808	45%	0.63
TOTAL	100%	331	100%	1.00	1,800	100%	1.00

Figure 75. KSI Crash Representative Ratios (Broome County) – Community Equity Status (Source: WSP, Census)
