# Two Rivers Greenway Trail Maintenance Report

PREPARED BY BMTS CENTRAL STAFF

# About the 2026 Trail Maintenance Report

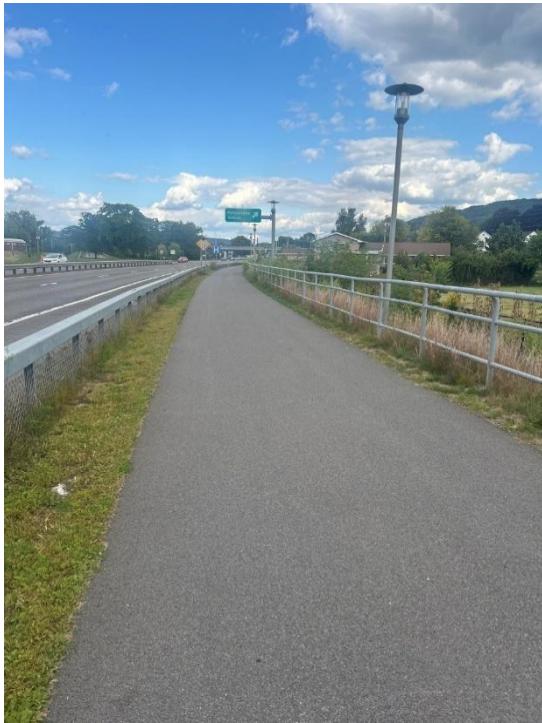
Photo 1. Eastern View at Hallam Street to MacArthur Park

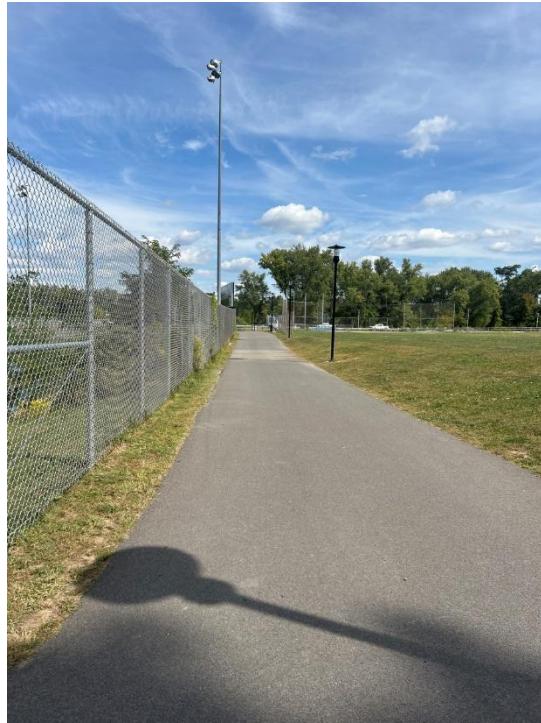
Photo 2. Northern View at MacArthur Park Parking/Trail Connection

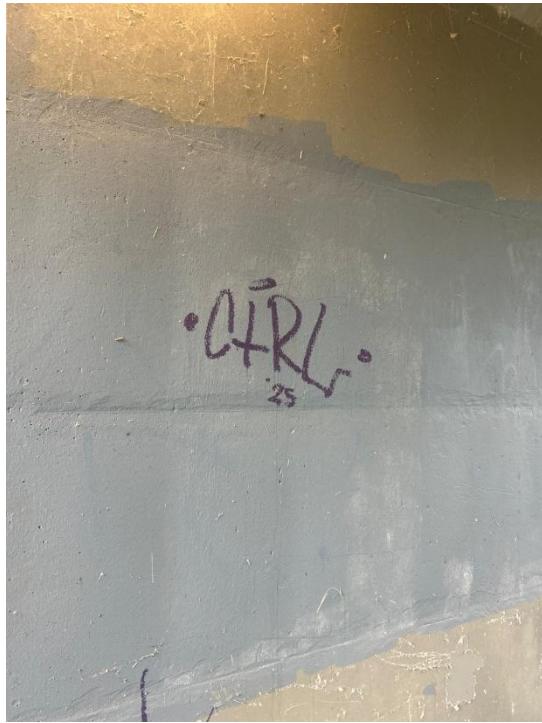
97% of the trail was maintained or well-maintained. Out of eight surveyed sub-sections of the 434 Greenway, five were well-maintained, two were maintained, and one was poorly maintained, giving the trail a weighted average maintenance score of 2.4 out of 3. The only poorly maintained section of the trail was the Pennsylvania Avenue Underpass, which had glass present on the trailway, as well as graffiti on the walls of the underpass (see Appendix A, Photo 3). Other maintenance issues on the trail included plant matter and other debris present on pavement, both loose and growing through pavement seams.

Photo 3. Graffiti at Pennsylvania Avenue Underpass

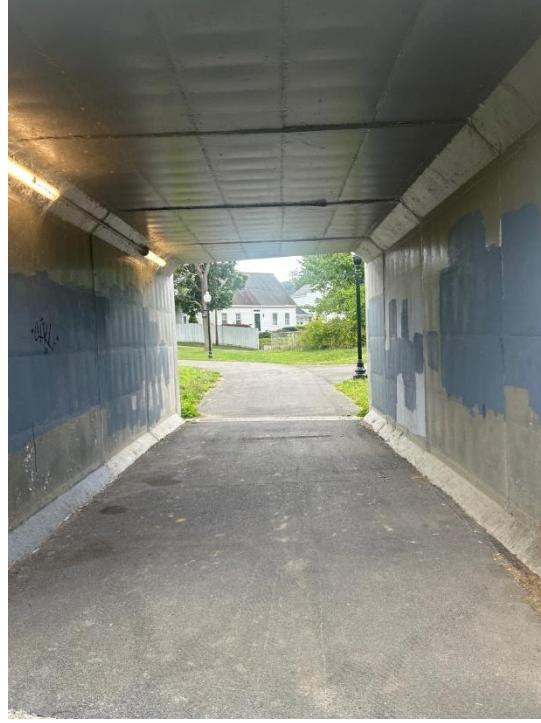
100% of the pavement of the 434 Greenway is in good or excellent condition. The only section of pavement not in excellent condition, was the Pennsylvania Avenue Underpass which was only in good condition due to minor pavement unevenness on the north side of the tunnel. The rest of the trail was in excellent condition. The Greenway was opened in 2023. As of 2025, the pavement has not deteriorated, and it remains in excellent condition.

Photo 4. Tunnel at Pennsylvania Avenue Underpass

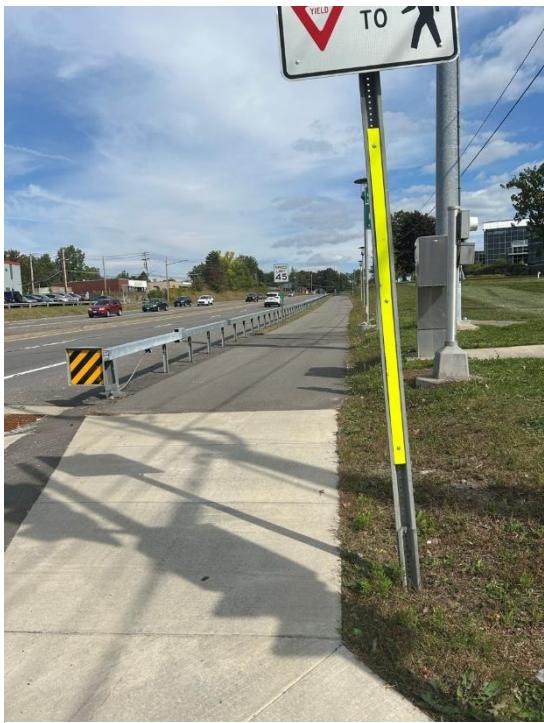
*Photo 5. Eastern View at UClub to Murray Hill Road*

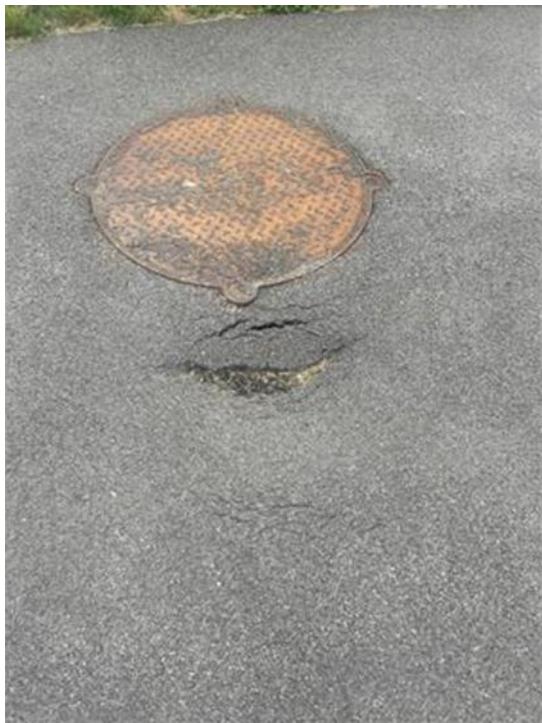
*Photo 6. Cracking/Depression at Hallam Street to MacArthur Park*

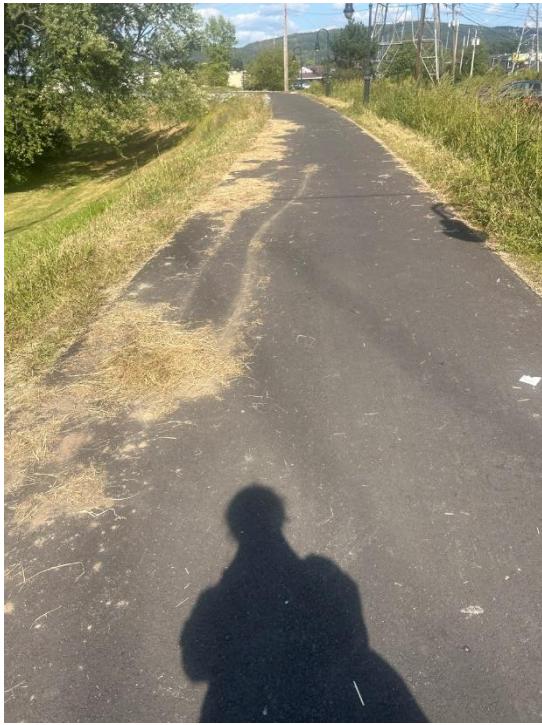
*Photo 7. Northern View at Serafini to Cheri Lindsay Park*

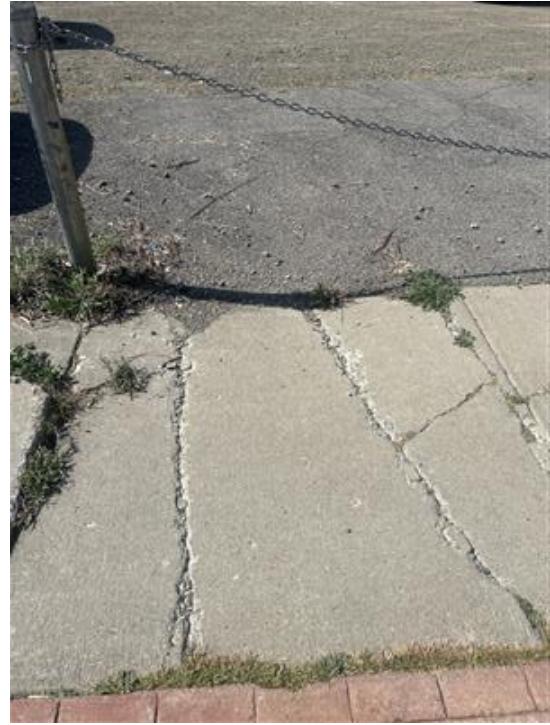
The percentage of good/excellent pavement was decreased by the poor condition of the pavement on the E Clinton Street to Eldredge subsection of the trail. Problems included large cracks and uncontrolled vegetation growth on the pavement (See Appendix A, Photos 8 and 11). The MLK Jr. Monument to E Clinton Street subsections have similar problems, with moderate pavement cracking.

*Photo 8. Sidewalk Cracking at E Clinton Street to Eldredge*

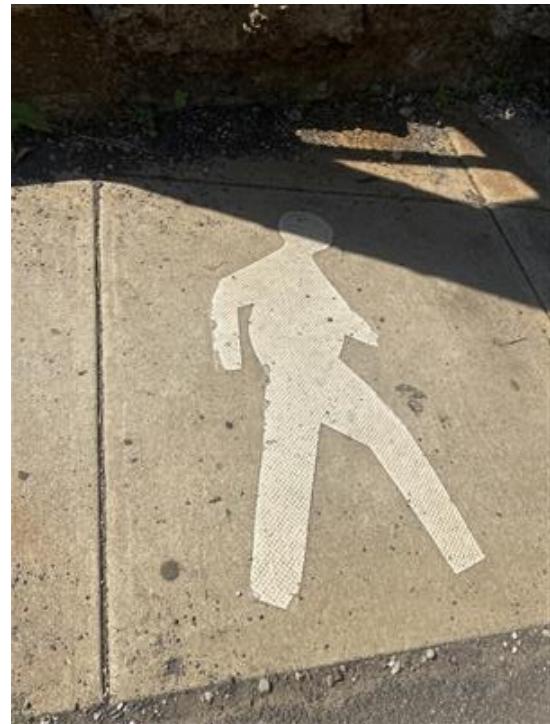
*Photo 10. Pedestrian Signage at E Clinton Street to Eldredge*

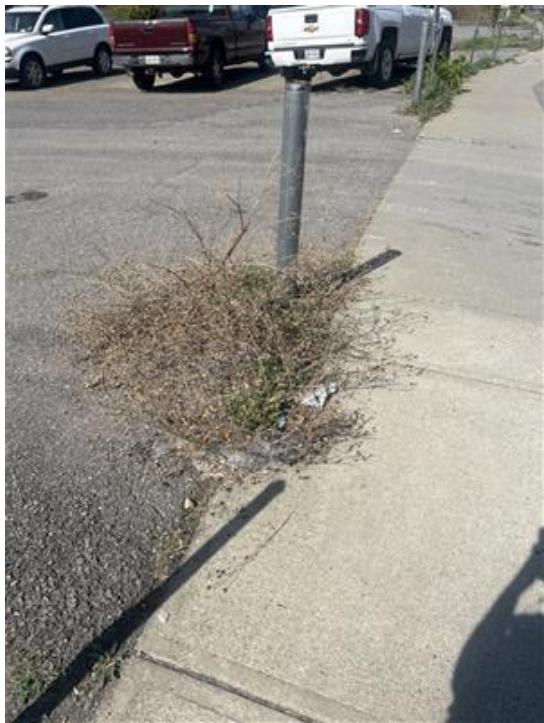
*Photo 11. Vegetation Growth at E Clinton Street to Eldredge*

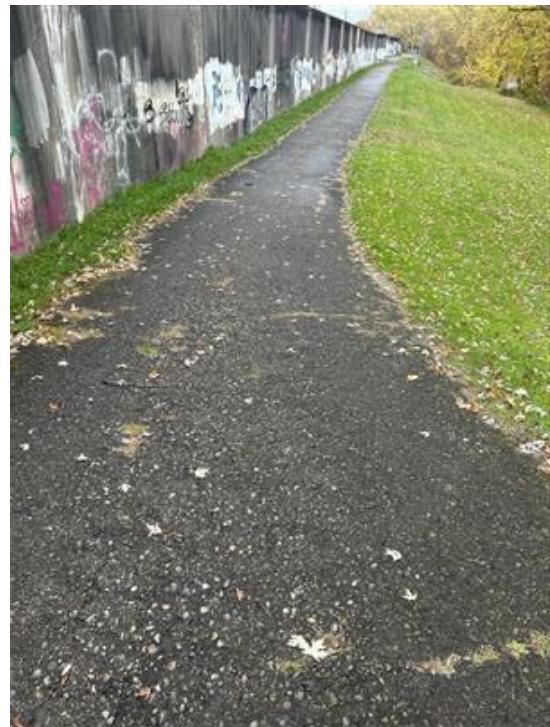
*Photo 13. Eastern View at River Terrace Entrance to Endicott Village Water Department*

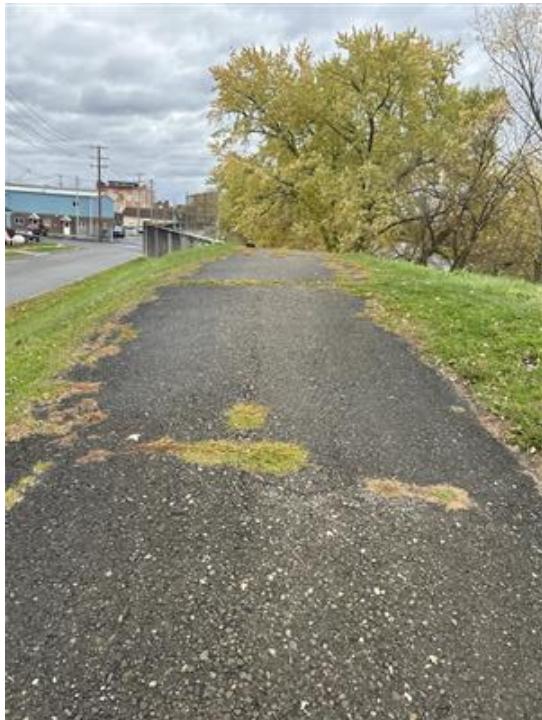
*Photo 14. Eastern View at River Terrace Main Trail Entrance*

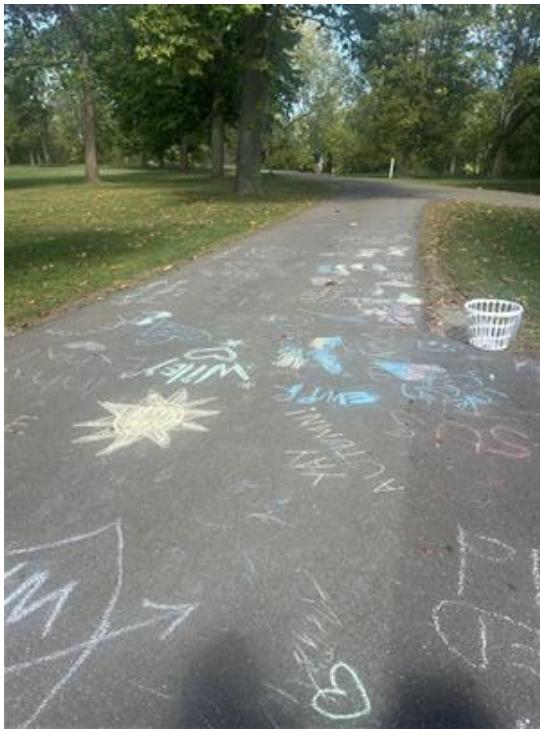
Photo 15. Chalk Art at Lake Loop West

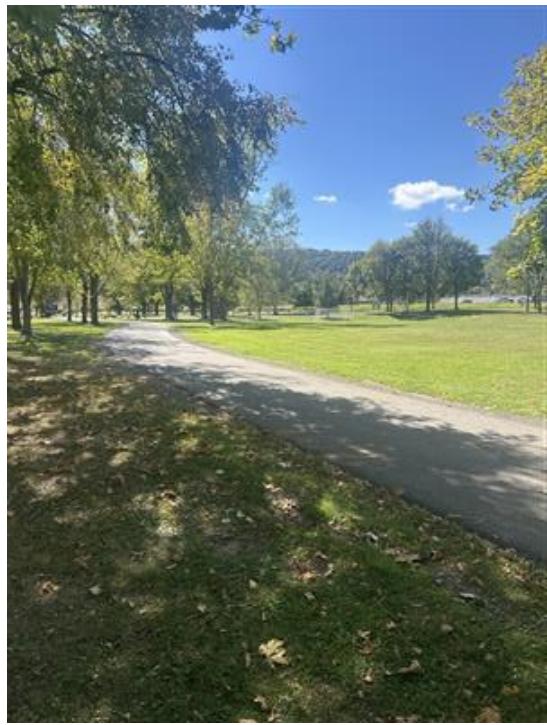
Photo 16. Southern View at Otsiningo Park Loop Northwest

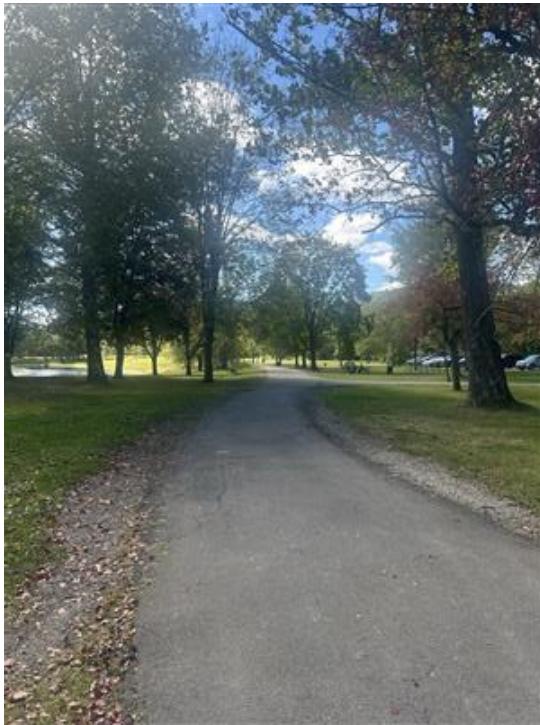
Photo 17. Southern View at Lake Loop West

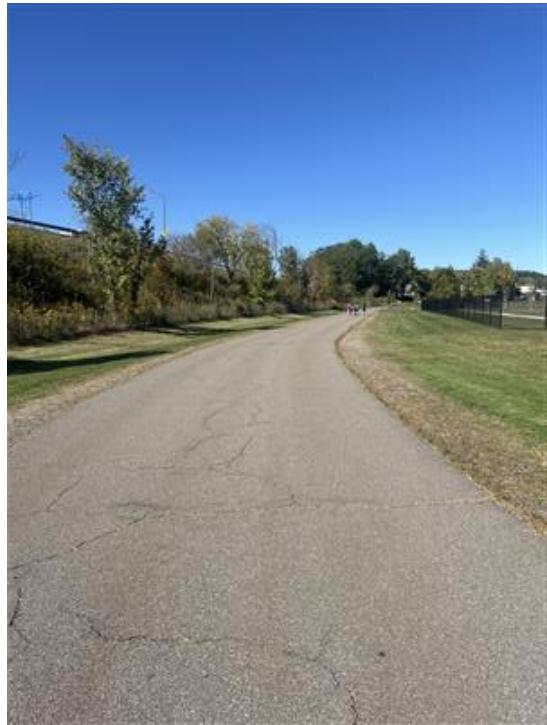
Photo 18. Northern View at Northern Upper Front Street

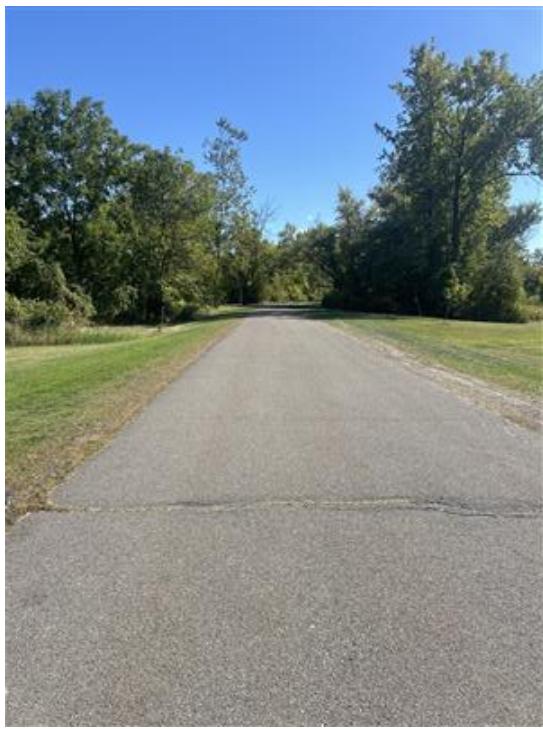
*Photo 19. Southern View at Northern Upper Front Street*

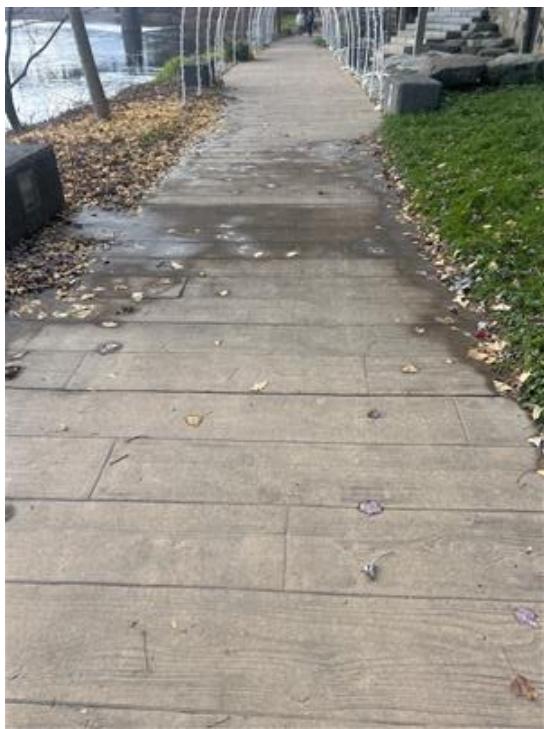
*Photo 20. Pavement at Main Trailway*

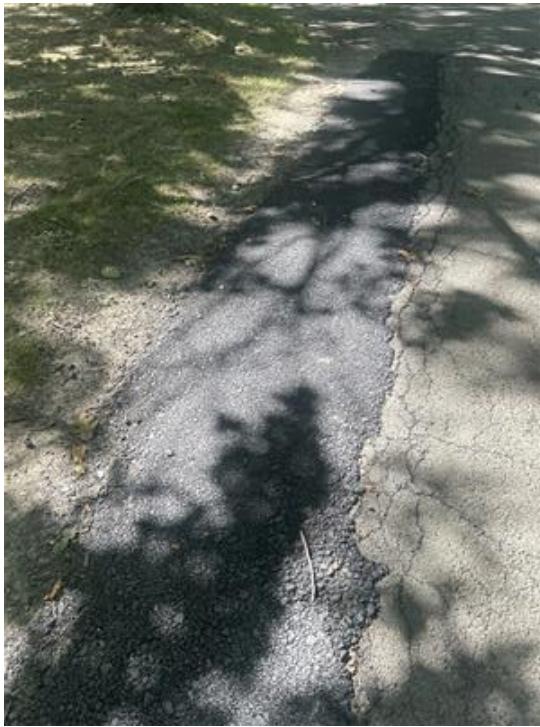
*Photo 21. Asphalt Patch at Center Path/Western Loop Segment*

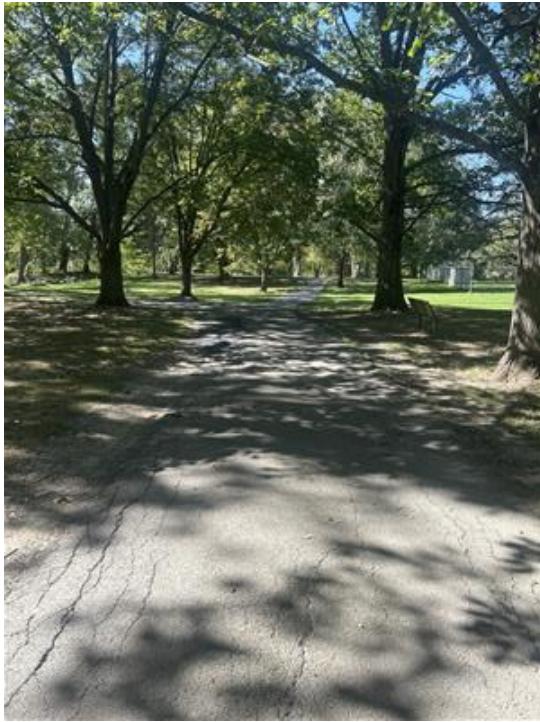
*Photo 23. Western View at Center Path/Western Loop segment*

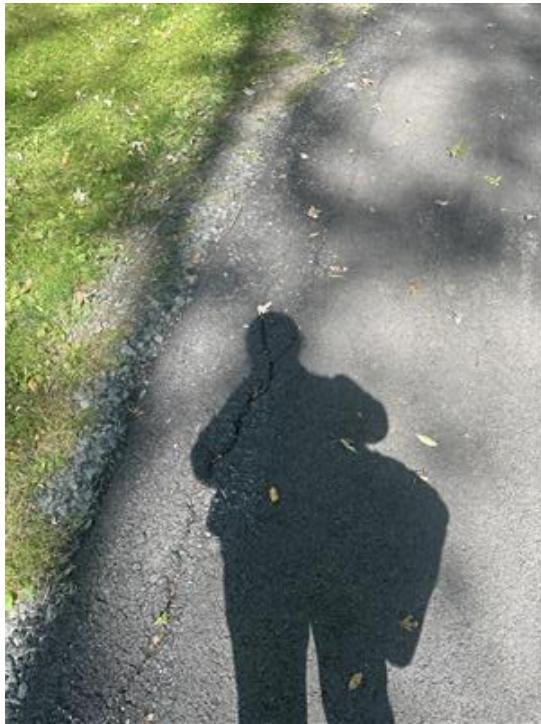
*Photo 25. Pavement Loss at North Loop Segment*

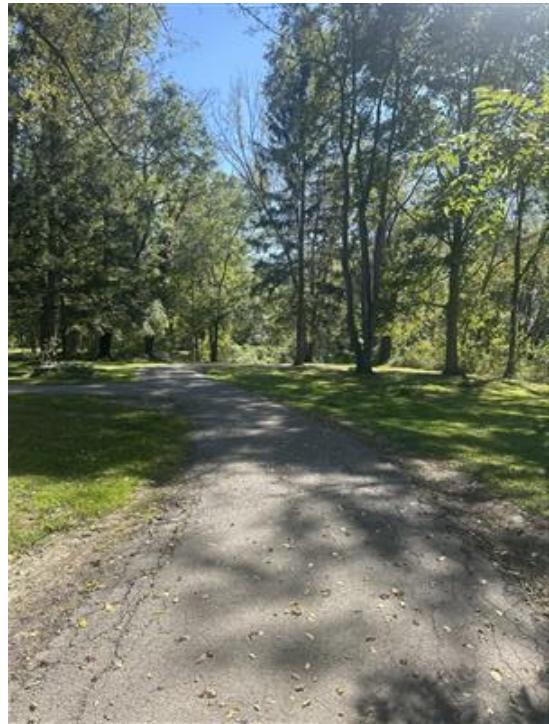
*Photo 26. Northern View at Western Loop Segment*

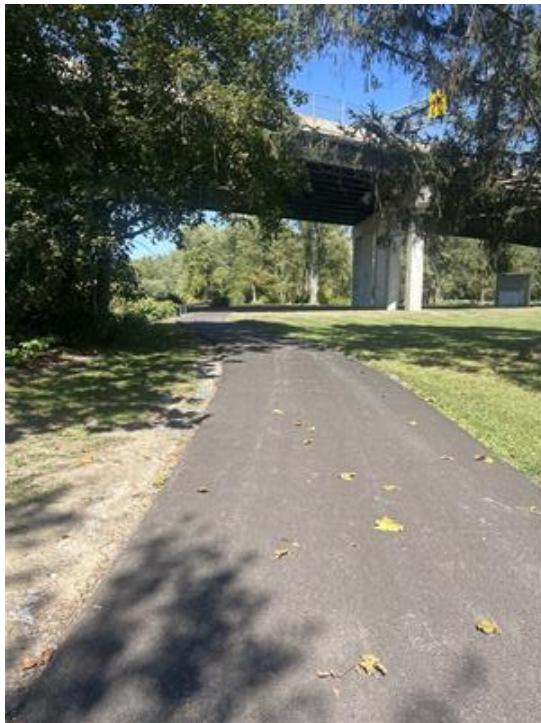
79% of Port Dickinson Community was in good/excellent condition. Northern swaths of the park's trail were recently repaved and in brand new condition (See Appendix A, Photos 24, 27, and 31). Three out of thirteen segments were in excellent condition. However, southern portions of the trail are in good to poor condition (See Appendix B, Photos 26-29). The biggest problems are in the Southern Loop Segments, which have major patches of uneven pavement due to crumbling asphalt. Major losses in asphalt were also present in the Southern Inner Path (See Appendix B, Photos 28 and 29). The trail was on average in good condition, scoring a 3 out of 4 in average pavement score.

*Photo 27. Northern View at Northwest Loop Segment*

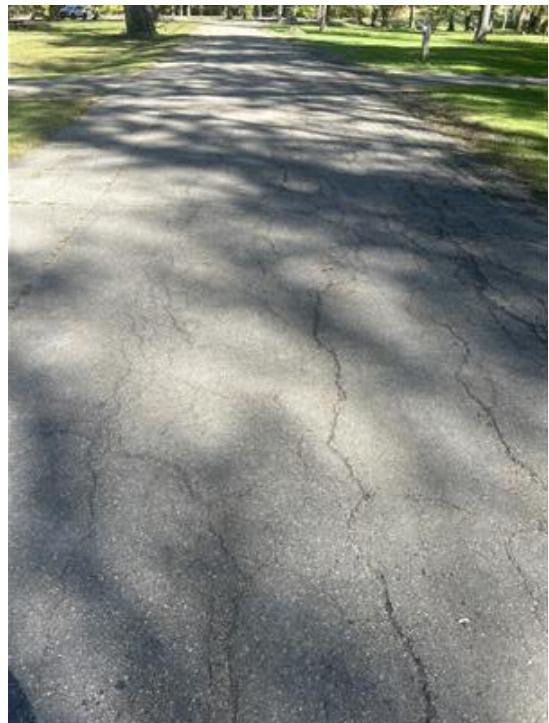
*Photo 28. Pavement at Southern Inner Path*

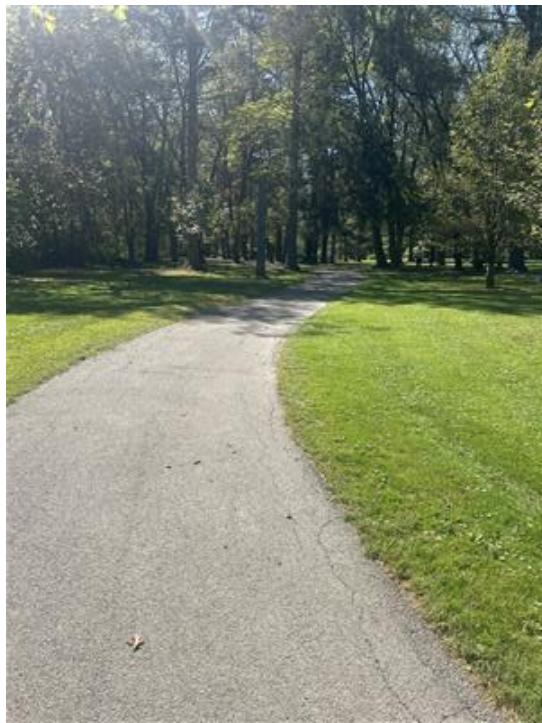
*Photo 29. Southern View at Southern Loop Segment*

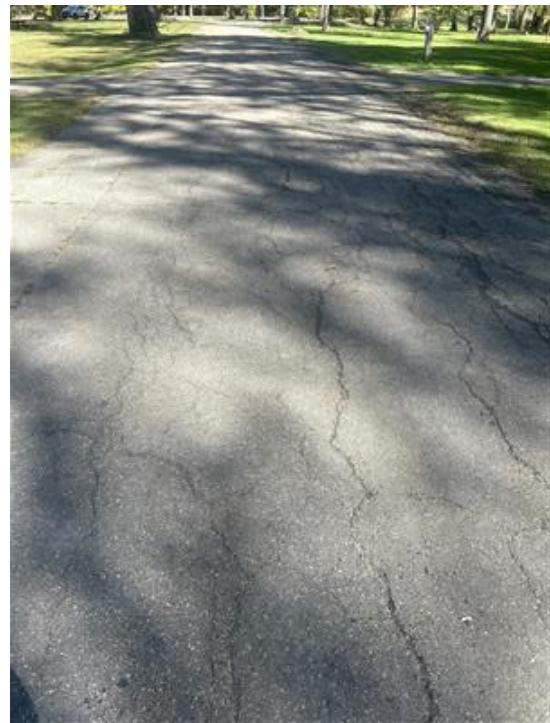
*Photo 30. Pavement at Southern Inner Path*

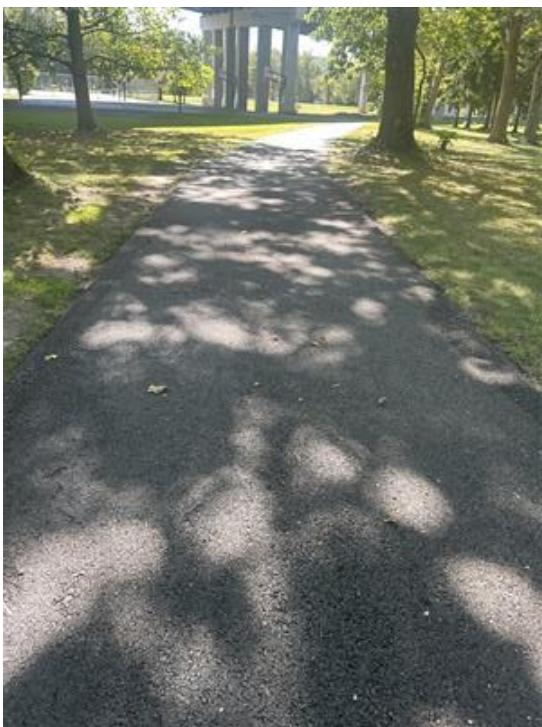
*Photo 31. Southern View at Northeastern Loop Segment*

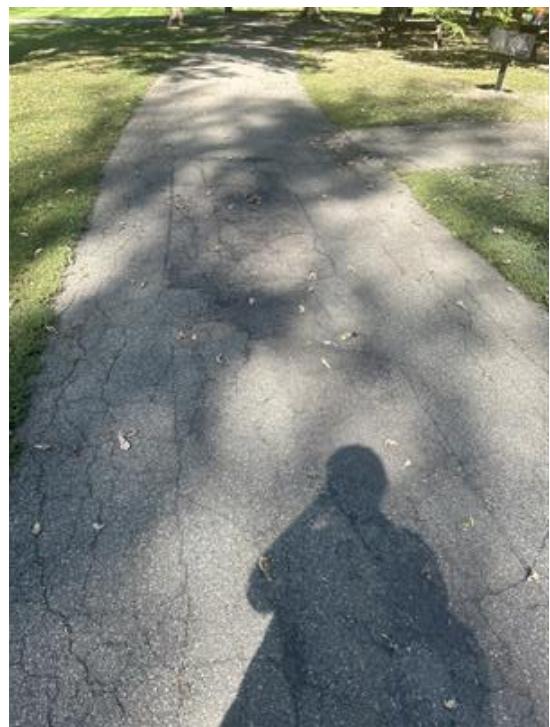
*Photo 32. Pavement at North/South Bathroom Path*

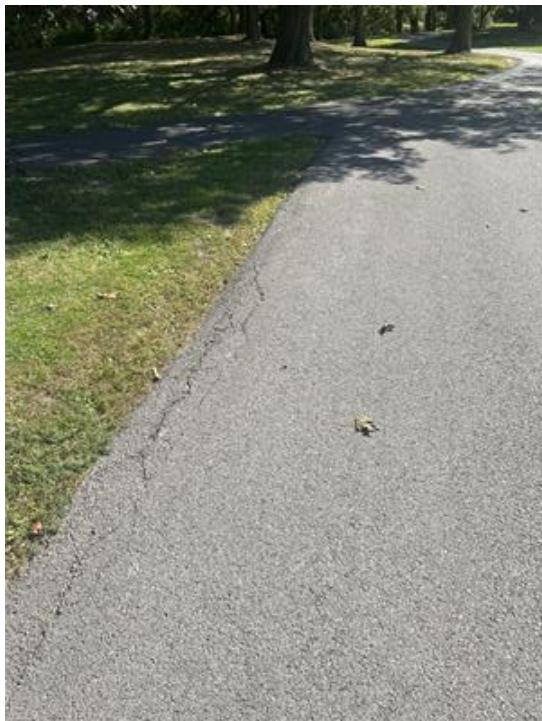
*Photo 33. Pavement at Eastern Loop Segment*

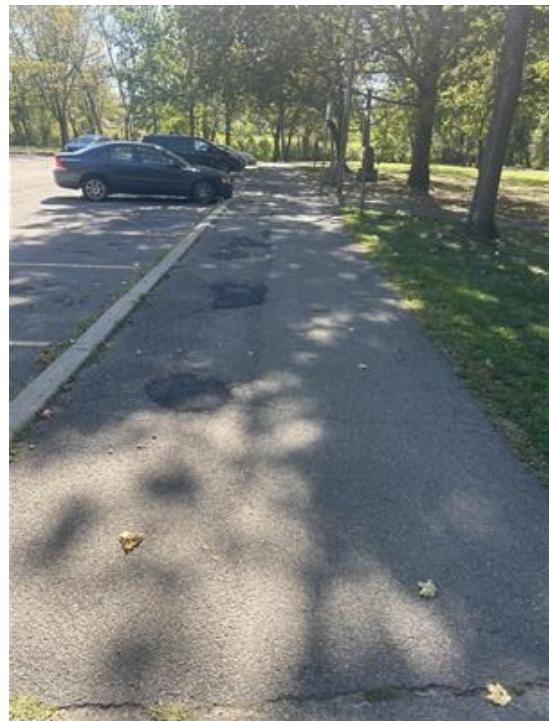
*Photo 34. Pavement at Entrance*

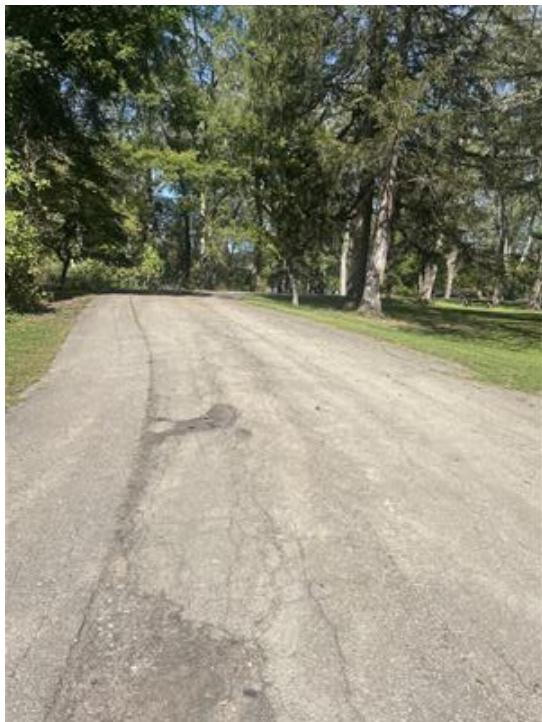
*Photo 35. Pavement at Southern Inner Path*

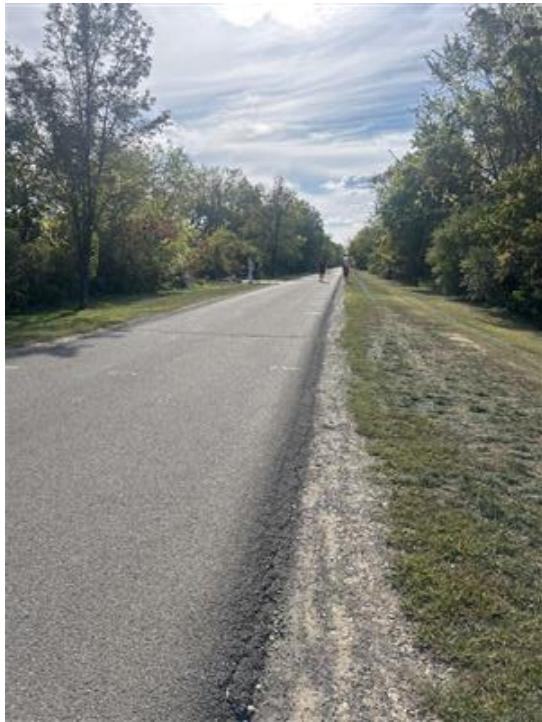
*Photo 36. Western View at Twin Orchard Park to Stage Rd Access Point*

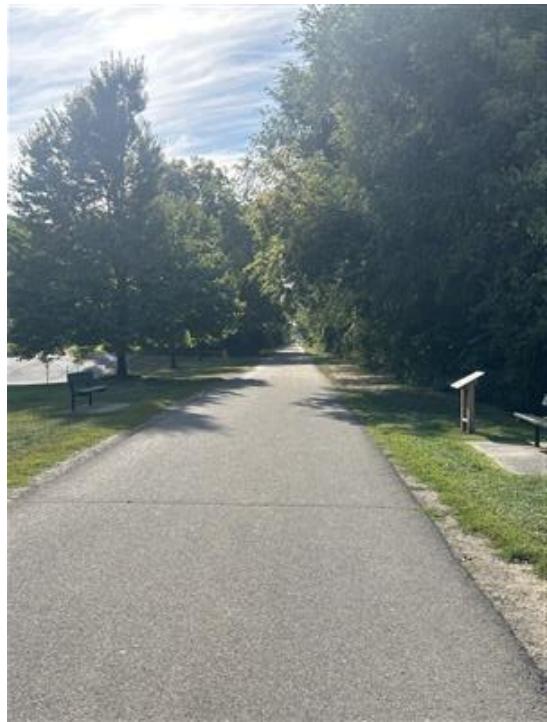
*Photo 37. Western View at African Rd Trailhead to Twin Orchard Park*

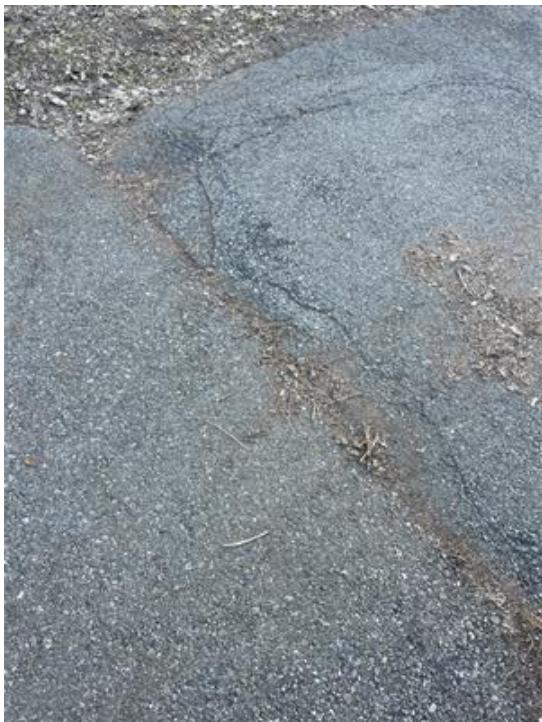
*Photo 38. Pavement at Stroehmann Bakeries*

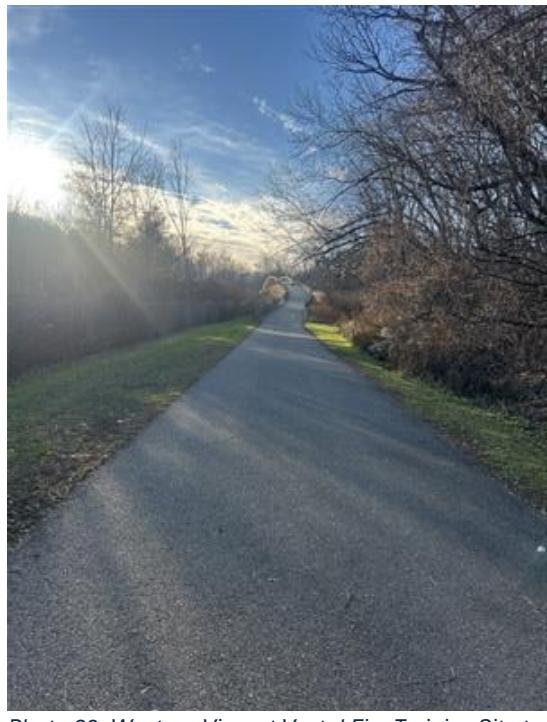
*Photo 39. Western View at Vestal Fire Training Site to Choconut Creek Bridge*

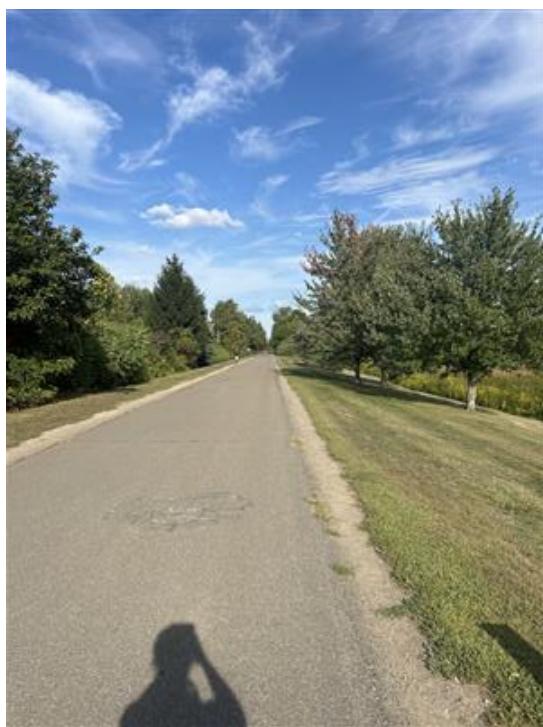
*Photo 42. Western View Twin Orchard Park to Stage  
Rd Access Point*

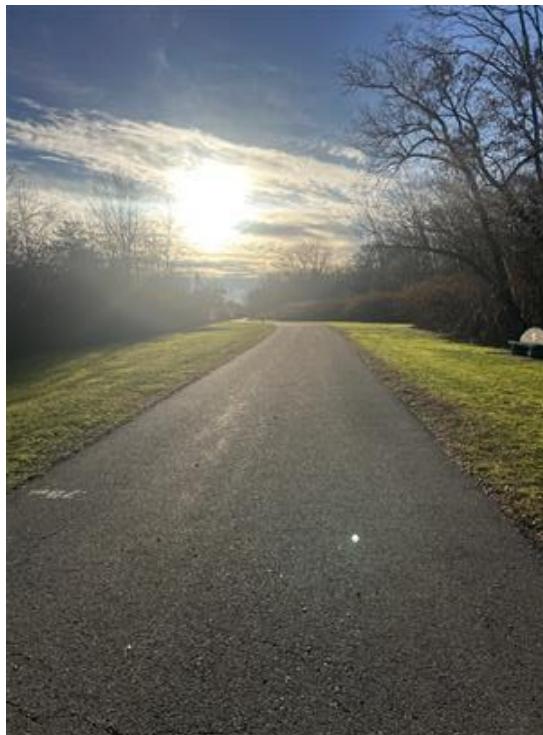
*Photo 44. Western View at Fairbanks Karate to Stroehmann Bakeries*

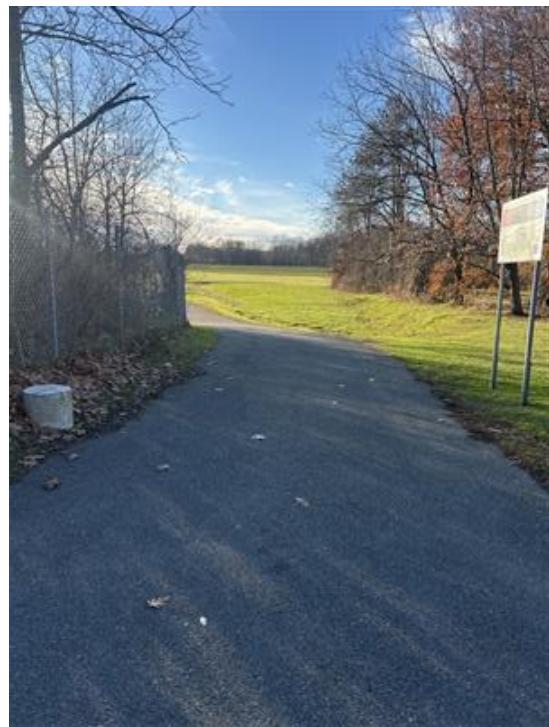
*Photo 45. Western View at N Main Street Access*

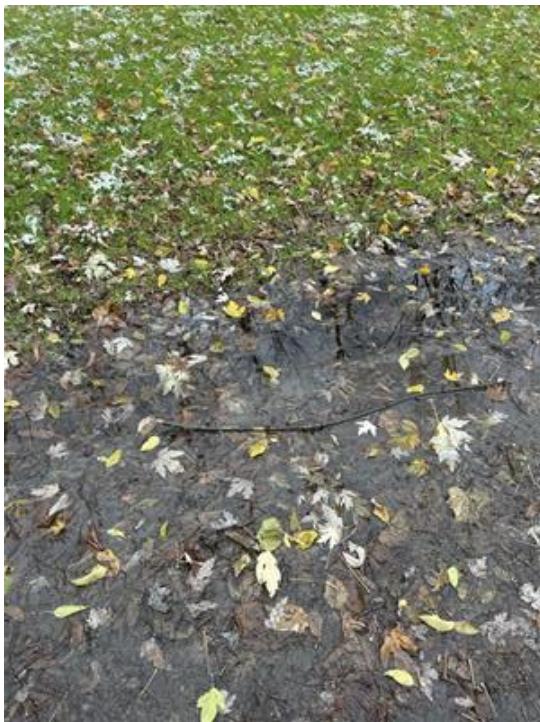
*Photo 13: Depression at Community Center to UE Stadium*

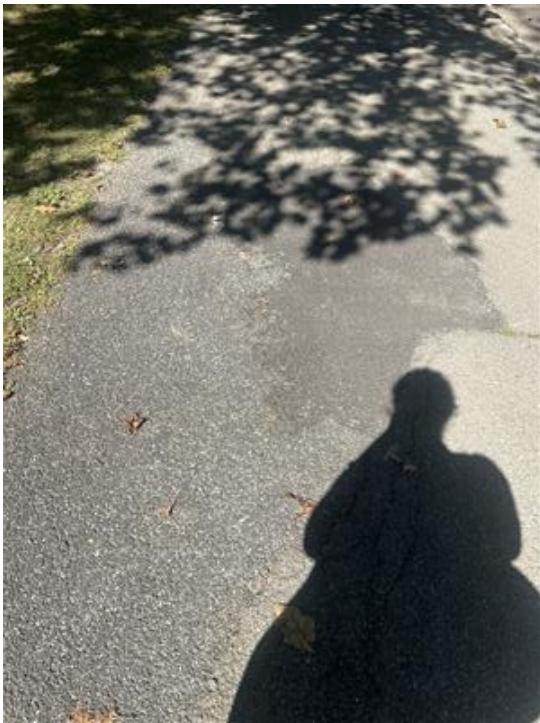
Five major issues were identified in Port Dickinson Community Park, localized to the southern swaths of the trail. Three of the five major issues included losses in pavement, creating holes in the pavement (Appendix B, Photos 26-29). Sinking and unevenness were also a problem (See Appendix B, Photos 23 and 24).

*Photo 23: Unevenness at Entrance*

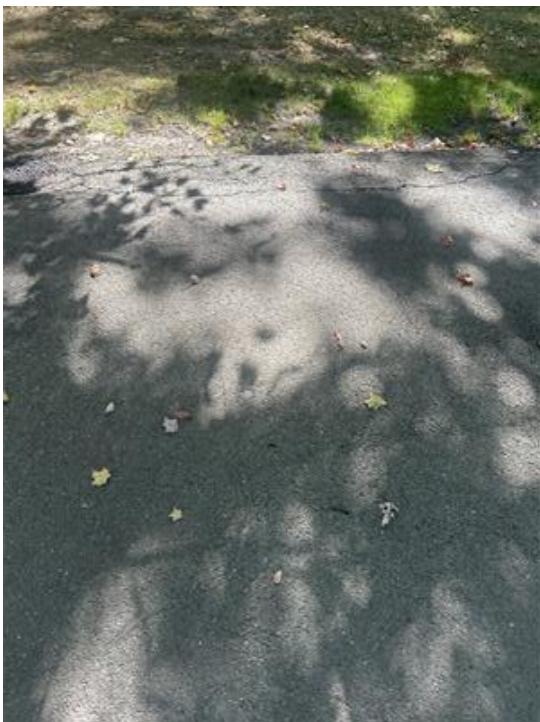
*Photo 25: Upheaval at Center Path/Western Loop Segment*

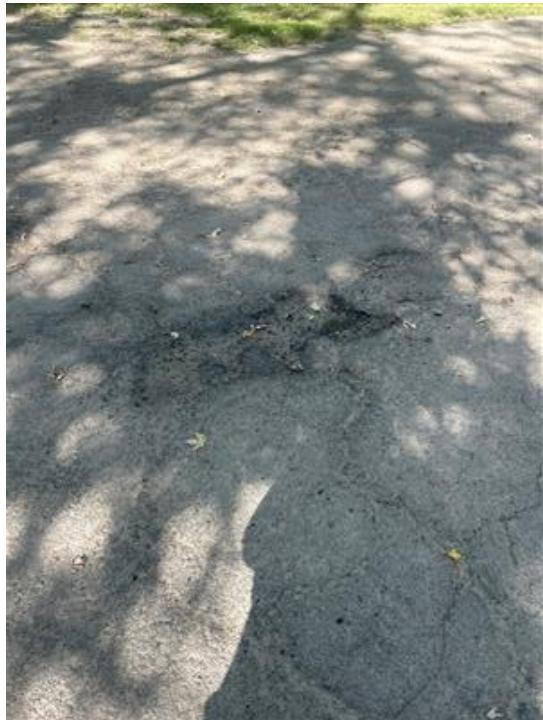
*Photo 27: Pothole at Southern Loop Segment*

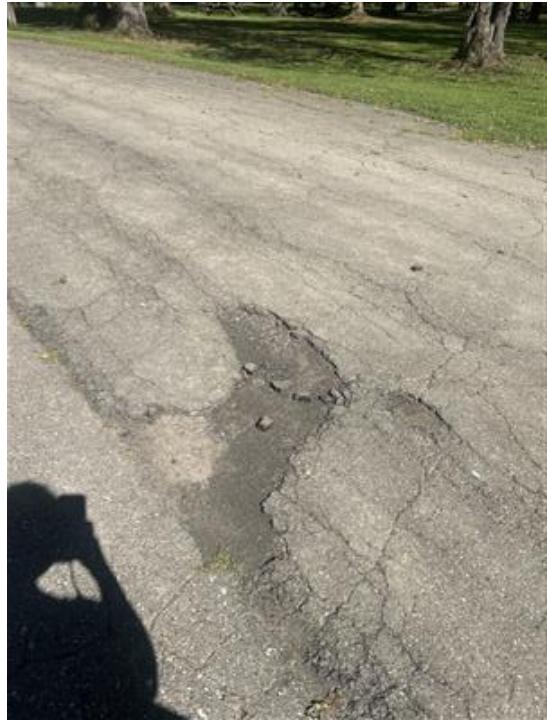
*Photo 28: Raveling at Southern Inner Path*

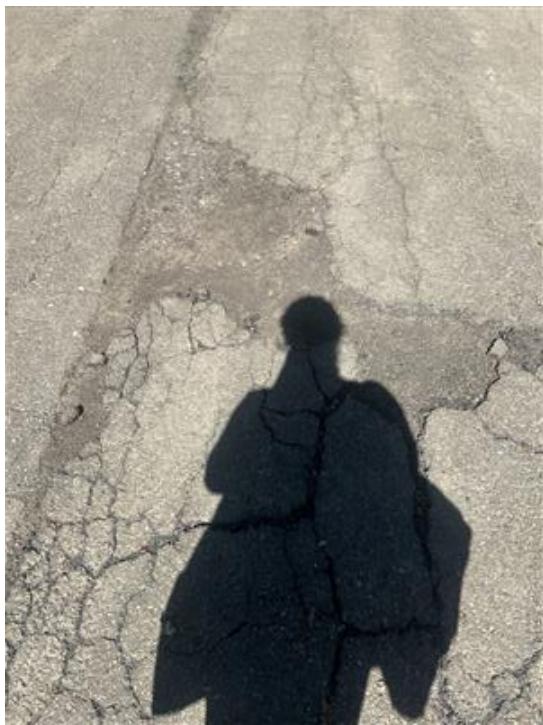
*Photo 29: Raveling at Southern Inner Path*
