2026

Two Rivers Greenway Trail Maintenance Report

PREPARED BY BMTS CENTRAL STAFF

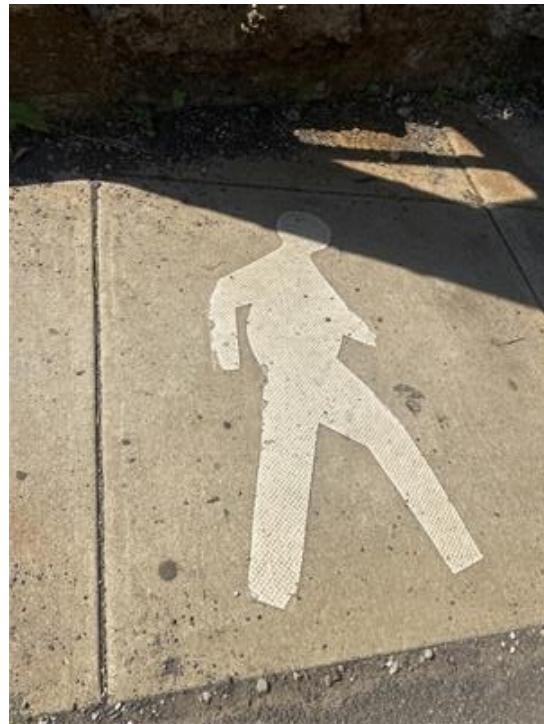
Photo 10. Pedestrian Signage at E Clinton Street to Eldredge

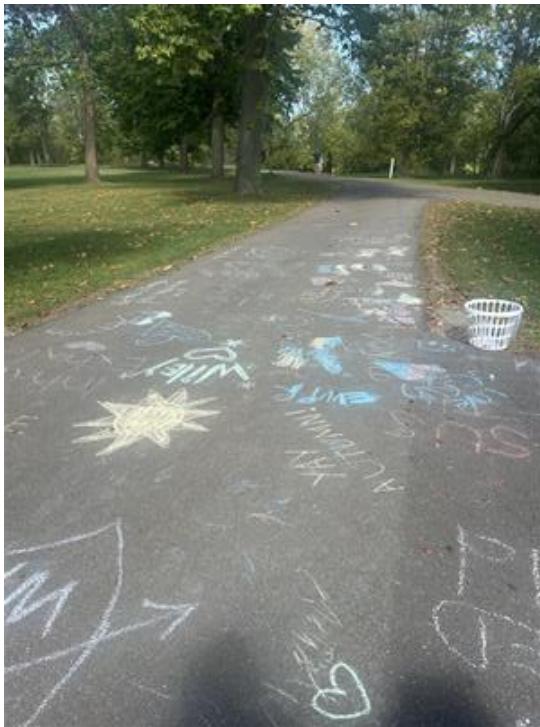
Photo 15. Chalk Art at Lake Loop West

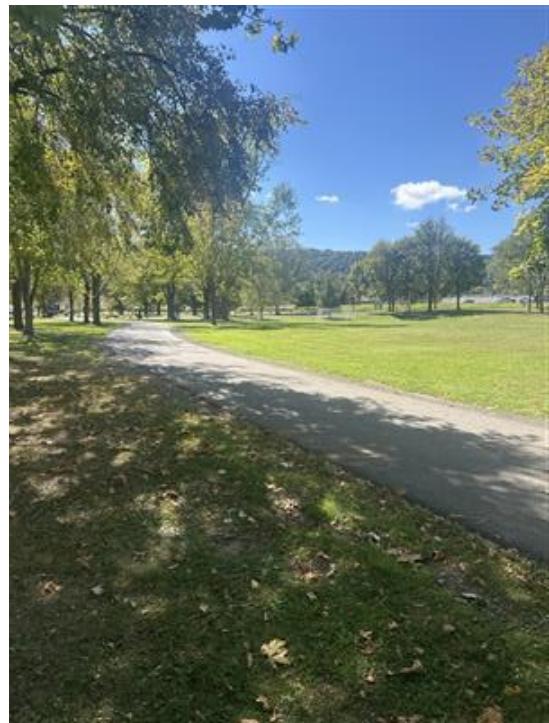
Photo 16. Southern View at Otsiningo Park Loop Northwest

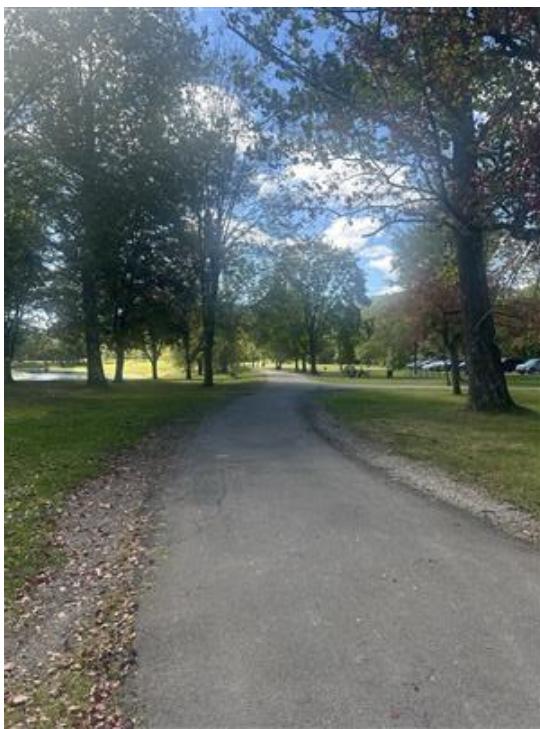
Photo 17. Southern View at Lake Loop West

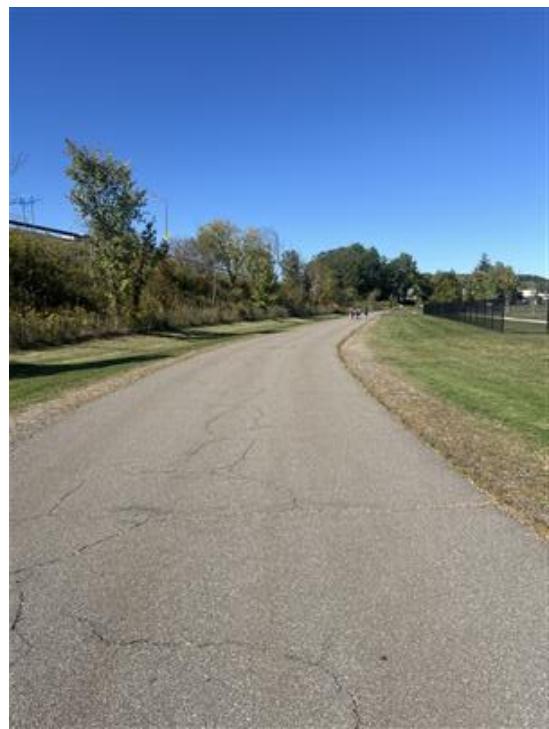
Photo 18. Northern View at Northern Upper Front Street

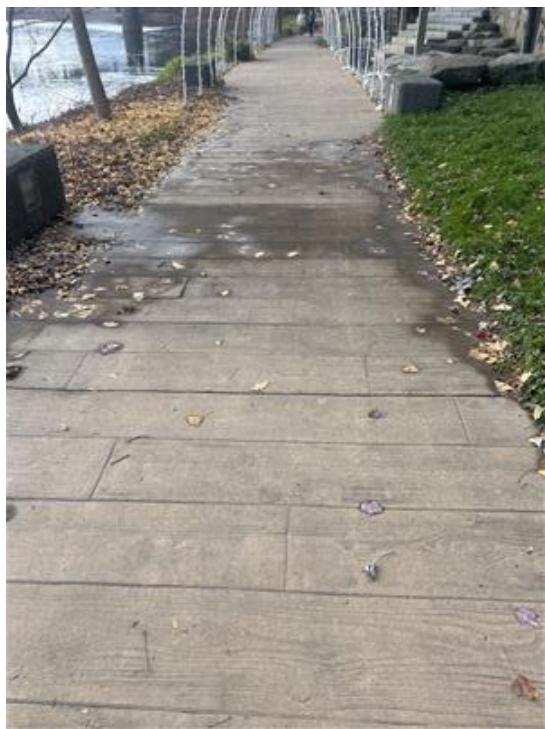
Photo 20. Pavement at Main Trailway

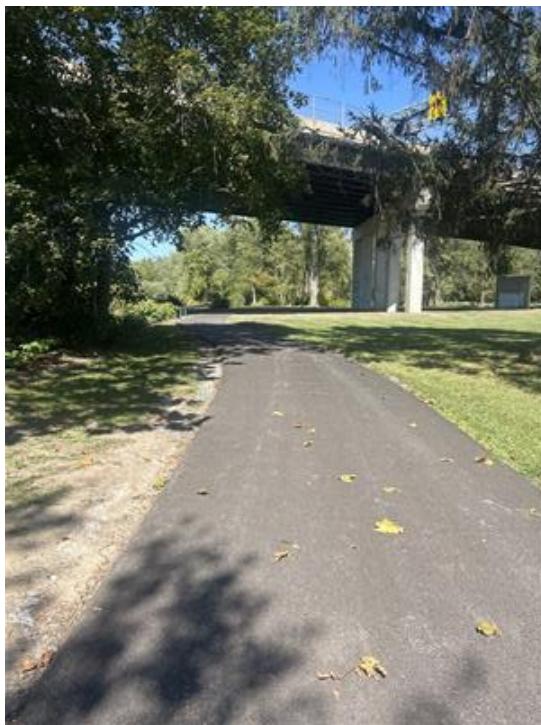
Photo 27. Northern View at Northwest Loop Segment

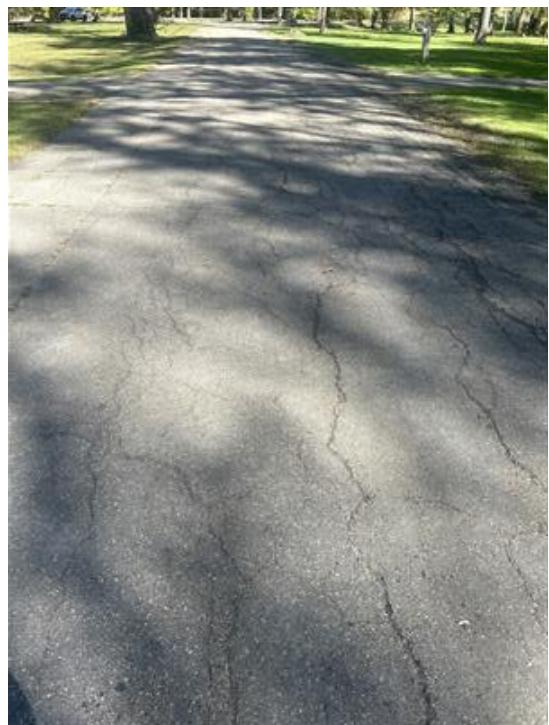
Photo 28. Pavement at Southern Inner Path

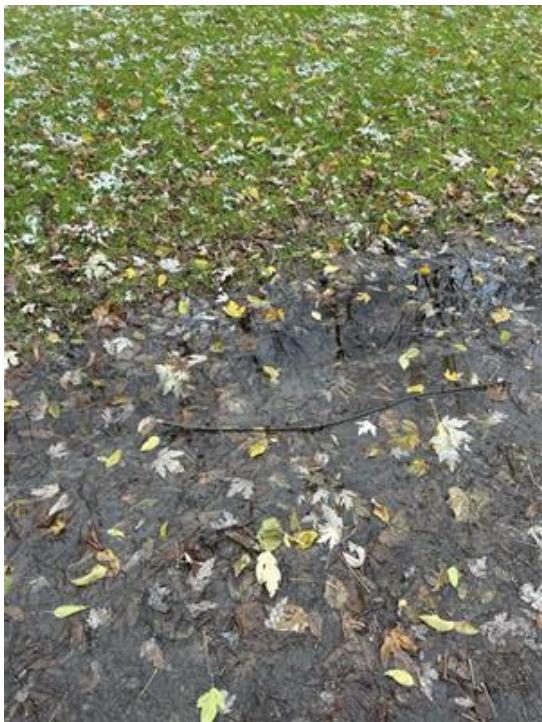
Photo 13: Depression at Community Center to UE Stadium
